Service Bulletin

Bulletin No.: 25-NA-054

Subject: Information on No Crank, Engine Will Not Rotate, No Start after Traveling in Cold Weather

Brand:	Model:	Model Year:		Build Date:		Engine:	Transmission:
		from	to	from	to		
Chevrolet	Silverado 2500HD/ 3500HD	2024	2025			L5P	
GMC	Sierra 2500HD/ 3500HD

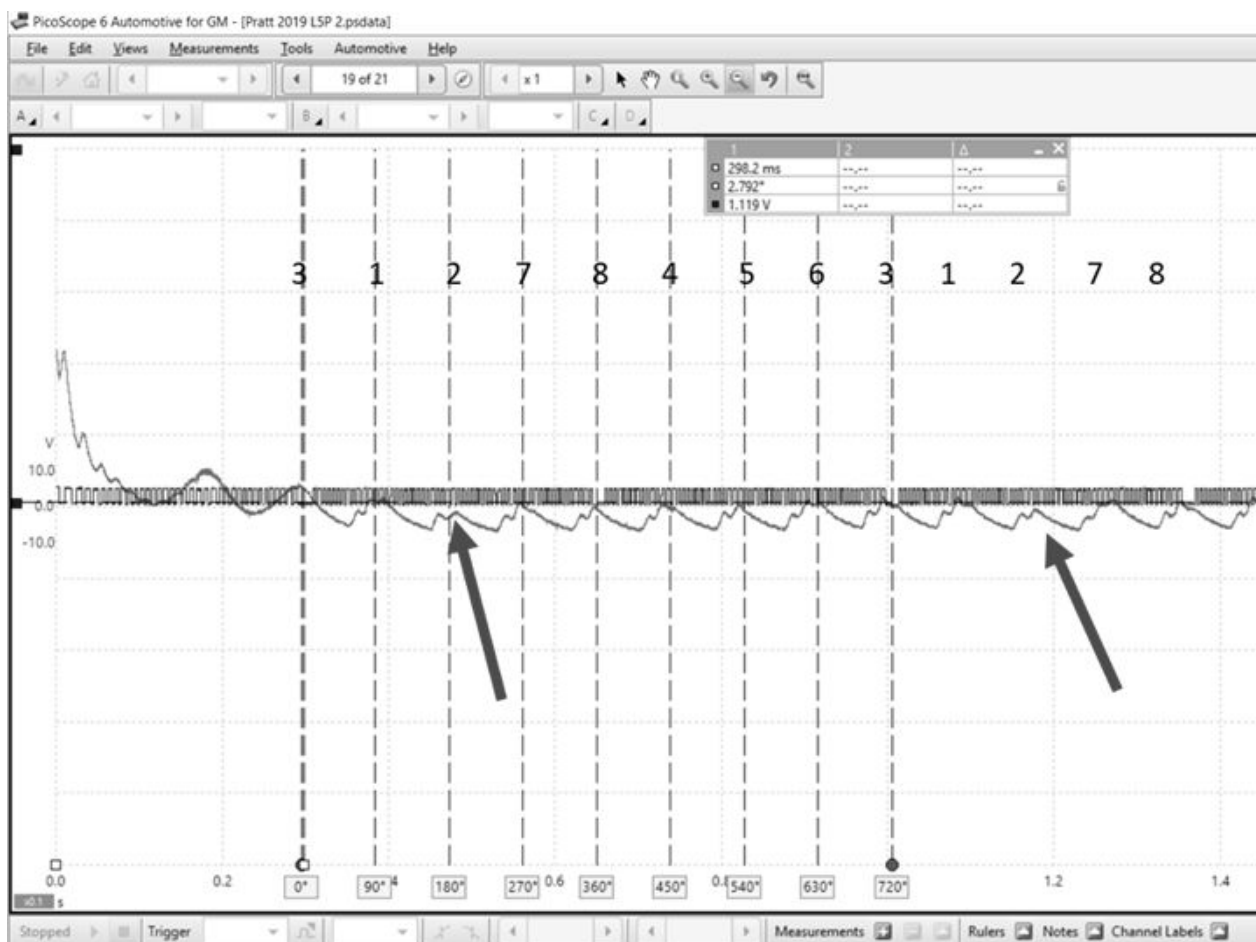
6860441

The graphic above is an example of a relative compression test performed on an engine that had a bent piston rod (Fuel System Disabled, Amp Clamp on 1000 A Setting).
