| Topic | Software update for the rear door control modules - 00BB and 00BC - 25MY (SC24/25) |
| Brand | Bentley |
| Campaign number | ED18 |

### New Continental GT and New Continental GTC

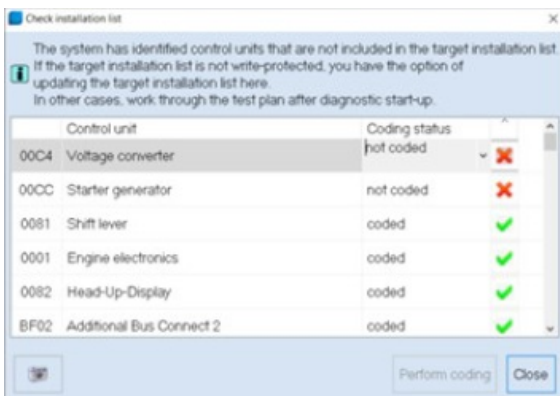
Figure 1

If a 'Check installation list' pop-up appears, select 'close' (Figure 1)

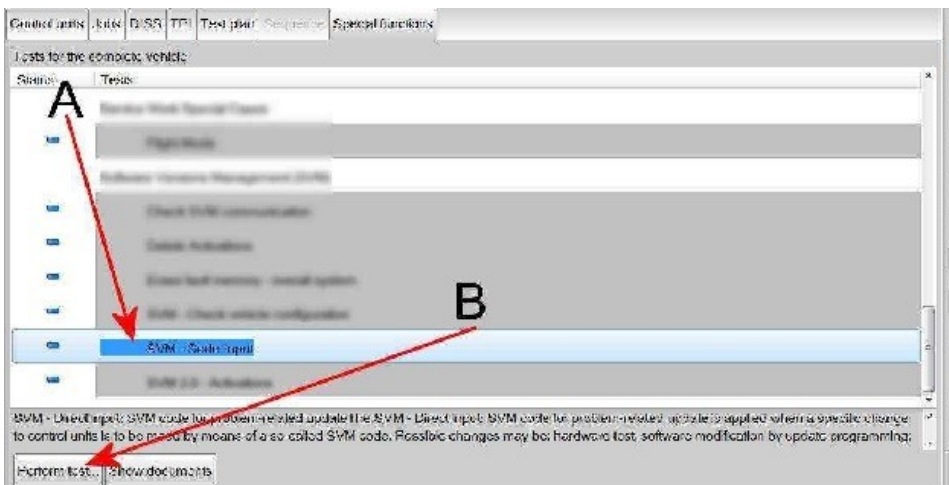
2) Referring to Figure 2 - Within the Special functions tab - Select SVM - Code Input (Point A)

• Select Perform test (Point B)

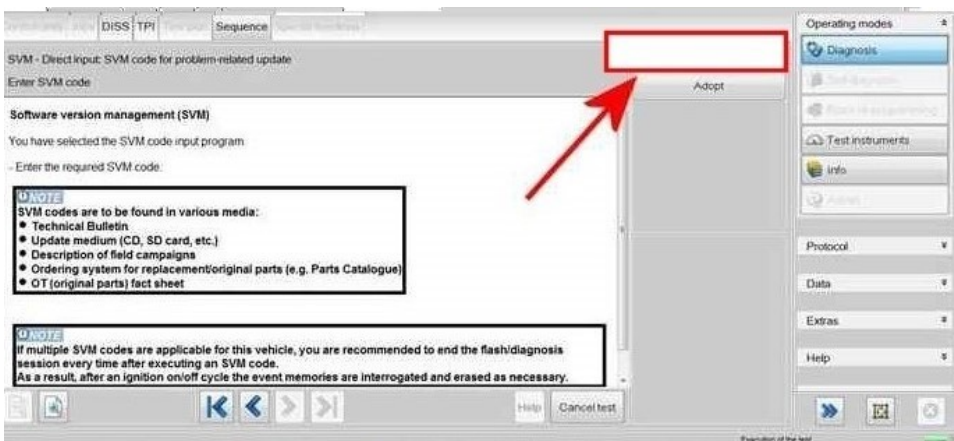
3) Referring to Figure 3 - Enter the SVM code 372WDD01

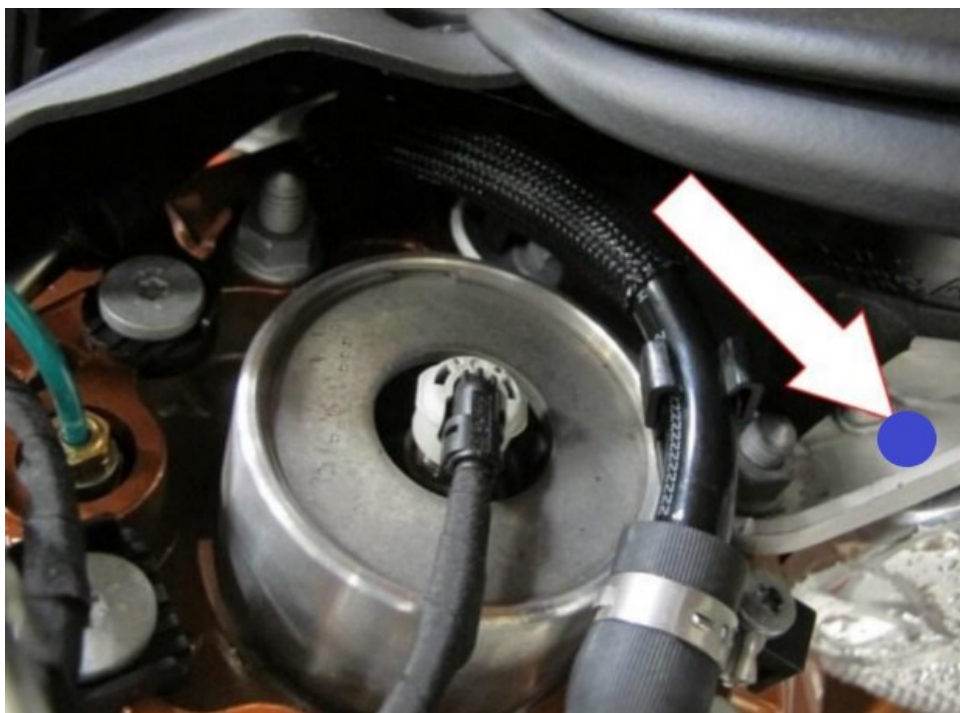
Figure 4

Blue paint completion mark on the engine partition brace

14) Referring to the Identification section - Apply a blue paint completion mark on the engine partition brace (Figure 4)
