54-372 Connect 5 Instrument Cluster (ICC5) Nuisance Fault Code

TSB-54-372-FTL

- ▶ Business Class M2-Plus
- ▶ 108SD Plus/114SD Plus
- ▶ Cascadia

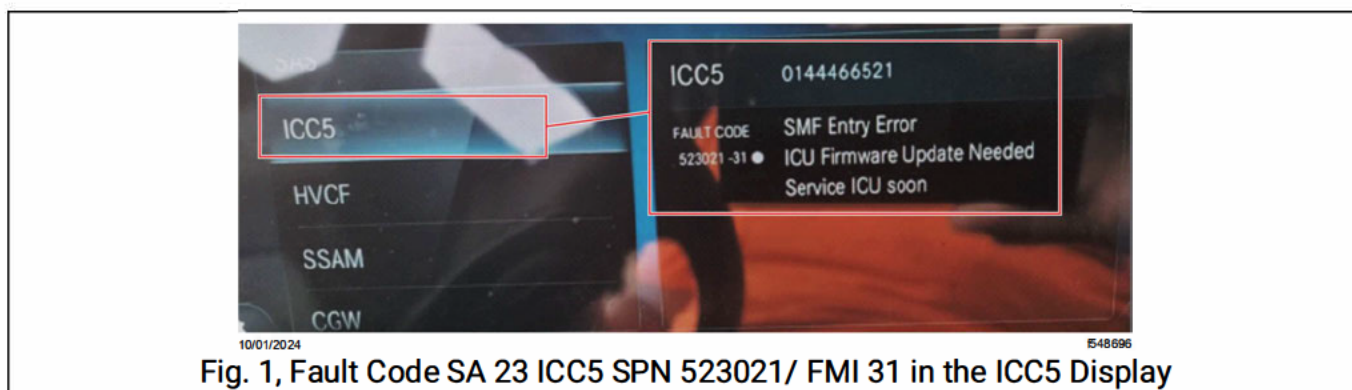
Fig. 1, Fault Code SA 23 ICC5 SPN 523021/ FMI 31 in the ICC5 Display

Vehicles equipped with a Connect 5 Instrument Cluster (ICC5) and ordered with the software package identified by sales codes 81Z-008, 81Z-308, or 81Z-808 (related to model year 2023 or software version 22.50.30) may display the fault code 'SA 23 ICC5 SPN 523021/ FMI 31 - The list of Electronic Control Units (ECUs) in the Warning Database (WDB) does not match the list of ECUs parameterized in PID 0x20.' This is considered a nuisance code and does not require any troubleshooting or programming changes.

Figure 1 shows what the fault code 'SA 23 ICC5 SPN 523021/ FMI 31' looks like on the ICC5 display.
