# TECH TALK - VOLUME 285

## MARCH/APRIL 2025

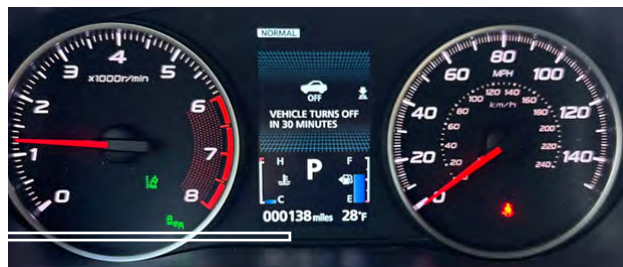
Some 2025 Eclipse Cross customers may comment their vehicle displays a warning message stating the vehicle will shut off in 30 minutes. 2025 Eclipse Cross vehicles equipped with F.A.S.T. Key have a feature called Vehicle Auto Turn-Off System. With the vehicle in park and the driver's door open, this message will be displayed, and a timer will automatically shut the vehicle off after 30 minutes of continued engine operation. This system can be temporarily shut off but will default to normal operation upon the next key cycle. Additional information regarding this feature is found on page 5-27 of the 2025 Eclipse Cross Owner's Manual.

If the driver's door is opened with the selector lever in the "P" (PARK) position and the engine running, a timer starts and the engine will automatically stop in 30 minutes. Also, 30 seconds after the engine is automatically shut off, the operation mode turns to OFF. When the timer starts, 30 seconds before the engine is shut off and 30 seconds before the operation mode is turned to OFF, the display on the information screen in the multi-information display and the buzzer will inform the driver. After the timer starts, auto engine shut-off can be canceled by depressing the brake pedal or the accelerator pedal.

Technicians are advised not to attempt any repairs for this concern as this a normal operating characteristic. Service Advisors should review the feature and its operation with their customers in the event customers raises a concern regarding the feature.

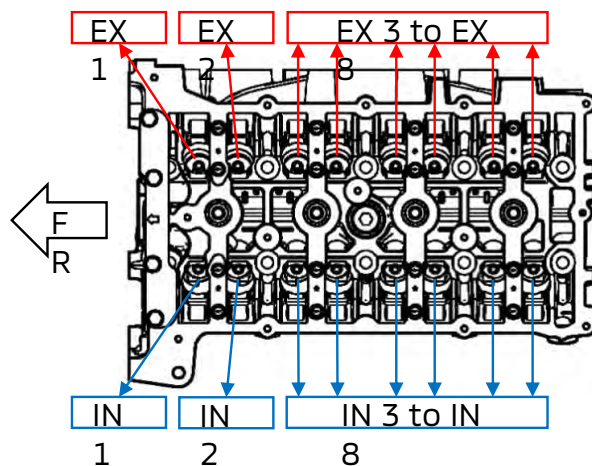
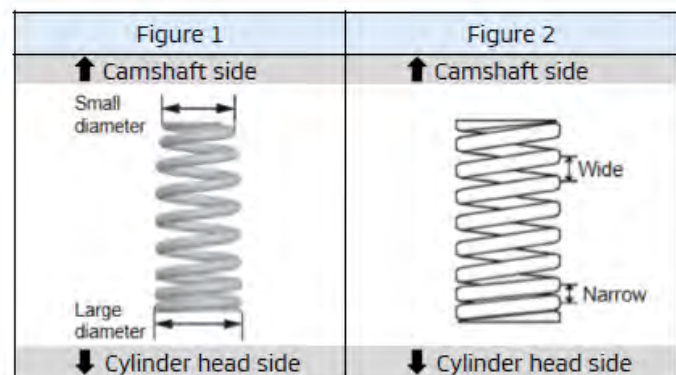
There are several shapes of valve springs, some of which have a specified installation direction. This direction can be identified by a paint mark on the valve spring, but the paint may be removed when the part is washed, potentially leading to incorrect maintenance work. Therefore, this article provides technical tips for the valve spring.

- ✓ If the top and bottom diameters of the valve spring are different, install it so that the smaller diameter faces the camshaft side. (Figure 1)
- ✓ If the spring has an unequal pitch, install it so that the wider pitch faces the camshaft side. (Figure 2)
- ✓ If the valve spring has the same top and bottom diameters and equal pitch, it can be installed in either direction.
