Incorrect Representation of the Vehicle Silhouette in the Instrument Cluster: Check and, if necessary, Update the Instrument Cluster Software Release (SY 04/25)

Vehicle Type: **911 Cabriolet (992) / 911 T Cabriolet (992) / 911 S Cabriolet (992) / 911 GTS Cabriolet (992) / 911 4 GTS Cabriolet (992)**

Model Year: **2025**

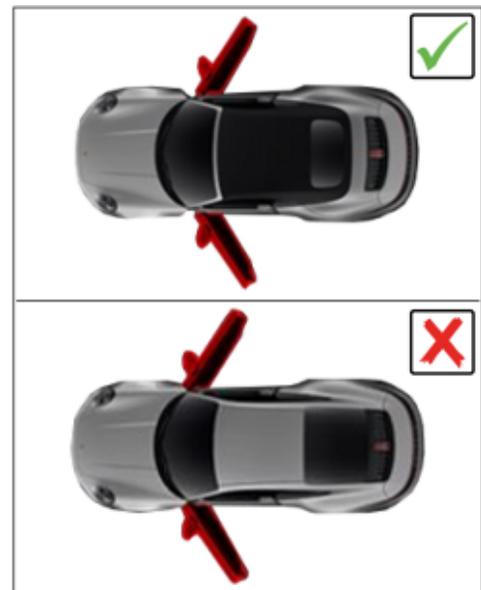
Presentation of vehicle silhouette

Symptom: **The customer complains that the display in the instrument cluster does not correspond to the actual vehicle silhouette.**

A coupé silhouette is shown instead of the cabriolet silhouette.

Cause: Faulty coding in the instrument cluster control unit.

Remedial Action: If there is a customer complaint, check the software release of the instrument cluster control unit and reprogram **or** recode the instrument cluster control unit depending on the software release.
