246/24 ENU 1001

Combustion Misfiring / Irregular Engine Running during Catalytic Converter Heating Phase and Yellow Malfunction Indicator Light (MIL) Active: Clean the Injector Valves (246/24)

Vehicle Type: **Panamera 4 E-Hybrid (971) / Panamera 4S E-Hybrid (971)**

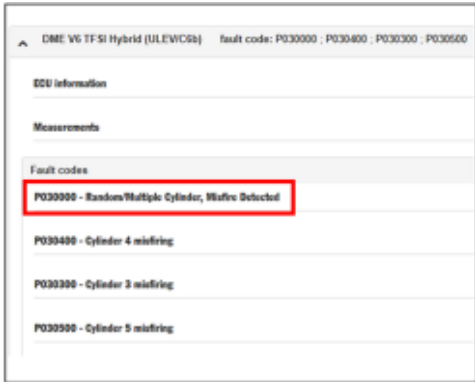
Assessment	Action
<ul style="list-style-type: none"> Fault "P030000 - Combustion misfiring detected" is present in the fault memory of the DME control unit ⇒ <i>DME control unit fault memory entry</i>

<p><i>DME control unit fault memory entry</i></p> <ul style="list-style-type: none"> In addition, the measured values show the following engine torque when the fault occurs: between 80 - 90 Nm (59 - 66.4 ftlb.) ⇒ <i>Engine torque measured values</i>

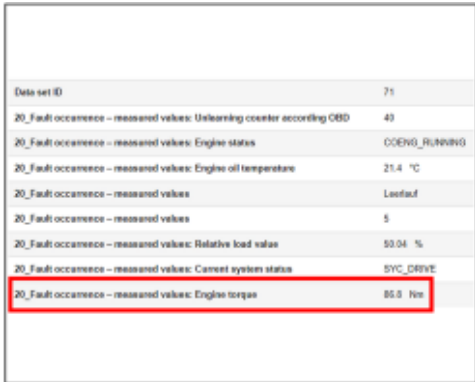
<p><i>Engine torque measured values</i></p>	<p>The fuel injectors are contaminated. Go to ⇒ 4.</p>
<p>Fault "P030000 - combustion misfiring detected" is not present in the fault memory of the DME control unit.</p>	<p>The irregular engine running cannot be solved by this SY. Continue with troubleshooting.</p>

- 4 Pour in two cans of "Keropur" to the fuel tank.
⇒ Fuel additive "Keropur".
