Countries: CANADA, UNITED STATES Document ID: IK1201511  
 Availability: ISIS, FleetISIS, IsSIR Revision: 0  
 Major System: ENGINE Created: 3/19/2025  
 Current Language: English Last Modified: 3/26/2025  
 Other Languages: NONE Author: Brandon Heisler  
 Viewed: 684

Title: Supplemental A26 MAF Fault Diagnostics

Applies To: All A26 Engines

This document will guide users through supplemental diagnostics for SPN 132, Mass Air Flow, fault codes.

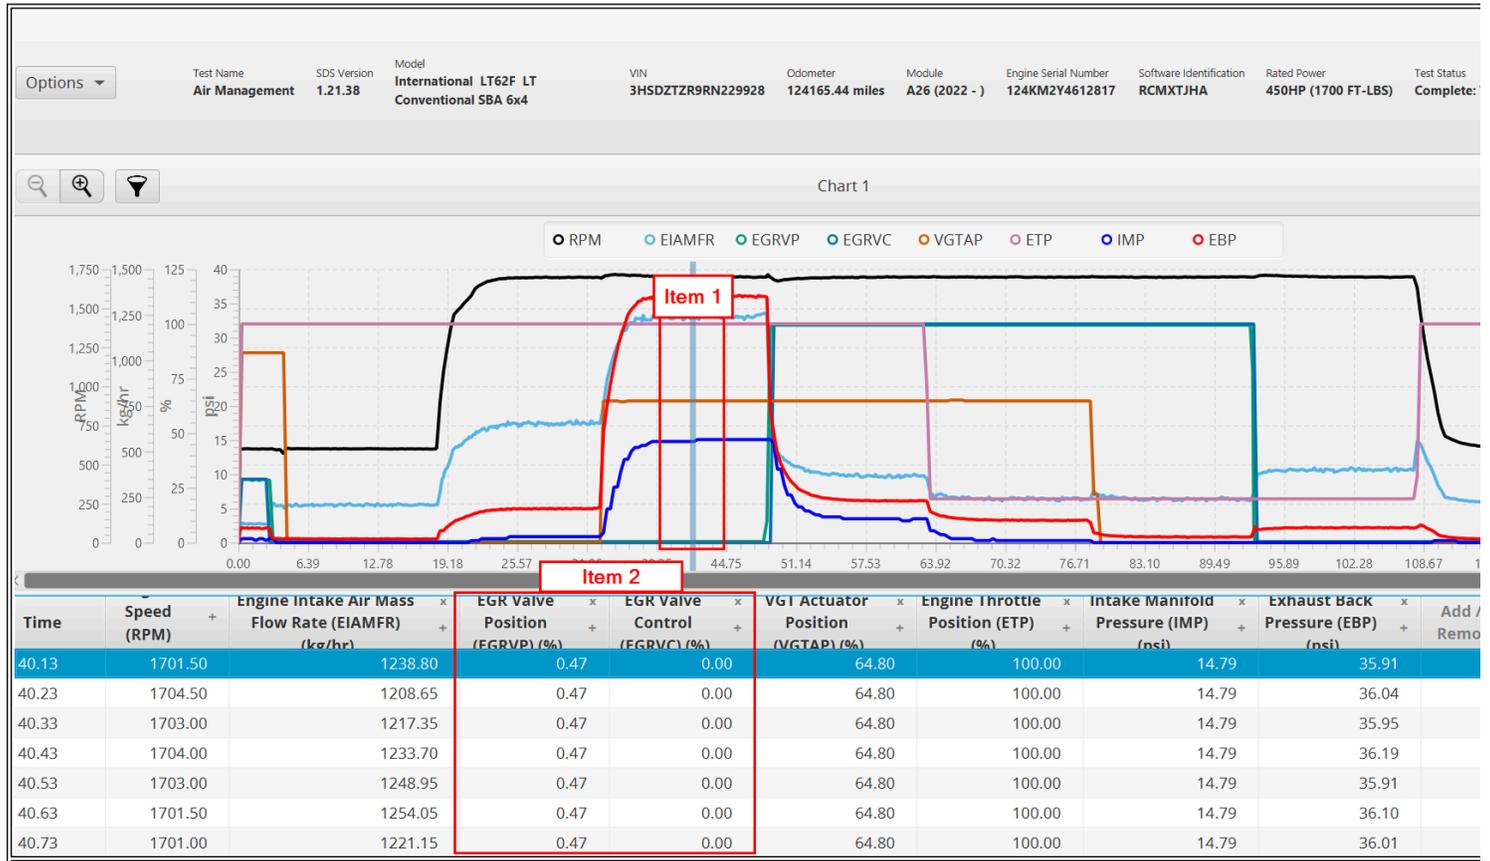
**STEP 5**

Step	Confirm EGRV operation	Decision
#5	<p>Perform an Air Management Test and inspect for EGRV operation per <a href="#">Image #1</a>:</p> <p>Was a failed EGRV identified?</p> <p><b>NOTE: At the selection point in Image 1, the EGRV should be 0.00% when commanded is 0.00%. If it is not, this should be considered a failed EGRV.</b></p>	<p><b>Yes.</b></p> <p>Replace the EGRV, perform a MAF calibration, and re-test for the issue. If the issue persists, proceed to step 6.</p> <p><b>NOTE: If the EGRV was replaced, another AMT should be completed before proceeding to step 6.</b></p>
		<p><b>No.</b></p> <p>Proceed to step 6.</p>

Item 1: Selection point of the AMT

Item 2: Example of EGRV position blowing open from commanded position
