Disconnected Panoramic Roof Drain Can Cause Electrical Faults

Bulletin #: 2507

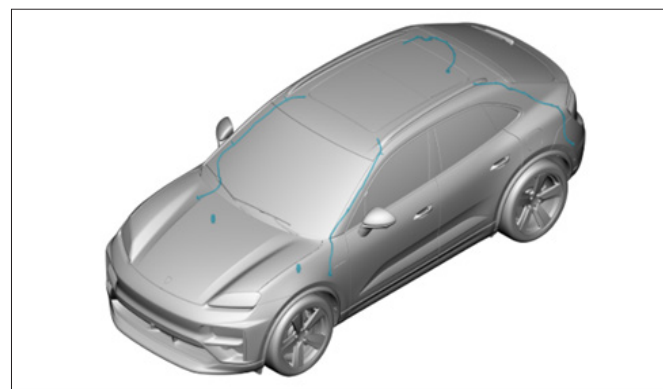
Figure 1

The assembly plant delivered some vehicles with the panoramic roof rear water drains not properly connected. So far, known cases produce chassis system warnings. However, the unwanted effects of this water intrusion are not limited to this system. Any ECUs housed in the rear of the vehicle may be affected. (See figure 1 for drain locations. Note where the drain inlets and outlets are to help understand which systems this unchanneled water may affect.)

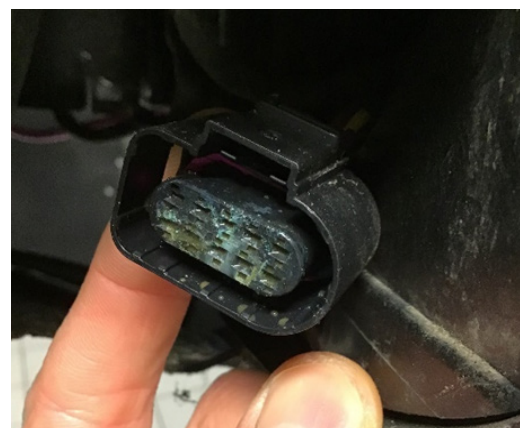
Figure 2

During diagnosis, the workshop may find that the connectors show evidence of water intrusion and corrosion. (See figure 2.) If this is the case, be sure to eliminate the possibility that one or more of the panoramic roof rear water drains are not connected at the inlet (top), by looking underneath the headliner and inspecting them.
