Shudder Sensation When Vehicle at Complete Stop

Section Hybrid Transmission/Transaxle

Some 2023 – 2025 Crown and 2024 – 2025 Grand Highlander Hybrid vehicles equipped with a Hybrid Transmission Assembly HPC60 may exhibit a shudder sensation when the vehicle is at a complete stop, the State of Charge (SOC) of the HV Battery is greater than 76%, and the transmission is in the Drive position with the brakes applied. Follow the Repair Procedure in this bulletin to address this condition.

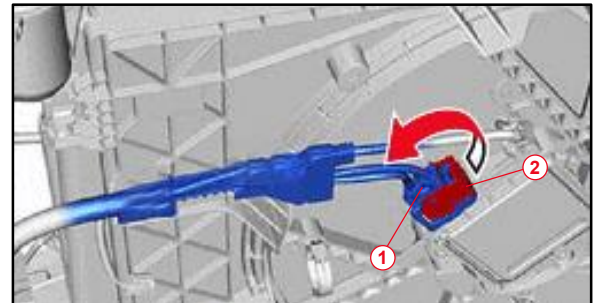
Figure 1.

1	Cooling Fan Motor Connector
2	Lock

2. Disconnect the cooling fans.

- A. Disconnect the cooling fan motor connector.
- B. Rotate the lever while pushing the lock and disconnect the cooling fan motor connector.

After disconnecting the cooling fan motor connector, make sure that dirt, water, or other foreign matter does NOT contact the connecting parts of the cooling fan motor connector.

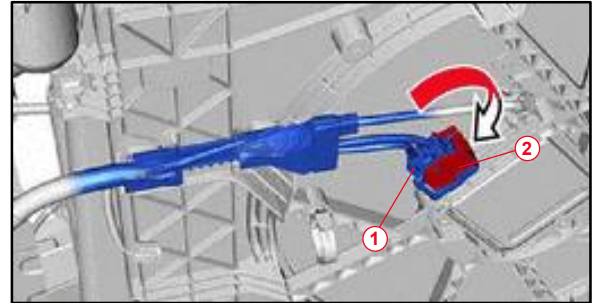
Figure 2.

1	Cooling Fan Motor Connector
2	Lock

4. Connect the cooling fans.
 - A. Connect the cooling fan motor connector.
 - B. Rotate the lever to lock it.

- When connecting the cooling fan motor connector, make sure that the connecting parts of the cooling fan motor connector are free of dirt, water, or other foreign matter.
- Be sure to securely connect the cooling fan motor connector.
