# Shudder Sensation When Vehicle at Complete Stop

**Section** Hybrid Transmission/Transaxle

YEAR(S)	MODEL(S)	ADDITIONAL INFORMATION
2023 - 2024	RX500H	
2024 - 2025	TX500H

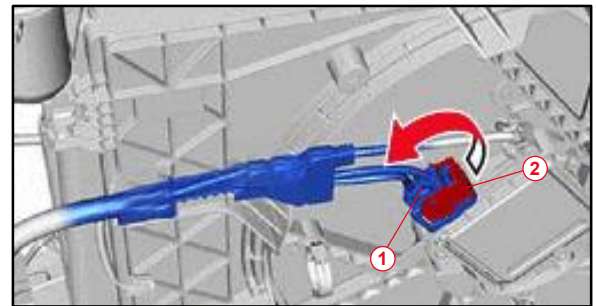
Figure 1.

1	Cooling Fan Motor Connector
2	Lock

2. Disconnect the cooling fans.

- A. Disconnect the cooling fan motor connector.
- B. Rotate the lever while pushing the lock and disconnect the cooling fan motor connector.

After disconnecting the cooling fan motor connector, make sure that dirt, water, or other foreign matter does NOT contact the connecting parts of the cooling fan motor connector.

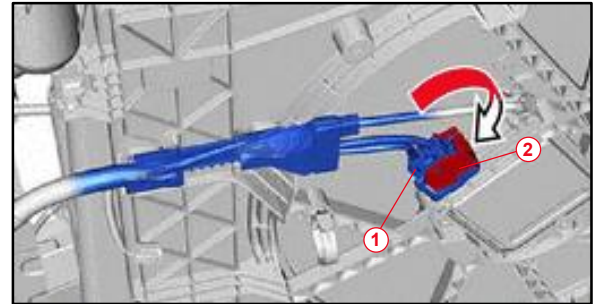
**Figure 2.**

1	Cooling Fan Motor Connector
2	Lock

4. Connect the cooling fans.
  - A. Connect the cooling fan motor connector.
  - B. Rotate the lever to lock it.

- When connecting the cooling fan motor connector, make sure that the connecting parts of the cooling fan motor connector are free of dirt, water, or other foreign matter.
- Be sure to securely connect the cooling fan motor connector.
