JLRTB02127NAS5

# TECHNICAL BULLETIN

303-03A

Engine Coolant Level Low with no Visible Loss of Coolant

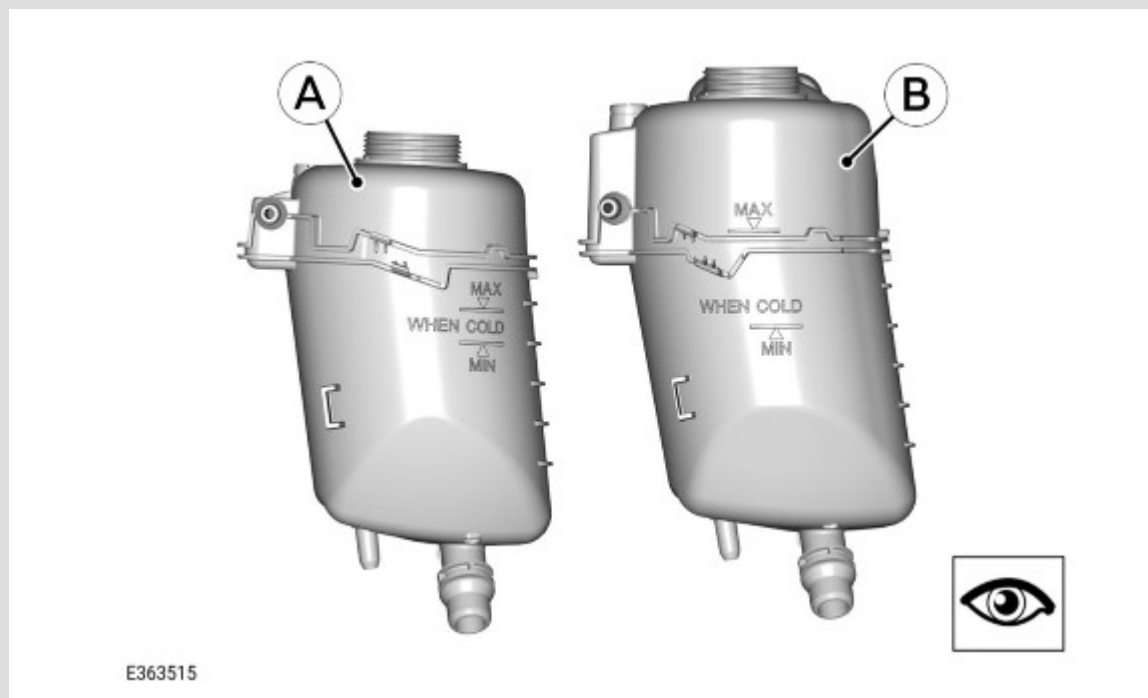
1.

Inspect the coolant expansion tank.

- If coolant expansion tank 'B' is installed **do not** continue with this bulletin. Repair as necessary with reference to TOPIx.
- If coolant expansion tank 'A' is installed continue to the next step.

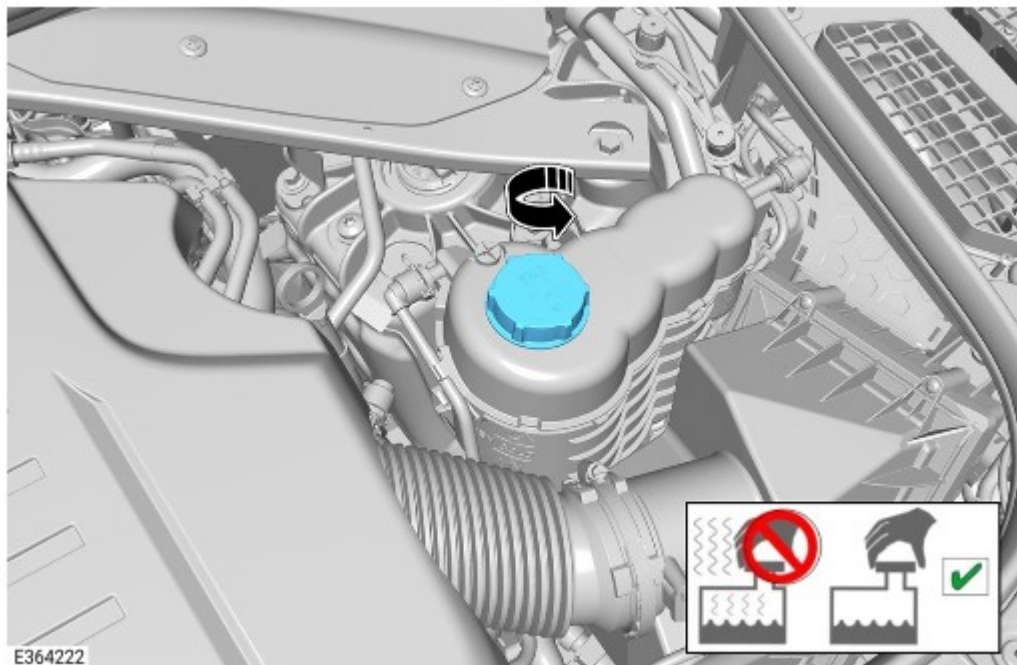
Remove the coolant expansion tank filler cap.

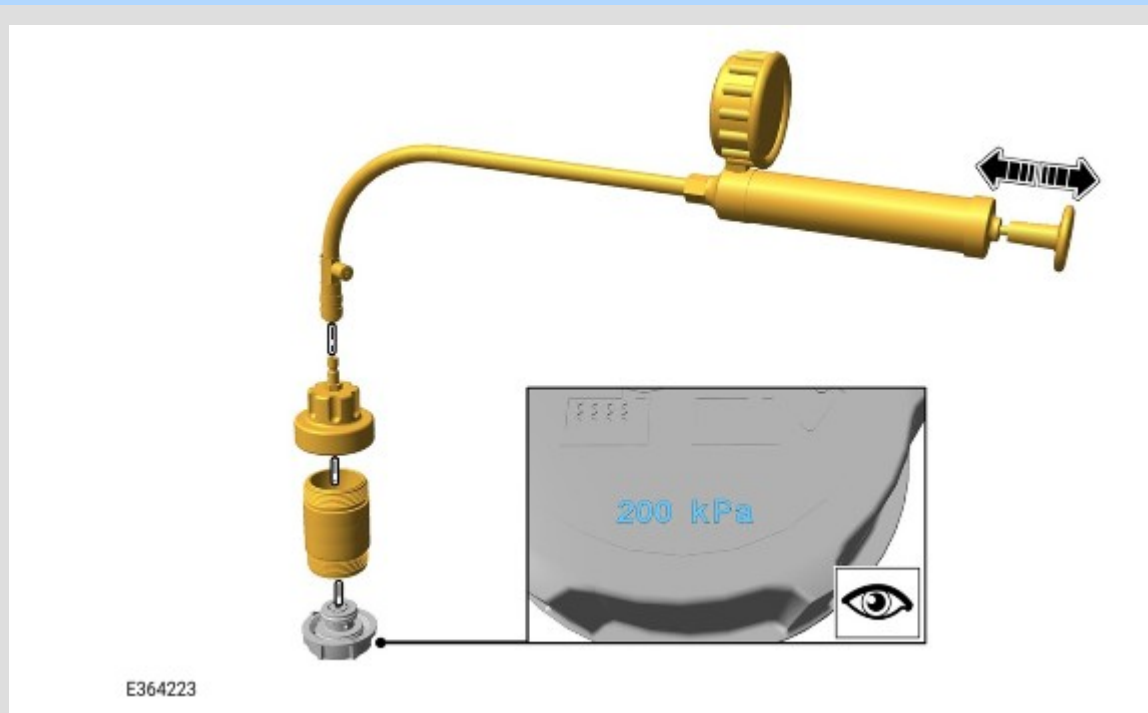
Using the correct adapter connect the cooling system pressure tester to the coolant expansion tank filler cap.

- Slowly pressurize the coolant expansion tank filler cap 1.6 bar (23 psi) as shown on the gauge. No significant drop in pressure must be noted on the coolant expansion tank filler cap. If after 5 minutes the pressure significantly drops, the coolant expansion tank filler cap must be replaced.
- If 1.6 bar (23 psi) is reached with no drop in pressure, validate the coolant expansion tank filler cap by increasing the pressure to between 1.7 bar (25 psi) to 2.1 bar (30 psi) to confirm the valve is operating as intended. The pressure must be released through the coolant expansion tank filler cap.
- If the coolant expansion tank filler cap fails this test, the coolant expansion tank cap must be replaced. This must be completed under related repairs and must be claimed as a separate warranty claim.

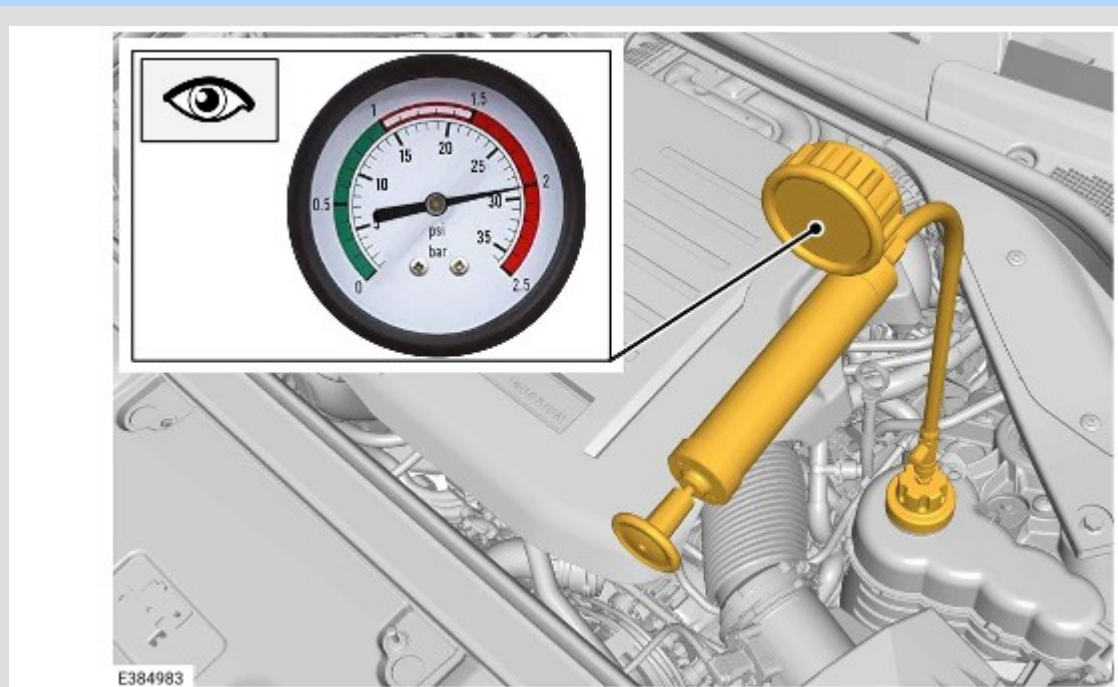
Using the correct adapter connect the cooling system pressure tester to the coolant expansion tank.

- Slowly pressurize the cooling system until 2.0 bar (28 psi) is shown on the gauge.
- No significant drop in pressure must be noted on the cooling pressure tester gauge. If after 5 minutes the pressure significantly drops, inspect the cooling system for leaks. A pressure drop of 0.15 bar (1psi) in the first minute is considered normal operation.

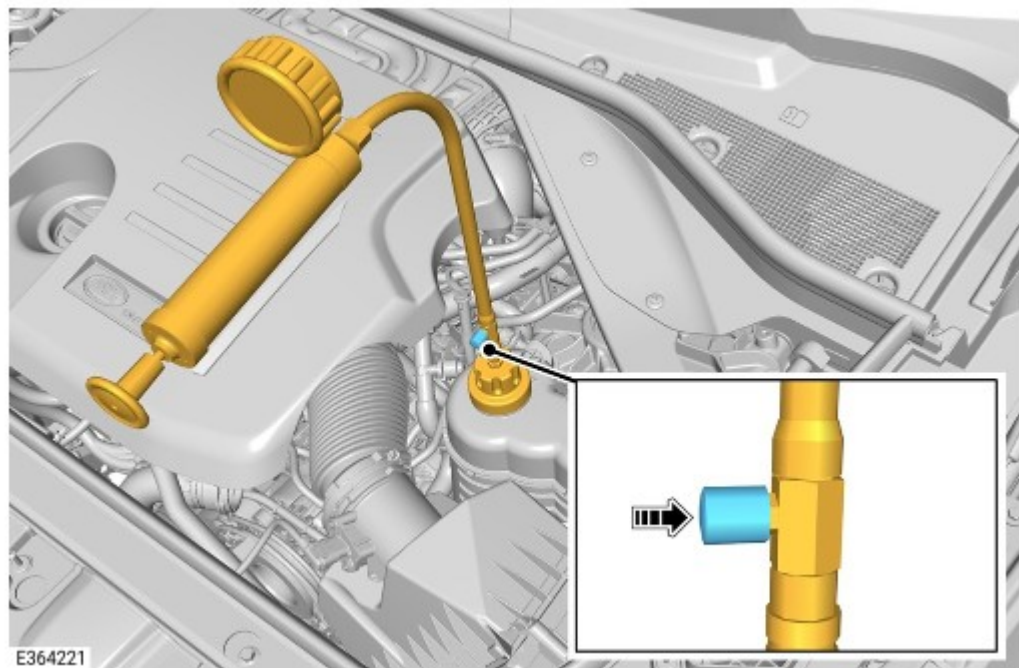
8.

Depressurize and remove the cooling system pressure tester.
