SERVICE BULLETIN

M1640 (REV A): COOLING SYSTEM ENHANCEMENT FOR 2024 CENTER COOLED TOURING MODELS

M1640

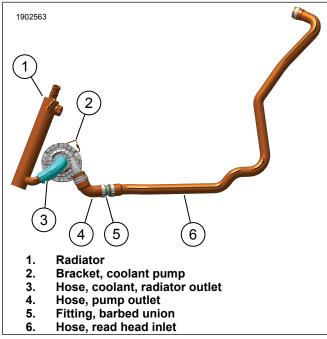
Figure 1. Original Coolant Pump

- The radiator outlet fitting location was changed from low to high.
- The coolant pump bracket was changed to lower the overall pump position. This improves the purging and helps any air pockets that could be trapped at the inlet of the coolant pump to move upward into the radiator.
- The coolant hose that goes from the coolant pump to the rear head inlet has improved geometry and no longer contains a union fitting.
