SERVICE BULLETIN

M1678: NEW MAXI FUSE LOCATION FOR REVOLUTION MAX VEHICLES AT PDI

M1678

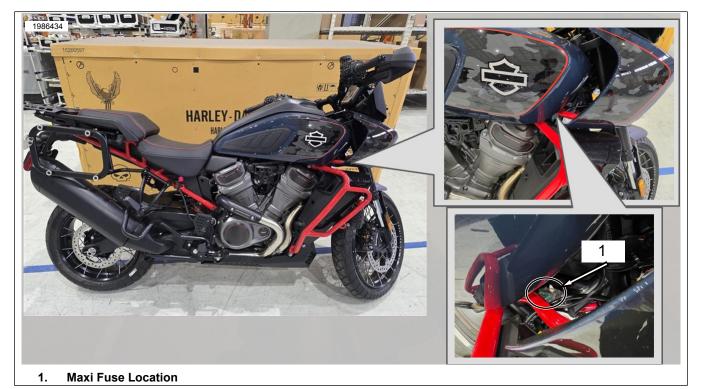
Figure 1. Pan America Maxi Fuse Location

1. Before notating a missing maxi fuse on the BOL, verify that it is not under or near the front side cover.

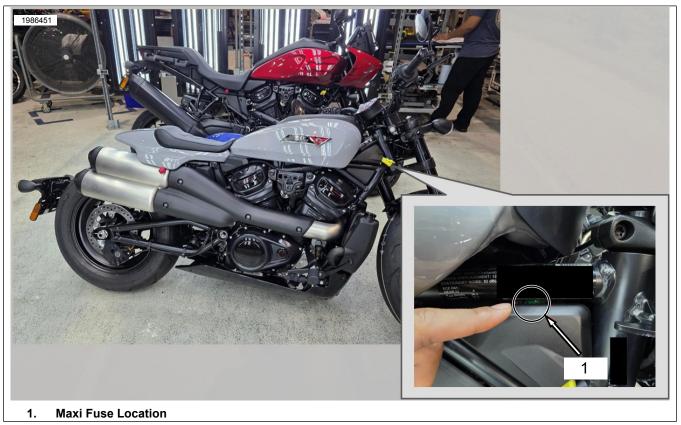
Figure 2. Sportster S Maxi Fuse Location

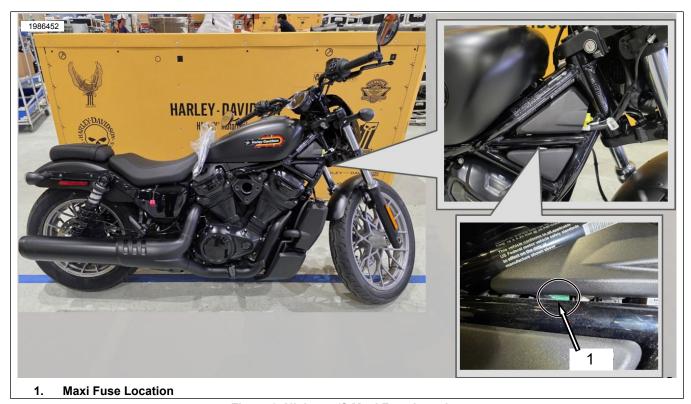
Figure 3. Nightster/S Maxi Fuse Location
