Technical Service Bulletin (TSB)

No Start, Loose Ground

REFERENCE:	TSB: 08-089-25 REV. A GROUP: 08 - Electrical	Date:	April 1, 2025	REVISION:	08-089-25
VEHICLES AFFECTED:	2024 (GG) Dodge Hornet This bulletin applies to vehicles built on or before June 07, 2024 (MDH 0607XX) equipped with a 2.0L I4 DOHC DI Turbo Engine w/ESS (Sales Code EC1).			MARKET APPLICABILITY: <div><input checked="" type="checkbox"/> NA<input type="checkbox"/> MEA <input type="checkbox"/> SA<input type="checkbox"/> IAP <input type="checkbox"/> EE<input type="checkbox"/> CH</div>	
CUSTOMER SYMPTOM:	Customers must experience a Malfunction Indicator Lamp (MIL) illumination and the vehicle must exhibit/set one or more of the following Diagnostic Trouble Codes (DTCs): <ul style="list-style-type: none">P0010 - Bank 1 Camshaft 1 Position Actuator Circuit Open.P0013 - Bank 1 Camshaft 2 Position Actuator Circuit Open. Customers may also experience the following: <ul style="list-style-type: none">The vehicle will not start.

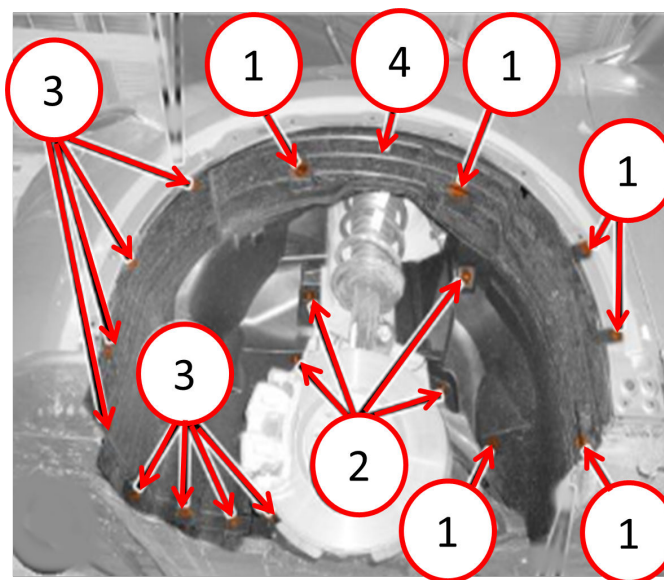
Fig. 1

Left Front Splash Shield Fasteners, Nuts And Screws

3. Remove the left front splash shield fasteners, nuts and screws from the splash shield [Fig. 1](#).

5. Install the left front splash shield fasteners, nuts and screws [Fig. 1](#). Tighten all screw and nut fasteners securely.
6. Install the left tire and wheel assembly. Refer to the detailed procedures available in DealerCONNECT > Service Library> under: 22 - Tires and Wheels / Installation.
7. Lower the vehicle.
8. Clear all DTCs that may have been set.

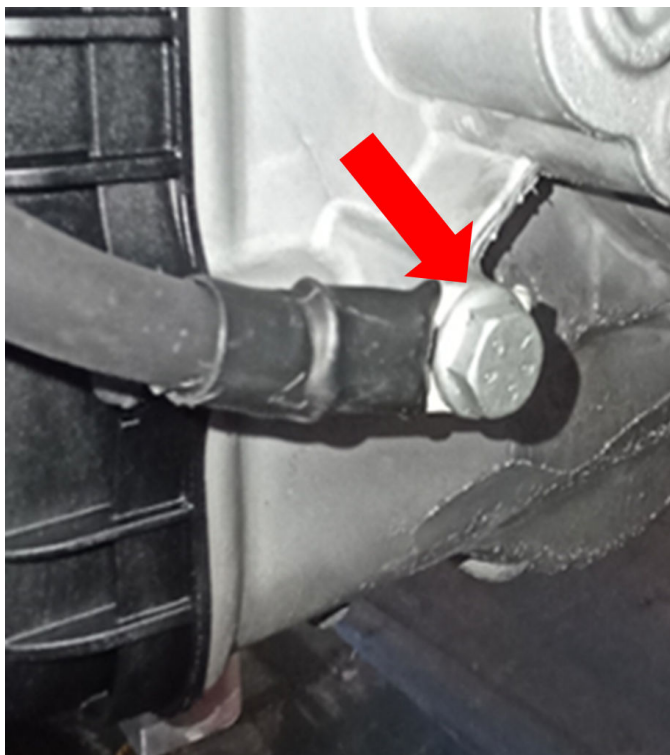
Fig. 2
G902A Ground Bolt

CAUSE:	Ground issue

4. Replace the G902A ground bolt [Fig. 2](#). Tighten the bolt to 15 N·m (11 Ft. Lbs.).
