Technical Service Bulletin (TSB)

HDMI Port Stays On After Ignition Is Turned Off

REFERENCE:	TSB: 08-092-25 GROUP: 08 - Electrical	Date:	April 1, 2025	REVISION:	—
VEHICLES AFFECTED:	2024 - 2025 (KM) Jeep Wagoneer S This bulletin applies to vehicles built on or before January 28, 2025 (MDH 0128XX) equipped with the Front Passenger Interactive Display (Sales Code RJA).			MARKET APPLICABILITY: <div><input checked="" type="checkbox"/> NA<input type="checkbox"/> MEA <input type="checkbox"/> SA<input type="checkbox"/> IAP <input type="checkbox"/> EE<input type="checkbox"/> CH</div>	
CUSTOMER SYMPTOM:	Customer may comment on the following: <ul style="list-style-type: none">The LED light on the HDMI port stays ON after the ignition is turned OFF.				
CAUSE:	Incorrect connection at assembly

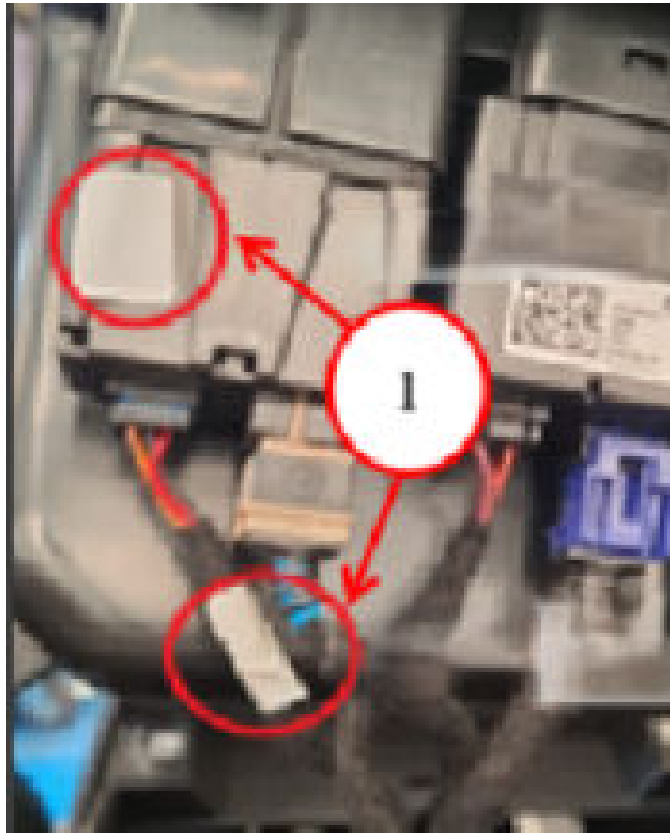
Fig. 1
Correct Orientation

2. Check if the module and connector harness both have a white label [Fig. 1](#).

1 - White labels

3. Is the harness connected correctly as shown in [Fig. 1](#)?
- YES>>>This bulletin does not apply. Perform further diagnostics.
 - NO>>> Proceed to [Step 4](#).
4. Swap the harness connectors. Connect the power harness previously attached to the HDMI module to the media hub and the media hub power harness to the HDMI module [Fig. 2](#).
