**Technical Service Bulletin (TSB)**  
**Camshaft Sensor DTC**

| REFERENCE: | TSB: 08-099-25<br>GROUP: 08 - Electrical 09 - Engine | Date: | April 4, 2025 | REVISION: | — |
| VEHICLES AFFECTED: | 2022 - 2023 (JL) Jeep Wrangler<br>2022 - 2023 (JT) Jeep Gladiator<br>This bulletin applies to vehicles equipped with 3.0L V6 Turbo Diesel Engine W/ESS (Sales Code EXJ). | | | MARKET APPLICABILITY:<br><div><input checked="" type="checkbox"/> NA<input type="checkbox"/> MEA<br/><input type="checkbox"/> SA<input type="checkbox"/> IAP<br/><input type="checkbox"/> EE<input type="checkbox"/> CH</div> | |

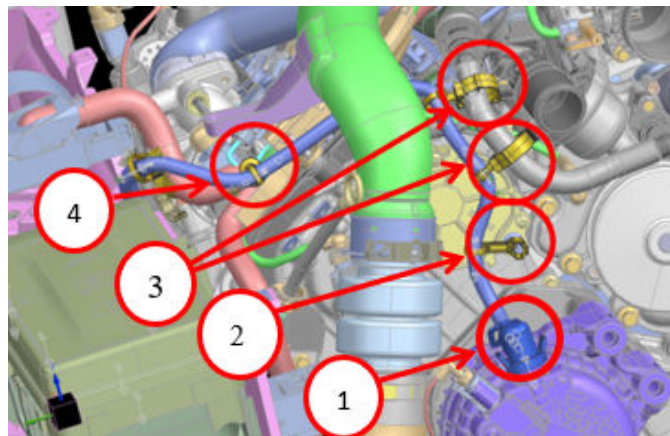
**Fig. 1**  
generator Field Harness

- 1 - Generator B+ Connector
- 2 - Stud Clip
- 3 - C - Clips
- 4 - Fir Tree Clip

1. Disconnect negative battery cable. Refer to the detailed service procedures listed in DealerCONNECT> Service Library> Service Info under: 08 - Electrical / 8F - Engine Systems / Battery System / Standard Procedure.
2. Disconnect battery positive cable from generator [Fig. 1](#).
3. Remove stud clip, two C-Clips and fir tree clip from harness (four clips) [Fig. 1](#).

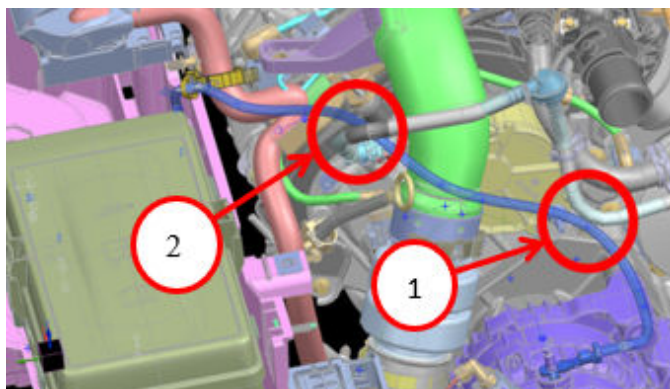
**Fig. 2**

Re-Routed Harness

1 - Re-routed Harness  
2 - Brake Booster Vacuum Hose

4. Re-route generator positive harness around the Charge Air Cooler (CAC) inlet hose and secure with two tie straps to brake booster vacuum hose [Fig. 2](#).

**NOTE: Ensure harness is not in contact with sharp edges.**

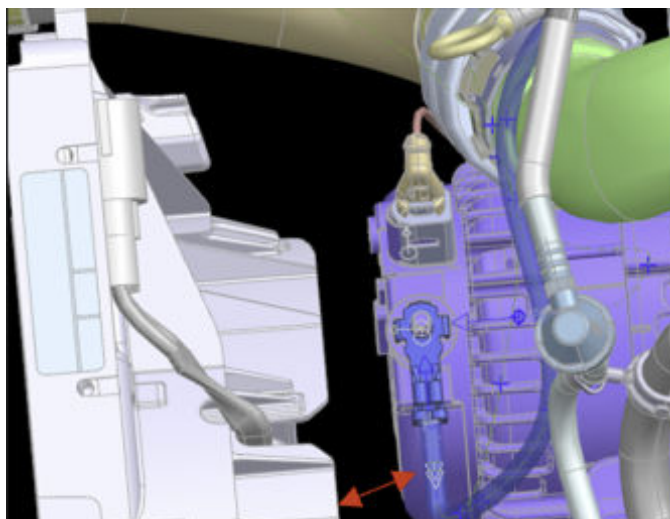
**Fig. 3**

Harness Wiring Orientation

5. Reconnect battery positive cable to generator in new orientation (facing vehicle left) [Fig. 3](#).

**NOTE: Ensure there is no excess slack and at least 25mm (1 in.) clearance to radiator fan shroud to any point of the generator positive cable harness.**

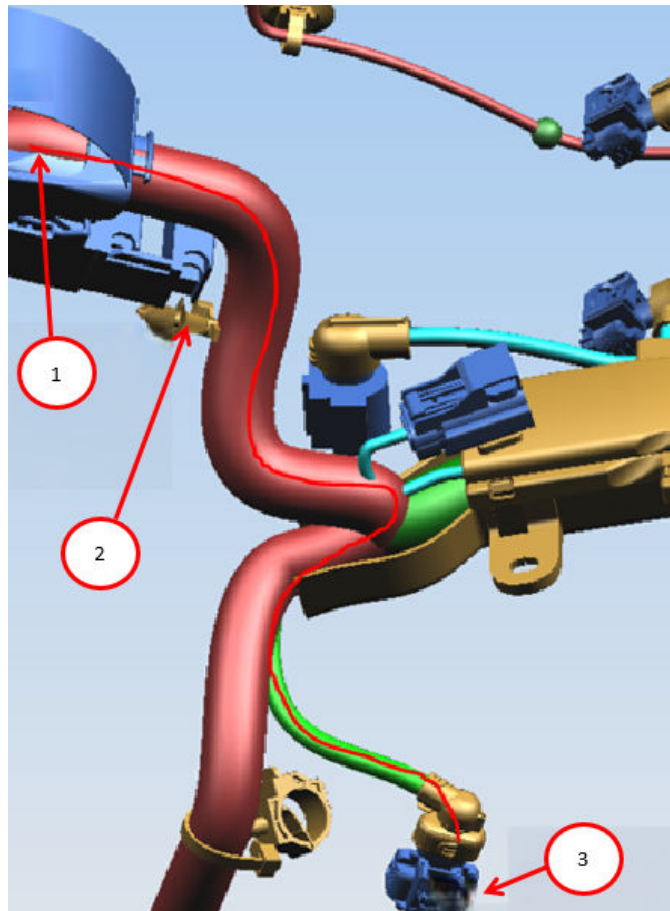
**Fig. 4**  
Cam Sensor Wiring harness

- 1 - PCM C2 Connector
- 2 - Clip Raymond
- 3 - Camshaft Sensor Harness connector

6. Disconnect the Powertrain Control Module (PCM) C2 connector at the PCM.
7. Remove the tie strap on the C2 harness trough [Fig. 4](#).
8. Remove the clip Raymond on C2 harness [Fig. 4](#).
9. Remove the tape on C2 harness [Fig. 4](#).
10. Extract the terminals from the Camshaft Sensor 3W connector [Fig. 4](#).

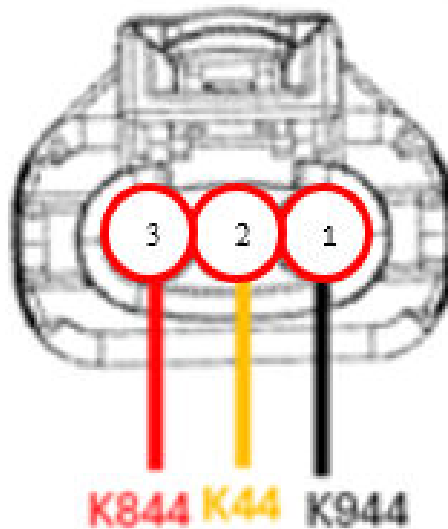
**Fig. 6**  
Camshaft Sensor Harness End

1 - Pin 1  
2 - Pin 2  
3 - Pin 3

13. Strip the wires and solder to the with twisted pair jumper kit using the solder sleeves included in the kit (refer to the kit instructions).
14. Insert kit harness terminals inside the original Camshaft Sensor 3W connector.
15. Tape the harness back up.
16. Fix clip on PCM C2 branch and use a tie strap on the trough to hold the harness within the trough.
17. Reconnect the PCM C2 connector at the PCM.
18. Reconnect the negative battery cable. Refer to the detailed service procedures listed in DealerCONNECT> Service Library> Service Info under: 08 - Electrical / 8F - Engine Systems / Battery System / Standard Procedure.
19. Perform an electrical pin-to-pin test with multimeter to confirm the electrical continuity [Fig. 6](#).

- With ECU connector inserted and KEY-OFF – measure with an ohmmeter set to Ohms.
    - Pin 2 to Pin 1 (SIGNAL Out to SIGNAL/SUPPLY negative) = OL.
    - Pin 2 to Pin 3 (SIGNAL Out to SUPPLY) = OL.
  - With ECU connector inserted and KEY-ON – measure with a voltmeter, at least 100 mV resolution.
    - Pin 2 to Ground (SIGNAL Out) = Around 4.6 V.
    - Pin 3 to Ground (SUPPLY) = 5 V.
    - Pin 1 to Ground (SIGNAL and SUPPLY negative) = 12 V.
20. Turn the key off and reconnect the cam sensor harness connector.
  21. Clear all DTCs that may have been set in any module.
