REFERENCE:	TSB: 08-101-25 GROUP: 08 - Electrical	Date:	April 4, 2025	REVISION:	-						
VEHICLES AFFECTED:	2024 (RU) Chrysler Pacifica This bulletin applies to vehicles built on or after October 02, 2023 (MDH 1002XX) equipped with: <ul style="list-style-type: none"> ● Uconnect 5 Nav w/10.1" Display (Sales Code UBN). ● Uconnect 5 Nav w/10.1" Display (Sales Code UEN). ● Uconnect 5 w/10.1" Display (Sales Code UBG). ● Uconnect 5 w/10.1" Display (Sales Code UEG). 			MARKET APPLICABILITY:

This bulletin involves inspecting the software level and updating the software to U33.9.

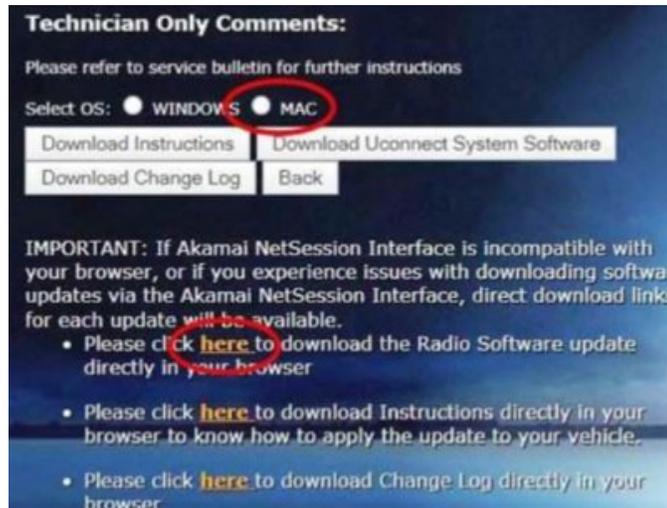
Fig. 1

MAC Download Steps

6. Download the software update file to your local PC's desktop. Make sure to select the "MAC" radial button for all downloads [Fig. 1](#).

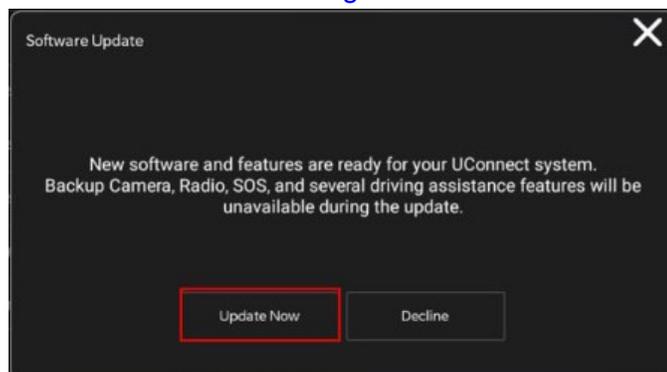
Fig. 2

Software Update Is Available

12. Once the system has verified there is an available update, press the "Update Now" button. Make sure the vehicle is in park. Do NOT turn the ignition off until the two minute timer has expired. The ignition doesn't have to be turned off to update the radio's software [Fig. 2](#).

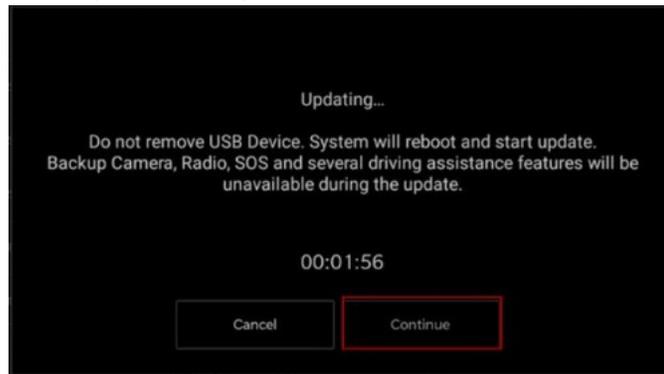
Fig. 3

Continue Display Screen

13. Press the “Continue” on the display screen [Fig.3](#).

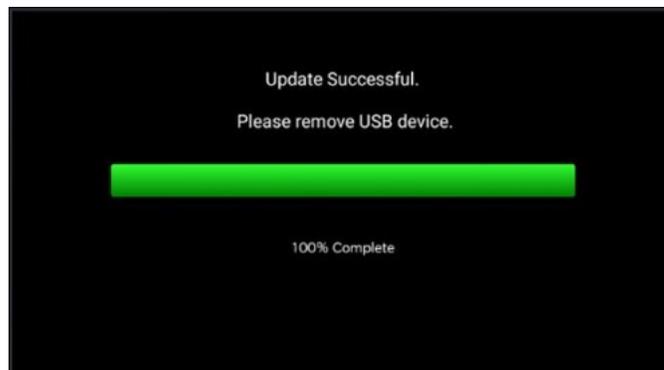
Fig. 4

Software Update Completed

14. The radio will reboot and the update will begin. The update should only take 30 minutes [Fig. 4](#).

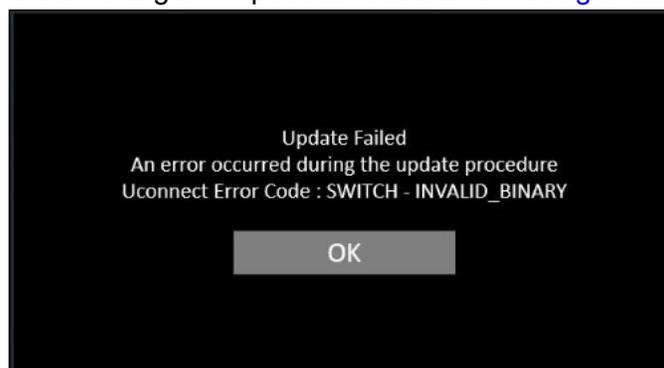
Fig. 5

Error Message

16. Sometimes the radio will display an error pop up “SWITCH- INVALID_BINARY “ after successful radio update. Please ignore this error message and press “OK” to continue [Fig. 5](#).

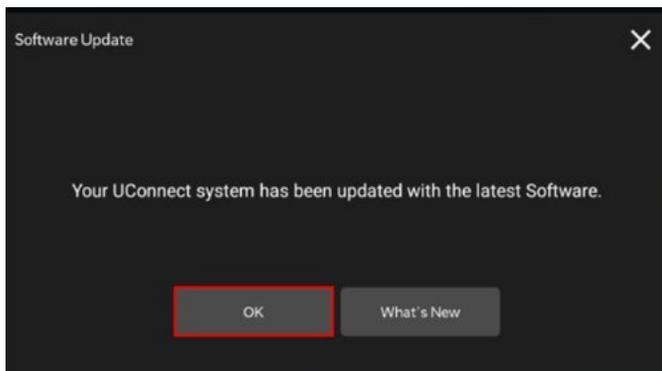
Fig. 6

Radio Software Has Been Updated

17. Press “OK” to continue [Fig. 6](#).
