**Technical Service Bulletin (TSB)**  
**R1H Radio Over The Air Update**  
**U35.26 Or U35.34 To U37.23 Software Version**

<b>REFERENCE:</b>	<b>TSB:</b> 08-102-25 <b>GROUP:</b> 08 - Electrical	<b>Date:</b>	April 5, 2025	<b>REVISION:</b>	—
<b>VEHICLES AFFECTED:</b>	<b>2024 - 2025 (LB) Dodge Charger</b> <b>This bulletin applies to vehicles built on or before April 05, 2025 (MDH 0425XX) equipped with a Global Telematics Box Module (Sales Code RDG) and one of the following radios:</b> <ul style="list-style-type: none"> <li>• Uconnect 5 Nav W 12.3" Display (USA) (Sales Code UBX).</li> <li>• Uconnect 5 Nav W 12.3" Display (CAN) (Sales Code UEX).</li> </ul>			<b>MARKET APPLICABILITY:</b>	
				<input checked="" type="checkbox"/> NA	<input type="checkbox"/> MEA
				<input type="checkbox"/> SA	<input type="checkbox"/> IAP
				<input type="checkbox"/> EE	<input type="checkbox"/> CH
<b>CUSTOMER SYMPTOM:</b>	<b>Customers may experience one or more of the following:</b> <ul style="list-style-type: none"> <li>• Pop-up messages text cut-off when using "Transfer to Passenger".</li> <li>• Missing active call details in phone widget after call swap is performed.</li> <li>• Missing blind spot system

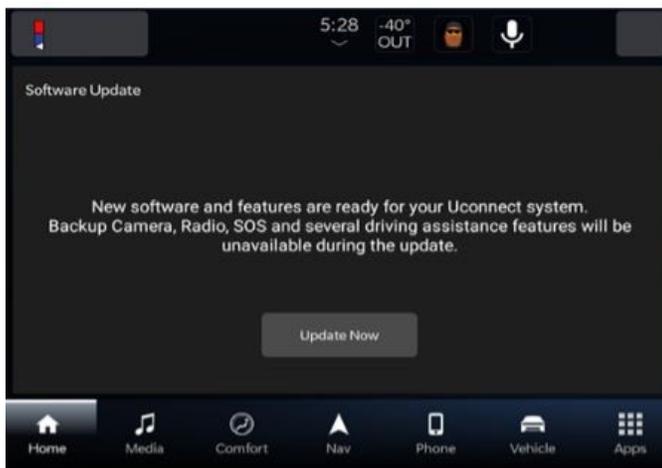
**Fig. 1**  
Software Update Screen

2. If the customer selects “Update Now” they can shut off the vehicle and leave. The update will be completed automatically [Fig. 1](#).

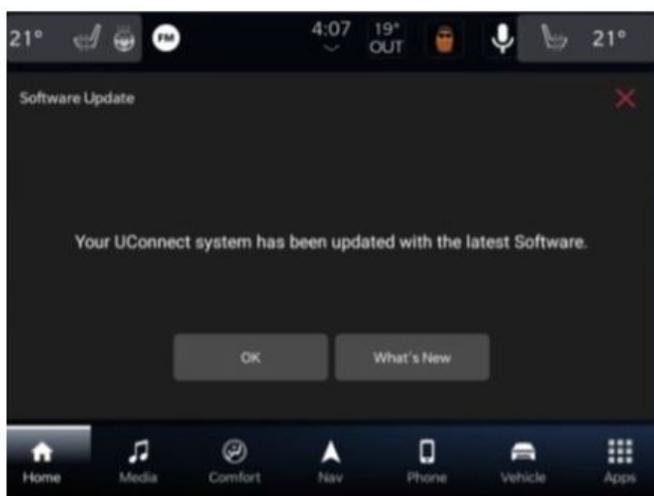
**Fig. 2**  
Software Update Confirmation Screen

3. Upon completion of update, the radio will display a confirmation message [Fig. 2](#).
