Technical Service Bulletin (TSB)
Radio U29.28 USB Software Update

REFERENCE:	TSB: 08-103-25 GROUP: 08 - Electrical	Date:	April 5, 2025	REVISION:	08-210-23 REV. A
VEHICLES AFFECTED:	2022 - 2023 (RU) Chrysler Pacifica This bulletin applies to vehicles equipped with one of the following: <ul style="list-style-type: none">Uconnect 5 Nav w/10.1" Display (Sales Code UBN).Uconnect 5 Nav w/10.1" Display (Sales Code UEN).Uconnect 5 w/10.1" Display (Sales Code UBG).Uconnect 5 w/10.1" Display (Sales Code UEG).			MARKET APPLICABILITY: <div><input checked="" type="checkbox"/> NA<input type="checkbox"/> MEA</div> <div><input type="checkbox"/> SA<input type="checkbox"/> IAP</div> <div><input type="checkbox"/> EE<input type="checkbox"/> CH</div>	
CUSTOMER SYMPTOM:	<p>The customer may describe one or more of the following:</p> <ul style="list-style-type: none">Amplifier module sets Diagnostic Trouble Code (DTC) U0485 - Implausible Data Received Set.Radio reset (Rearview camera functions normally).Voice Recognition (VR) inoperable.Wireless CarPlay® inoperable.Audio sources inoperable.Display switches to Nav on VR prompt.Vehicle Positioning (Lat/Long) inoperable.Surround View Camera inoperable (Rear

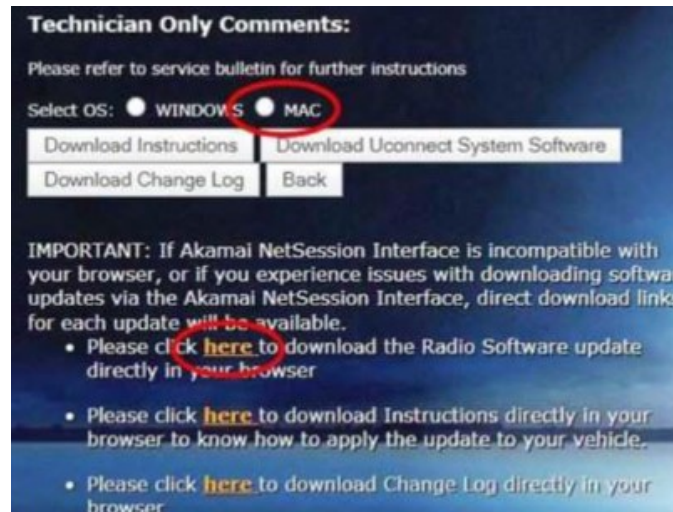
Fig. 1

MAC Download Steps

6. Download the software update file to your local PC's desktop. Make sure to select the "MAC" radial button for all downloads [Fig. 1](#).
