STAR ONLINE PUBLICATION

Case Number: S2523000025

Symptom/Vehicle Issue: Front Floor Console Has A Gap Between The Right Side Panel And The Screen Bezel.

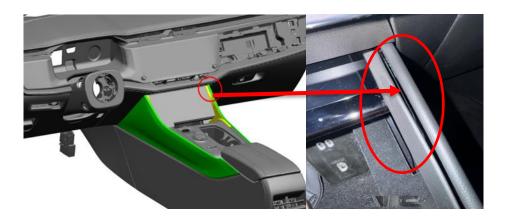
Discussion: Inspect and verify a gap exists as shown in the image above. If the gap does exist, replace the Right-Side Upper Side Panel with AD or later part. Use STARParts online catalog with the vehicle's vin to obtain the correct interior color part (Fig 1).

Refer to Service Library 23 - Body / Interior / CONSOLE, Floor, Side Panel / Removal and Installation for replacement instructions.
