Announcement Of Future Addition To Exchange Order Type

Coolant Leak & Engine Overheating Issue - MY 2021 - 2025 - Jeep Wrangler (JL), Jeep Grand Cherokee (WL), Jeep Compass (MP), Dodge Hornet (GG)/ Alfa Romeo Tonale (GC)

2025 Warranty Bulletin Highlights

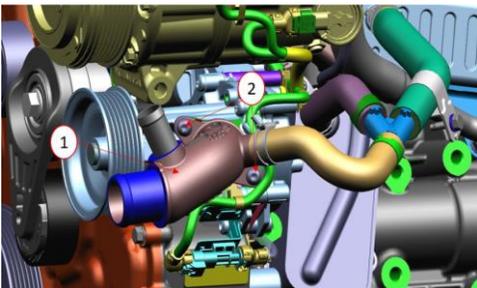
- A. Water pump inlet pipe (1) losing bolts/torque (2):

testing they are determined to be no trouble found. Above are the possible parts which may be causing the coolant leak: water pump inlet pipe bolts losing torque (refer to CSN ZD8), thermostat's bolts losing torque, cylinder block casting porosity /cracks versus combustion chamber, oil coolant exchanger internal crack (evidence of coolant and oil mixing).

When diagnosing an engine overheated due to coolant leak, be aware that it's not necessary to replace the full engine. There are several components failing that may be the root cause and, in most cases, just this component needs to be replaced rather than the long block*.

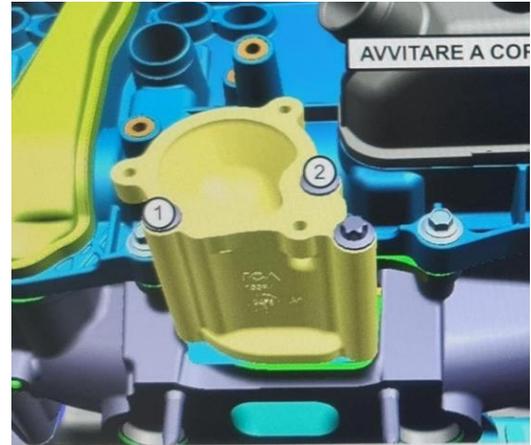
C. Thermostat column manifold losing torque/bolts:

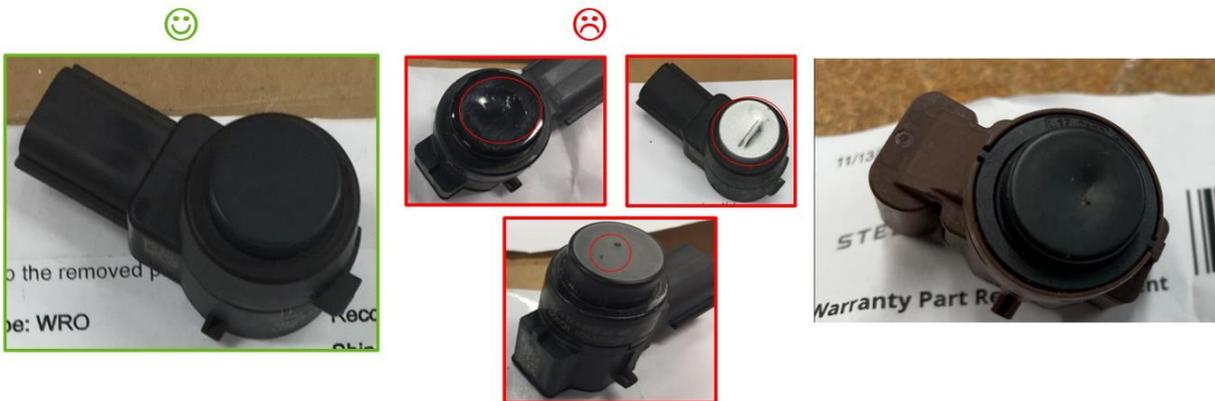
Examples of Physical Damage:

We have found during supplier analysis, that the park assist sensors are found to have physical damage, potentially caused by an external force such as road debris. Symptoms for this issue are found in Service Library. If the park assist

sensor has physical damage, it is not considered a defect in material or workmanship yet could be considered for Consumer Goodwill with the support of the business center.

Please remove sensors carefully when performing repairs.
