Service Bulletin

Bulletin No.: 23-NA-163

Subject: No Crank, No Start, Quick Start/Stall, No FOB Detected, Key FOBs Inoperative, B3924 00, B3925 00, B3926 00, B3927 00, B3928 00 Set

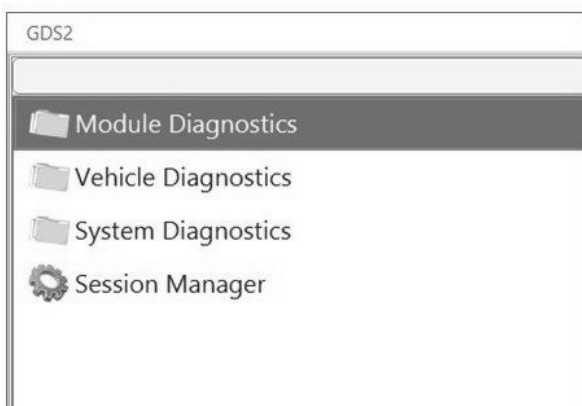
6482606

Verify you have a GEN3R BCM Base Model Part Number. Only GEN3R BCMS are eligible for this bulletin. Navigate to GDS2 > Module Diagnostics > [K9] Body Control Module > Identification Information > Identification Information.
