Coolant Leak & Engine Overheating Issue - MY 2021 - 2025 - Jeep Wrangler (JL), Jeep Grand Cherokee (WL), Jeep Compass (MP), Dodge Hornet (GG)/ Alfa Romeo Tonale (GC)

FCA CARIBBEAN WARRANTY OPERATIONS NEWSLETTER

VOLUME 11, ISSUE 4

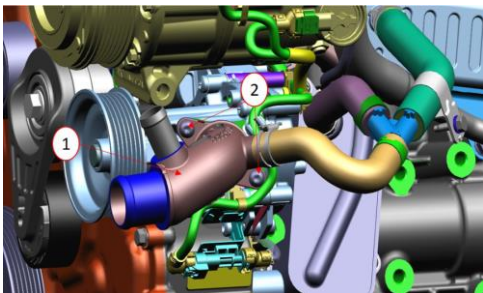
- A. Water pump inlet pipe (1) losing bolts/torque (2):

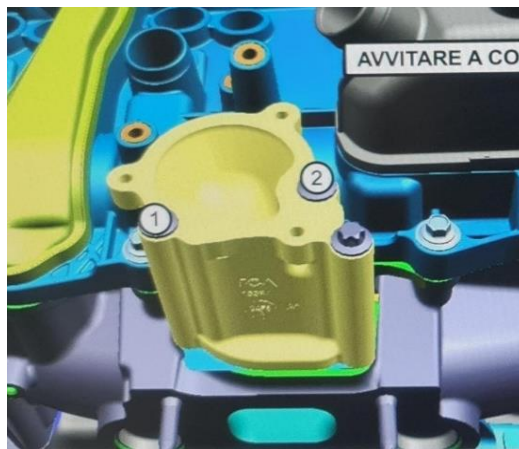
- C. Thermostat column manifold losing torque/bolts

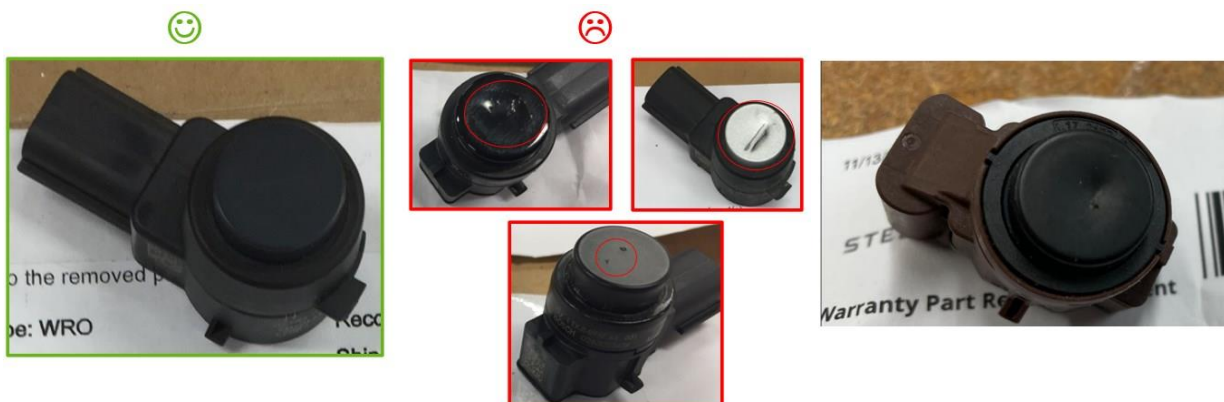
Examples of Physical Damage:

We have found during supplier analysis, that the park assist sensors are found to have physical damage, potentially caused by an external force such as road debris. Symptoms for this issue are found in Service Library. If the park assist sensor has physical damage, it is not considered a defect in material or workmanship yet could be considered for Consumer Goodwill with the support of the business center.

Please remove sensors carefully when performing repairs.

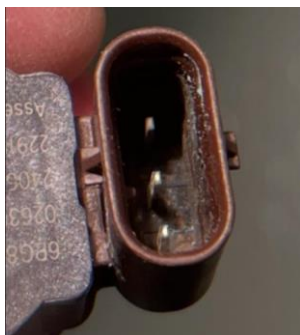
Example of Sensor Connector Corrosion:

If corrosion is visible in sensor connector area, LOP should be assigned to a wiring repair. Only use the Park Assist sensor LOP if the sensor is replaced.

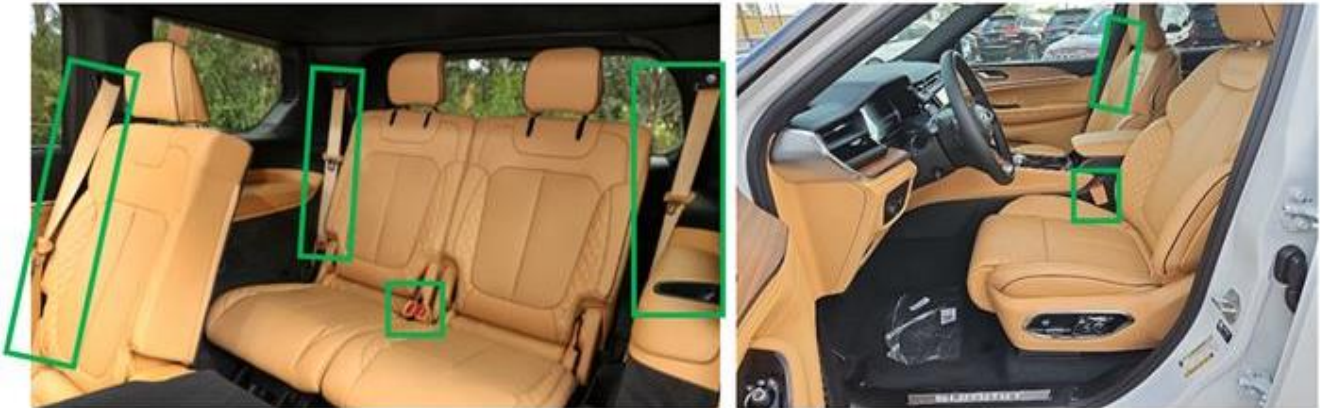
Before:

Due to a production change, Jeep Grand Cherokee Summit and Summit Reserve vehicles with Tupelo interior (-T7) as of 04/03/2025 (MDH

0403XX) will have seat belts and buckles of Global Black (TX7) color in place of Tupelo (WT5). See before/after picture examples below.
