GENERAL MOTORS
DCS7196
URGENT - DISTRIBUTE IMMEDIATELY

Subject: N252499750 - Service Update
Low Torque Front Brake Lines

Models: 2025 GMC HUMMER EV

N252499750 Low Torque Front Brake Lines

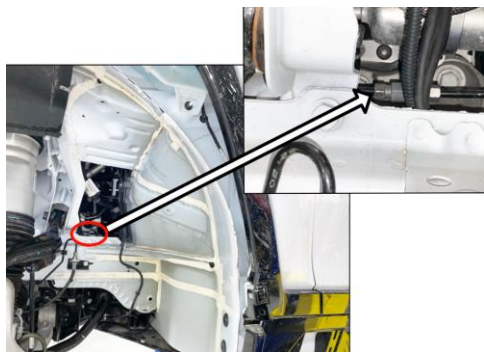
6880274

Note: Only the Forward Brake Pipe Nut (shown as left above) needs to be torqued.

2. Torque the LH Front Brake Front Pipe to 15-29 N•m.
3. Remove the High Voltage Battery Tray Lower Front Reinforcement. Refer to *High Voltage Battery Tray Lower Front Reinforcement Replacement* in SI.

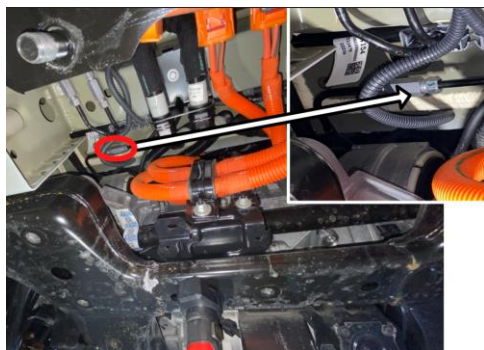
6880275

Note: Only the Right Brake Pipe Nut as shown above needs to be torqued.

4. Torque the RH Front Brake Front Pipe to 15-29 N•m.
5. If any brake fluid leak was observed, check brake fluid reservoir level and add as necessary.
6. Install the High Voltage Battery Tray Lower Front Reinforcement. Refer to *High Voltage Battery Tray Lower Front Reinforcement Replacement* in SI.
7. Install LH Front Wheelhouse Rear Liner. Refer to *Front Wheelhouse Rear Liner Replacement* in SI.
