# Service Bulletin

Bulletin No.: 25-NA-057  
Date: March, 2025

**Subject: Front Wheel Opening Moldings Not Flush and/or Poor Fitment**

Brand:	Model:	Model Year:		VIN:		Engine:	Transmission:
		from	to	from	to		
Chevrolet	Colorado	2023	2025	-	-	All	All

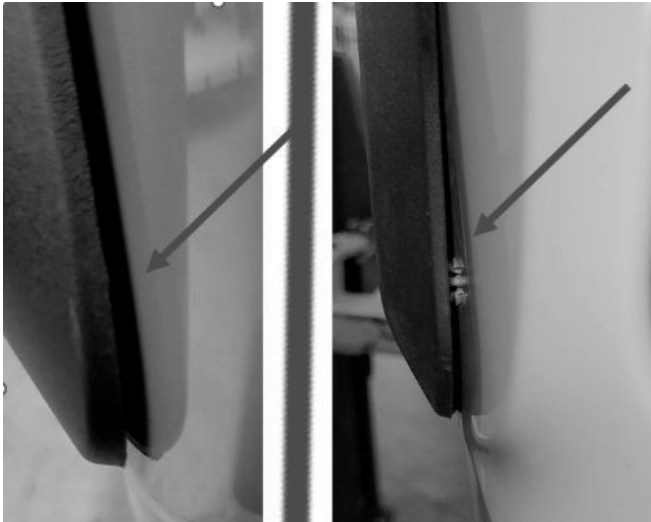
</div> <p>Some Customers may comment the Front Wheel Opening Molding is loose near the front bumper.</p> <p>Some Customers may comment the Front Wheel Opening Molding does not sit flush against the fascia and there is poor fitment.</p>
Cause	The cause of this concern is that the front fascia may not be stiff enough to allow for the complete engagement of the Front Wheel Opening Molding Clip into the front fascia.
Correction	Reinstall the lower Front Wheel Opening Molding Clip by following the below procedure.
