**Technical Service Bulletin (TSB)**  
**High Voltage Wiring Repair**

| REFERENCE: | TSB: 08-082-25 REV. A<br>GROUP: 08 - Electrical | Date: | April 12, 2025 | REVISION: | 08-082-25 |
| VEHICLES AFFECTED: | 2021 - 2024 (JL) Jeep Wrangler<br>This bulletin applies to vehicles equipped with the 2.0L I4 DOHC DI Turbo PHEV Engine (Sales Code ECX) **and China Country Code (Sales Code 8BL)**. | | | MARKET APPLICABILITY:<br><div><input type="checkbox"/> NA<input type="checkbox"/> MEA</div> <div><input type="checkbox"/> SA<input type="checkbox"/> IAP</div> <div><input type="checkbox"/> EE<input checked="" type="checkbox"/> CH</div> | |
| CAUSE: | Water intrusion | | | | |

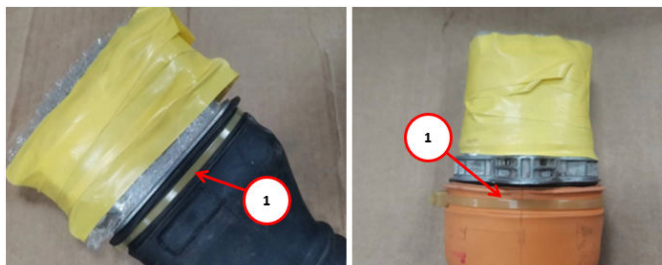
**Fig. 2**  
HV Cable Harness Connectors

1 - HV Cable Harness Connector Zip Ties

3. Is the HV cable harness damaged or rubbed through near the transmission driveshaft CV joint shield?
4.
  - YES>>> Replace the PIM to Transmission HV cable harness. Proceed to [Step 17](#).
  - NO>>> Proceed to [Step 5](#).
5. Using a suitable protective cover and tape, protect both ends of the HV cable harness connectors to prevent dust and contaminants from entry [Fig. 2](#).
6. Remove the plastic zip tie on the HV cable harness connector rubber sleeve [Fig. 2](#).

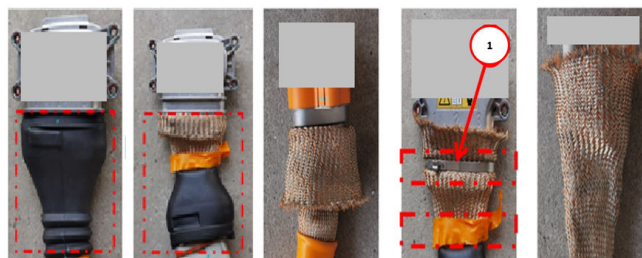
**Fig. 3**  
HV Cable Harness Exposed Metal Mesh Shielding

1 - Metal Clamp

7. Fold the rubber sleeve backward to its maximum position to expose the metal mesh shielding [Fig. 3](#).

8. Remove the tape from the shielding layer and remove the metal clamp, then stretch the mesh shielding layer up forward [Fig. 3](#).
9. Using compressed air, thoroughly clean the shielding layer and the HV wires from contaminants, oxides, and moisture.

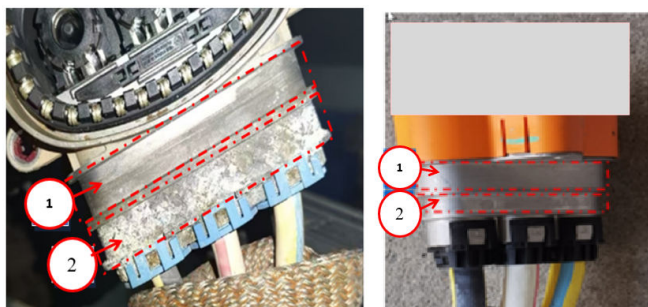
**Fig. 4**  
HV Cable Harness Connector Grooves Exposed

1 - Zone A Groove  
2 - Zone B Groove

10. Fold the shielding layer and HV wires and make maximum exposure of the groove [Fig. 4](#).

11. Use the wire brush to thoroughly clean the HV cable harness connector end of oxidation and dust in Zone A and Zone B [Fig. 4](#).

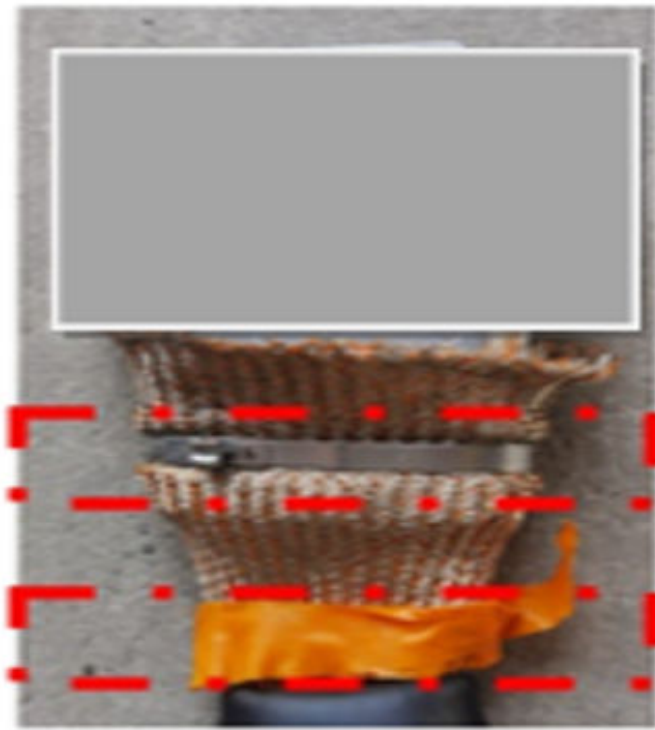
**Fig. 5**

Proper HV Cable Harness Connector Mesh And Clamp Positioning

- If the oxidization is too severe and cannot be cleaned, sand polish the groove, (**DO NOT over polish**).
  - Use the air compressor gun to blow away the dust and make the area clean.
12. Put back the metal mesh shielding layer around the HV cable harness connector and use the original metal clamp to secure the connector and shielding layer. Wrap with electrical tape [Fig. 5](#).

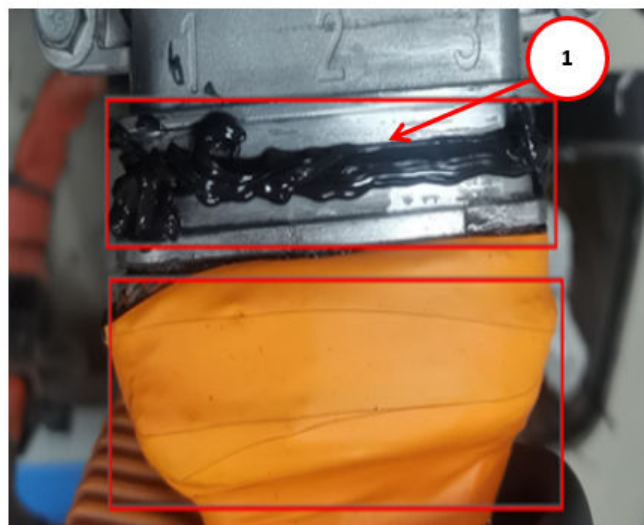
**Fig. 6**

HV Cable Harness Connector Sealed Using Darbound 2598

1 - Sealed HV Cable Harness Connector

13. Apply Darbond 2598 sealing compound evenly around the tightening area between the HV cable harness connector and the rubber sleeve in Zone A [Fig. 4](#) and [Fig. 6](#).

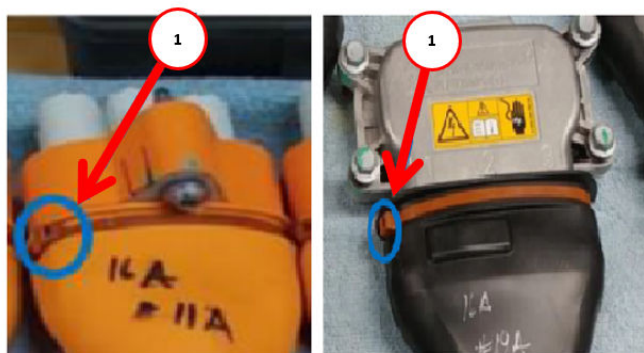
**Fig. 7**

HV Cable Harness Connector Sleeve With Cable Tie

1 - Plastic Cable Tie Position On Connector

14. Reattach the rubber sleeve and secure it within 15 minutes of applying the sealing compound and tighten the plastic cable tie using the HellermannTyton EVO7 tool to 225 N·m (166 Ft. Lbs.). Repeat the same process for the other end connector of the HV cable harness [Fig. 7](#).

**NOTE: Ensure the zip tie head is positioned on the connector side and thoroughly wipe away any excess compound.**
