Technical Service Bulletin (TSB)

Right Front Heated Seat Inoperative

REFERENCE:	TSB: 08-111-25 GROUP: 08 - Electrical	Date:	April 9, 2025	REVISION:	_	
VEHICLES AFFECTED:	2025 (WL) Jeep Grand Cherokee/ Grand Cherokee L This bulletin applies to vehicles built on or after October 17, 2024 (MDH 1017XX) and on and before October 25, 2024 (MDH 1025XX) equipped with Heated Front Seats (Sales Code JPM).			MARKET AP	PLICABILITY: MEA IAP CH	
CUSTOMER SYMPTOM:	 Customers must experience a Malfunction Indicator Lamp (MIL) illumination and the vehicle must exhibit/set the following Diagnostic Trouble Code (DTC): B1E9A - Front Right Heater Control 1 – Circuit Open. Customers may experience the following: Right front heated seat will not activate or will shut off after a few seconds. 					
CAUSE:	Damaged harness connector

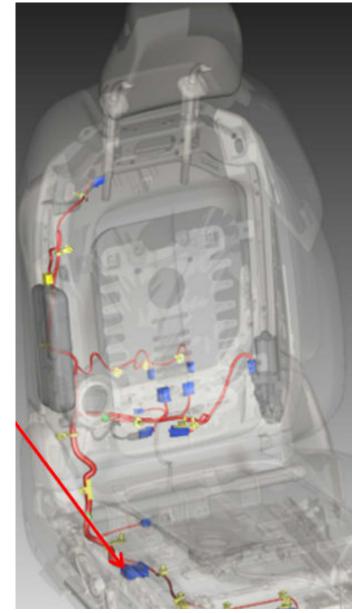
- 1. With the vehicle ignition on, open the right rear door.
- 2. Under the front passenger seat, disconnect inline connector XY444A and inspect pin 18 for a spreading condition Fig 1, Fig. 2.

Fig. 1 XY444A Harness Connector Location

- 3. Is Terminal 18 spread?
 - YES>>> Proceed to Step 6.
 - NO>>> Proceed to Step 4.
- 4. Reconnect XY444A and wiggle test and push-pull-push the connector while monitoring for DTC B1E9A to set.
- 5. Did DTC B1E9A set?
 - YES>>> Proceed to Step 6.
 - NO>>> This bulletin does not apply. Use Inspect LOP (23-20-38-9A) to close this active RSU.
- 6. Repair terminal 18 using kit 68502132AA.
- 7. Clear any DTC's.
