Service Bulletin

Bulletin No.: 08-03-10-006I

Subject: Tire Slowly Goes Flat, Tire Air Loss, Low Tire Pressure Warning Light Illuminated, Aluminum Wheel Bead Seat Corrosion (Clean and Resurface Wheel Bead Seat)

Models: 2026 and Prior GM Passenger Cars and Light Duty Trucks

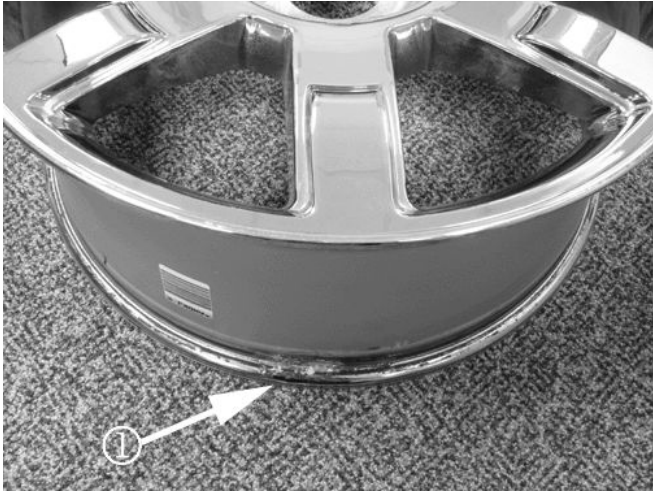
2103715

Abrasive elements in the environment may intrude between the tire and wheel at the bead seat. There is always some relative motion between the tire and wheel (when the vehicle is driven) and this motion may cause the abrasive particles to wear the wheel and tire materials. As the wear continues, there may also be intrusion at the tire/wheel interface by corrosive media from the environment. Eventually a path for air develops and a 'slow' leak may ensue. This corrosion may appear on the inboard or outboard bead seating surface of the wheel. This corrosion will not be visible until the tire is dismantled from the wheel.

1. Remove the wheel and tire assembly for diagnosis. Refer to *Tire and Wheel Removal and Installation* in SI.
2. After a water dunk tank leak test, if you determine the source of the air leak to be around the bead seat of the wheel, dismount the tire to examine the bead seat. Shown below is a typical area of bead seat corrosion.

Typical Location of Bead Seat Corrosion

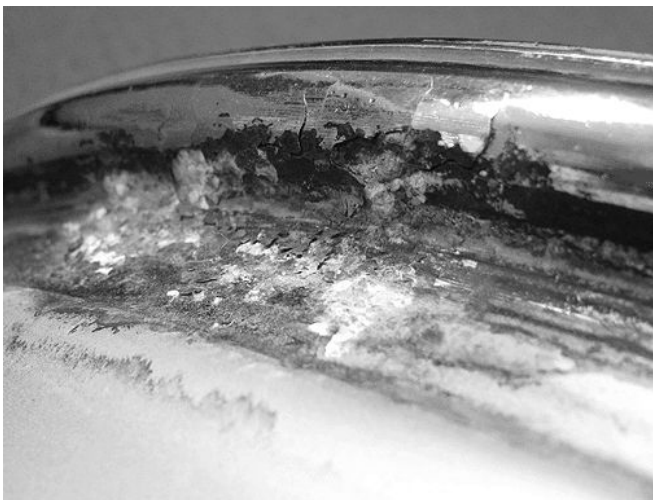
2103722

3. Bead seat corrosion is identified by what appears like blistering of the wheel finish, causing a rough or uneven surface that is difficult for the tire to maintain a proper seal on. Below is a close-up photo of bead seat corrosion on an aluminum wheel that was sufficient to cause slow air loss.

Close-Up of Bead Seat Corrosion

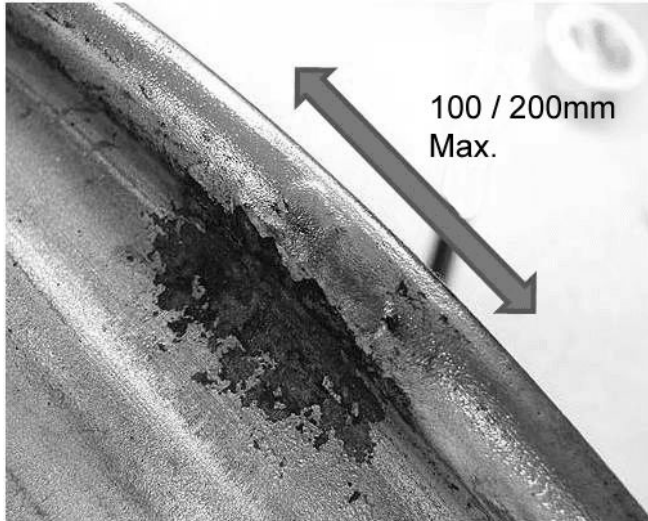
2365347

4. If corrosion is found on the wheel bead seat, measure the affected area as shown below.

- For vehicles with 32,186 km (20,000 mi) or less, the total allowable combined linear area of repairable corrosion is 100 mm (4 in) or less. If the total area(s) of corrosion exceed these dimensions, the wheel should be replaced.

- For vehicles that have exceeded 32,186 km (20,000 mi), the total allowable combined linear area of repairable corrosion is 200 mm (8 in) or less. If the total area(s) of corrosion exceed these dimensions, the wheel should be replaced.

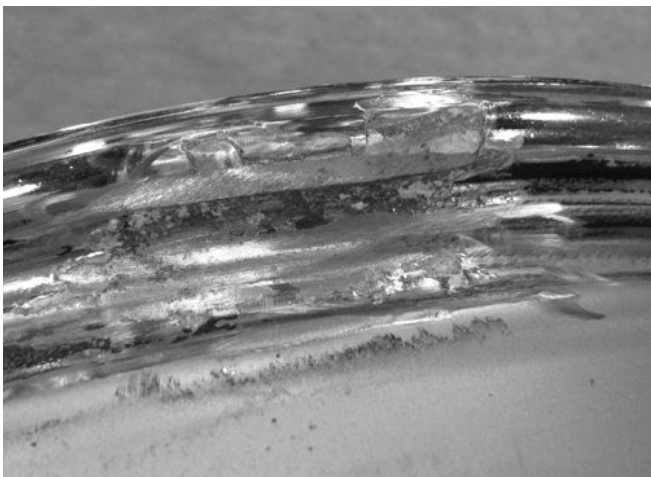
2103726

Acceptably Prepared (Cleaned-Up) Wheel Surface

5. In order to correct the wheel leak, use a clean-up (fine cut) sanding disc or biscuit to remove the corrosion and any flaking paint. You should remove the corrosion back far enough until you reach material that is stable and firmly bonded to the wheel. Try to taper the edge of any flaking paint as best you can in order to avoid sharp edges that may increase the chance of a leak reoccurring. The photo below shows an acceptable repaired surface.

Important: Remove ONLY the material required to eliminate the corrosion from the bead seating surface. DO NOT remove excessive amounts of material. ALWAYS keep the sealing surface as smooth and level as possible.

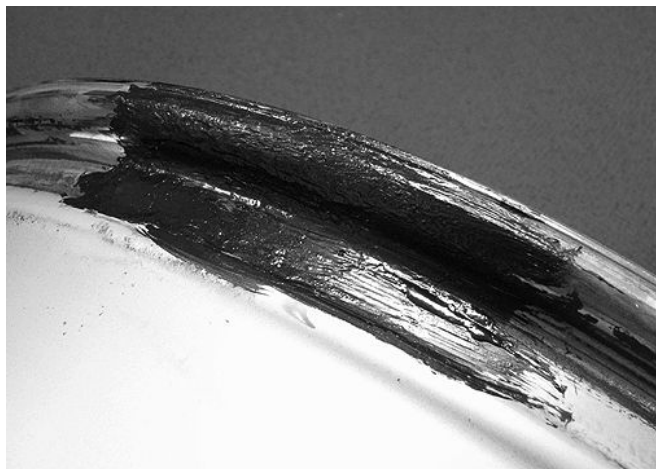
2103731

Coated and Sealed Bead Seat

6. Once the corrosion has been eliminated, you should coat the repaired area with a commercially available tire sealant such as Patch Brand Bead Sealant or equivalent. Commercially available bead sealants are black rubber-like coatings that will permanently fill and seal the resurfaced bead seat. At 21°C (70°F) ambient temperature, this sealant will set-up sufficiently for tire mounting in about 10 minutes.
