Service Bulletin

Bulletin No.: 23-NA-165

Subject: Vehicle Will Not Lock and Unlock (Loss of Active Functions) Crank or Start (Loss of Passive Functions) with DTC P0513 Set

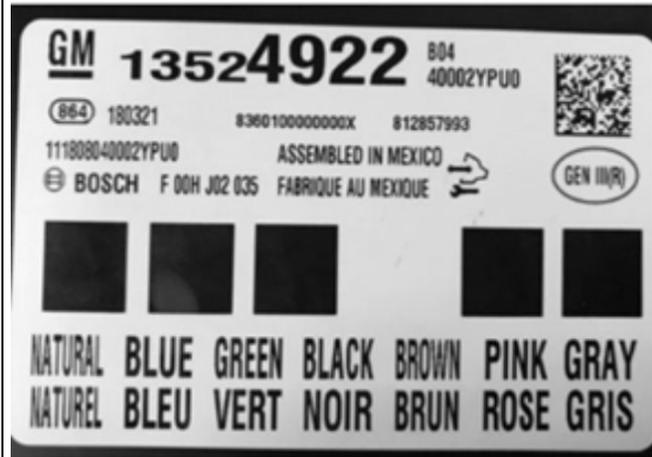
6430397

GEN3R BCMs can be identified by either the label on the module or looking up the BMPN part number information in GDS2.

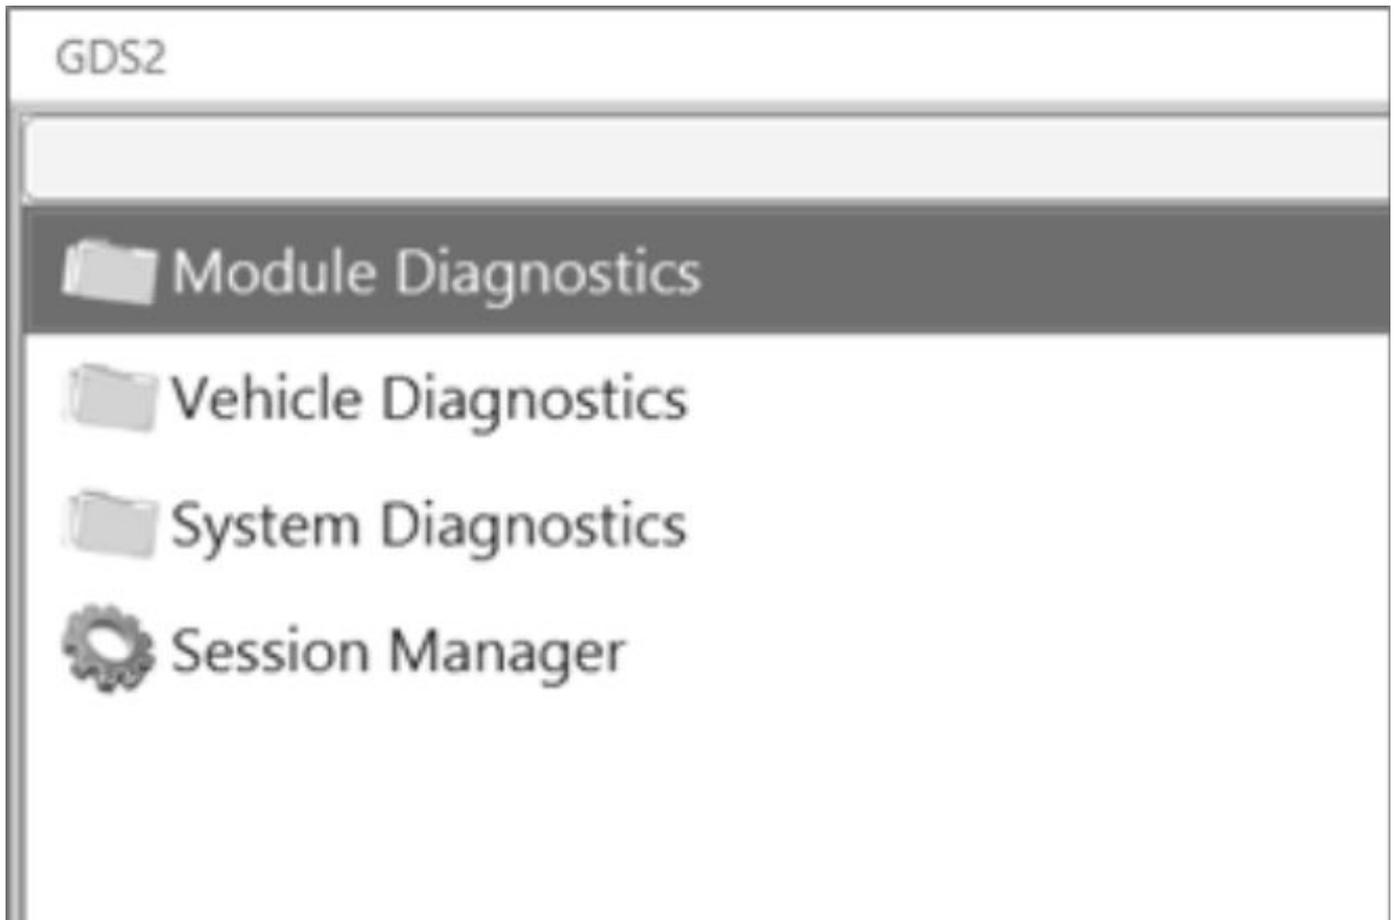
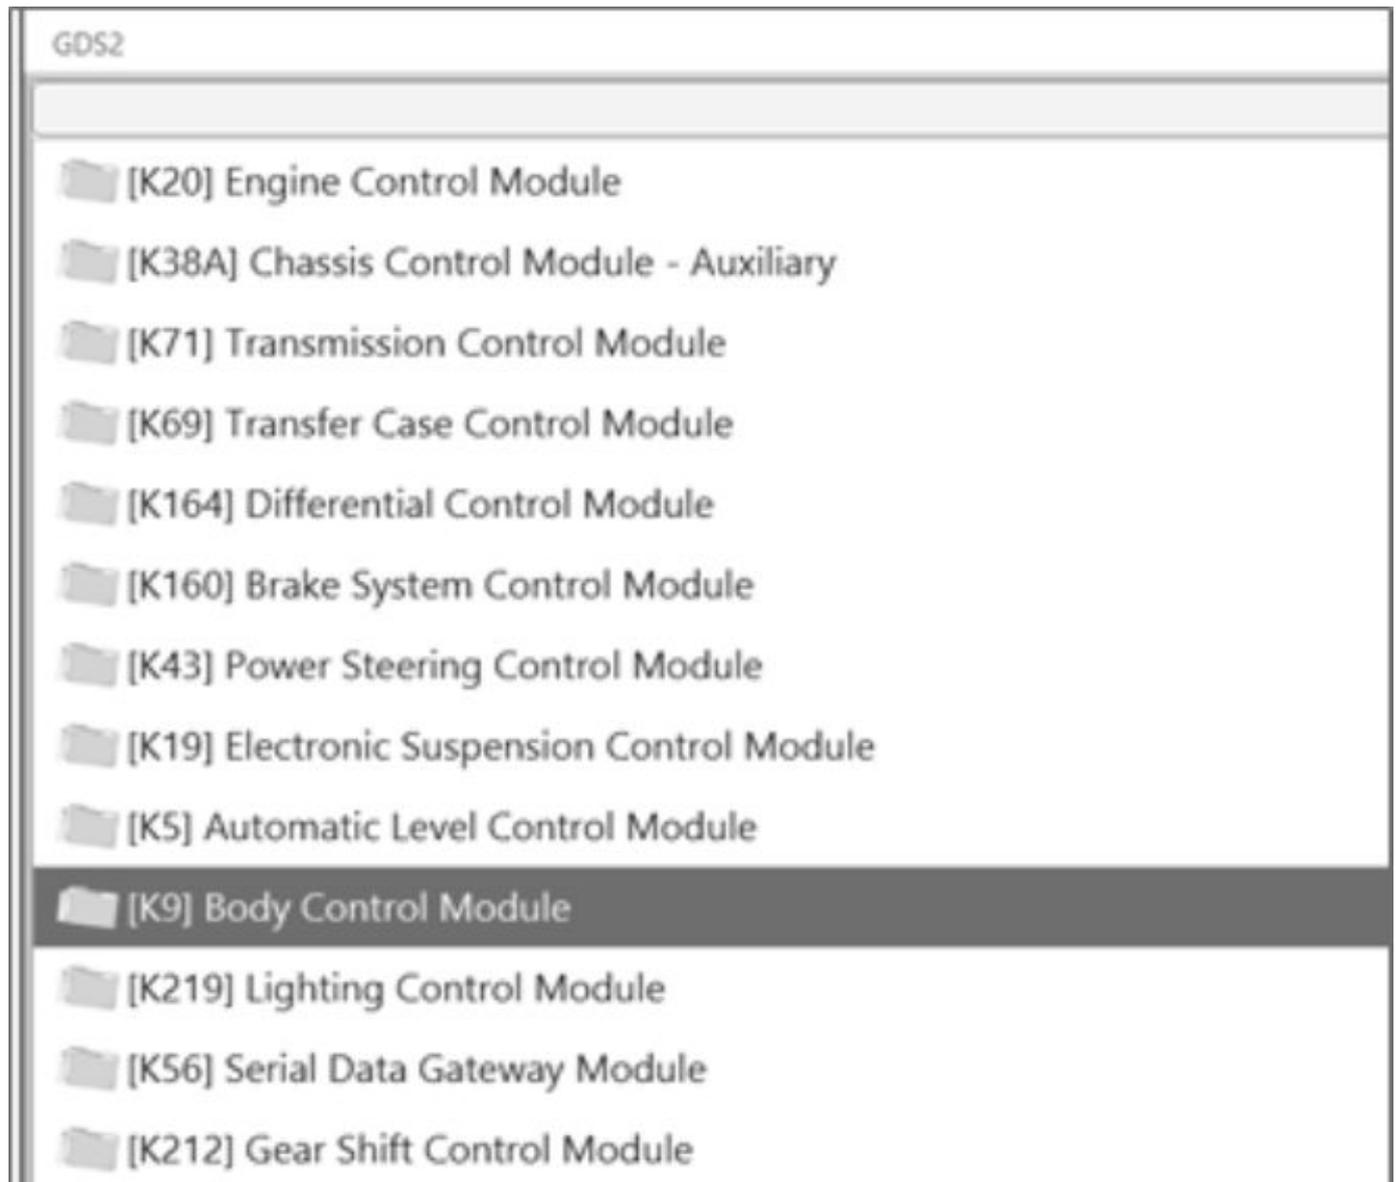
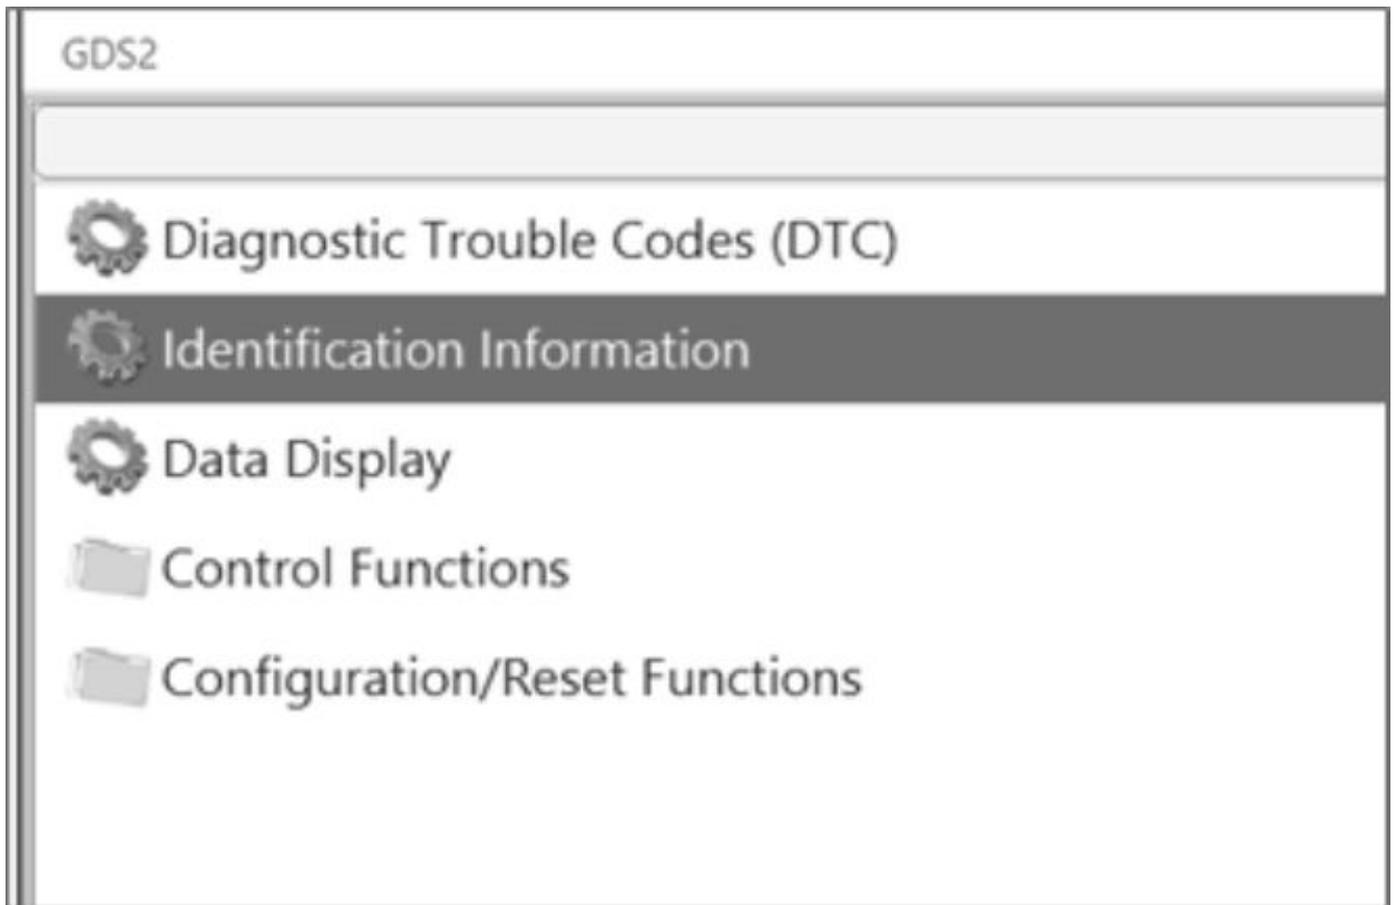
6430394

Verify you have a GEN3R BCM Base Model Part Number. Only GEN3R BCMS are eligible for this bulletin. Navigate to GDS2 > Module Diagnostics > [K9] Body Control Module > Identification Information > Identification Information.

BMPNs eligible for this bulletin: 13518569, 13518570, 13518602, 13518603, 13519619, 13519620, 13519648, 13527252, 13527260, 13527261, 13527297, 13527298, 13527827, 13529492, 13529493, 13533809, 13533813, 13533814, 13533817, 13533821.
