Service Bulletin

Bulletin No.: 24-NA-003
Date: March, 2025

Subject: Sunroof Wind / Air Deflector Inoperative

Brand:	Model:	Model Year:		VIN:		Engine:	Transmission:
		from	to	from	to		
Buick	Enclave	2017	2024	-	-	All	All
Chevrolet	Traverse						
GMC	Acadia

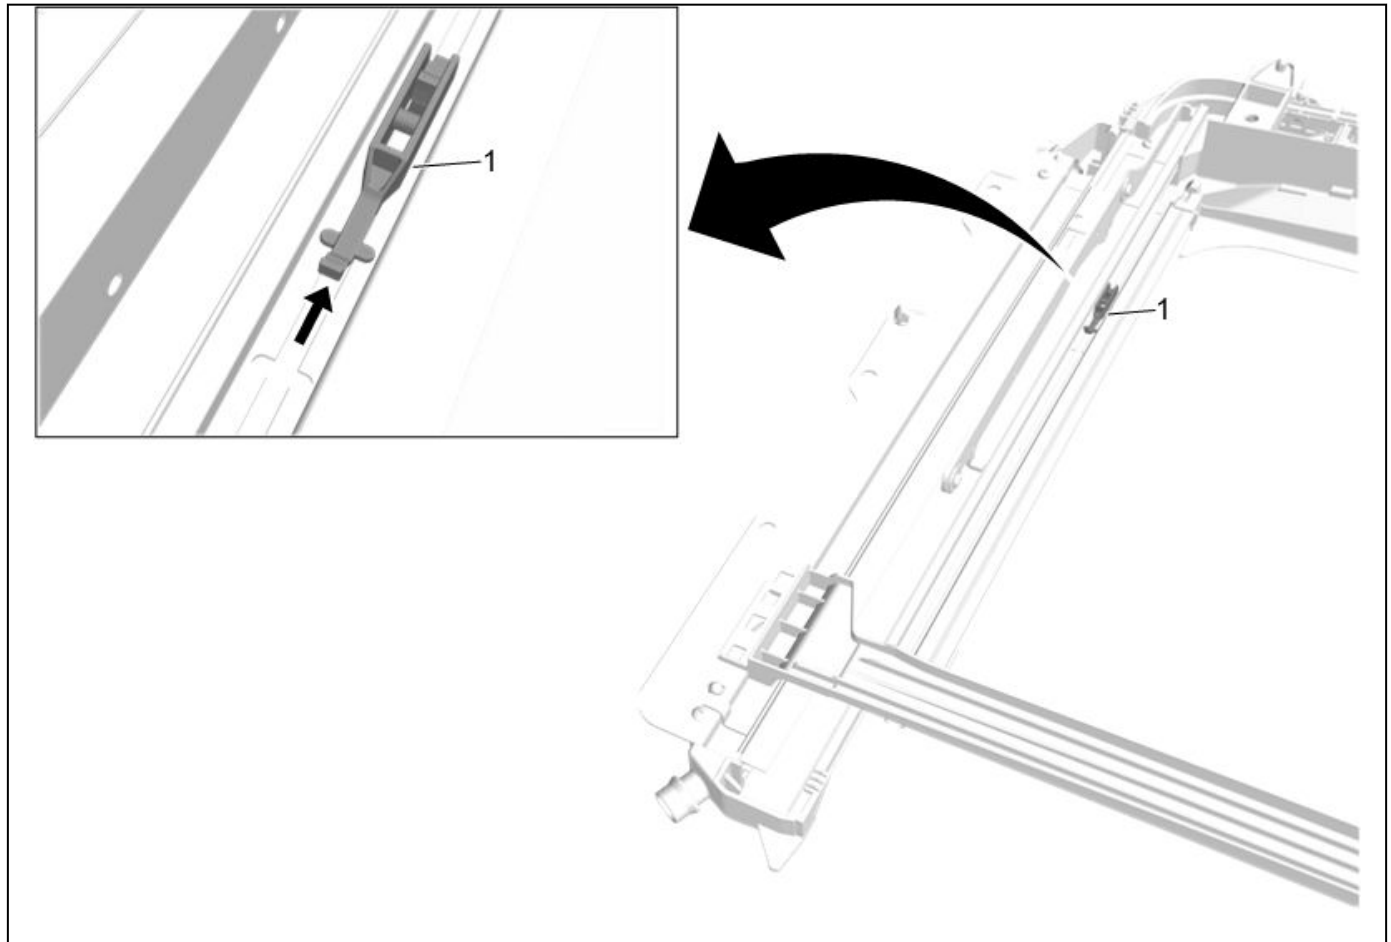
6489927

Note: If the sunroof air deflector clip is broken, confirm that all pieces are found and removed.

2. Using a suitable tool, push the sunroof air deflector (2) down and back to release it from the sunroof housing assembly clips (1).

3. Pull the sunroof air deflector (2) upward and back to remove.
