Model series 223 with code 96B (Active driving noise compensation) [ANC] - static noise from speakers while driving

| Topic number | LI82.62-P-076176 |
| Function group | 82.62 - Loudspeakers, amplifiers, antennas |
| Validity | Model series 223 with code 96B |

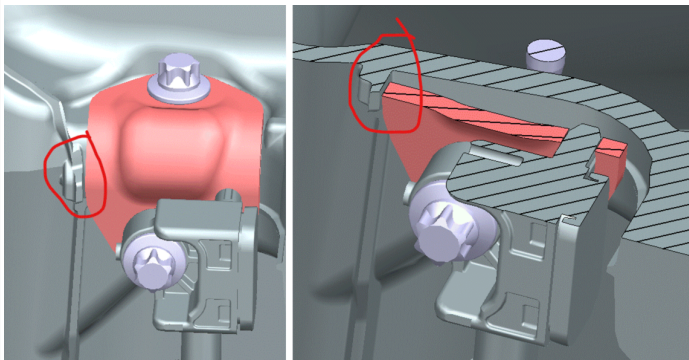
- Due to tolerances, it may be the case under certain circumstances that the angle bracket of the sensors at the integral carrier does not have sufficient contact with the integral carrier ("longitudinal member") of the body. It is also possible that the stipulated tightening torque of the screw connection has not been adhered to, which results in the transferred impulses being falsified. As a result, unintended vibrations may be transferred via the holder to the sensor. During assembly, the contact areas must be clean and free of dust and foreign objects. Control unit N156/1 then interprets these falsified signals as driving noise and attempts to compensate for this, which results in static noise coming through the speakers.

Disassembly of both RNS sensors from the integral carrier. The RNS sensors should remain on the RNS sensor holders as a first step.

Apply an adhesive sealing disk to the RNS sensor holder. This adhesive sealing disk serves as an intermediate layer between the RNS sensor holder and integral carrier. The dampening adhesive film below the RNS sensor holder (as an intermediate layer for the integral carrier) can be minimally trimmed to achieve better dimensional accuracy.

Assemble the new RNC sensor holder fitted with the adhesive pad at the integral carrier. The following assembly notes must be adhered to.

During the assembly of the RNS sensor holder, it must be ensured that this only makes contact with the screwed-on surface at the integral carrier. Avoid having the outer edge of the RNS holder make contact with a protruding edge of the integral carrier, as otherwise no force-fitted, wide-area connection is established.

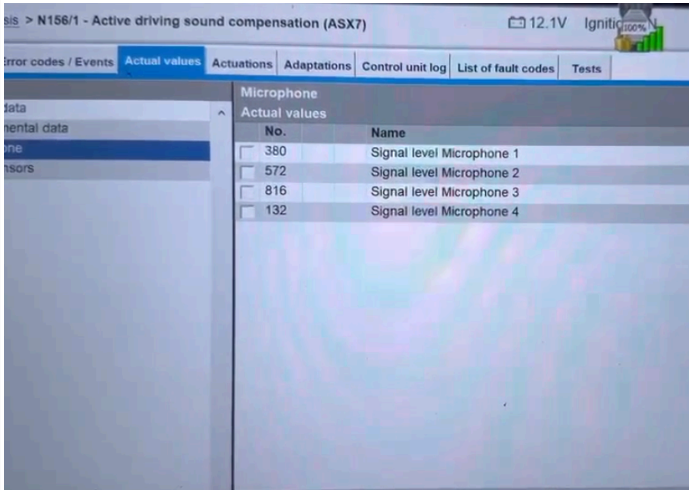
- The microphones could be connected to the wrong channels at control unit ASX 156/1, i.e. with swapped connections. The correct assignment of the microphones can be checked with XENTRY. (See remedy)

5. Check whether the 4 ANC microphones are correctly connected. This check is essential and should be performed in any event when problems with the RNC system occur. To do so, display the microphone level of the 4 microphones in XENTRY (see the picture in the attachment) and check that the microphones have been assigned correctly by scratching a finger against the microphone grille. The displayed level in [mV] normally increases to a value greater than 1000 mV when a fingernail is scratched against the microphone grille. Microphone

- 380 microphone 1 = Front left position
 - 572 microphone 2 = Front right position
 - 816 microphone 3 = Rear left position
 - 132 microphone 4 = Rear right position

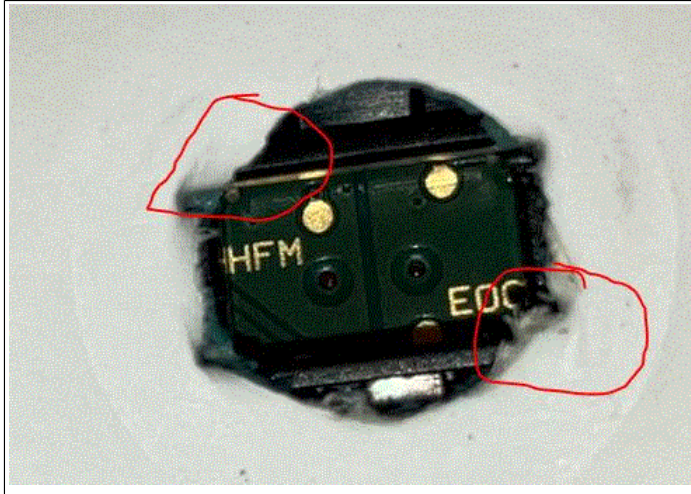
| Example of protruding material on microphone | | | | | | | | | | |

Note: Fibers pinched between microphone and cover prevent the microphone from being sealed tightly, which causes unwanted external noise to be transmitted and therefore may impair system function. Carefully cut off protruding fibers with a suitable implement. When mounting the cover, make sure that you hear and feel it engage.

- Check for correct assembly of the microphones: To do so, remove microphone cover in the headliner and perform visual inspection as to whether the edges of the cutout are frayed. (See picture in attachment)
