## TECHNICAL SERVICE BULLETIN

### Non-Shelby GT-350 - Various Concerns With The Active Exhaust System

**25-2146**

<b>Ford</b> 2020-2022 Mustang Shelby GT500	Engine: 5.2L Supercharged
2018-2023 Mustang	Engine: 2.3L EcoBoost Engine: 5.0L

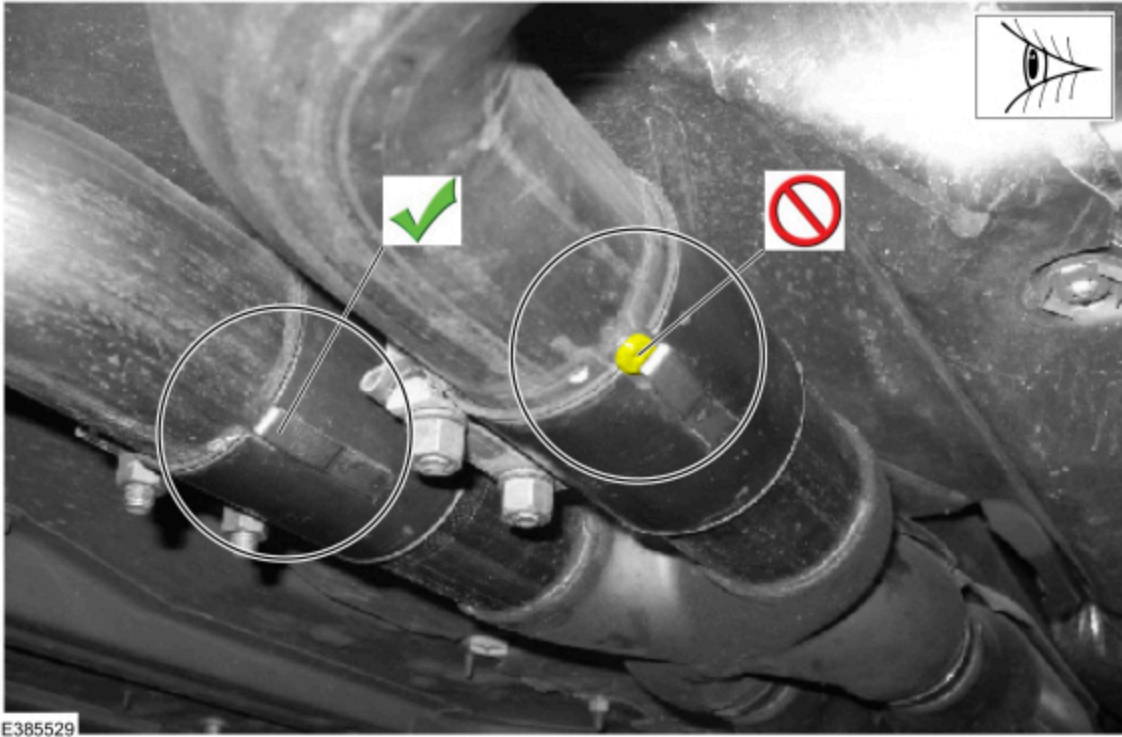
Figure 1 - Exhaust clamp locking tabs.

### 5. Inspect the muffler and tailpipe assembly and both catalytic converters for proper positioning of the exhaust clamps securing them together. Make sure the exhaust clamp locking tab is fully engaged to the catalytic converters (Refer to Figure 1). Make sure the knurled/ridge area of the muffler and tailpipe assembly are covered

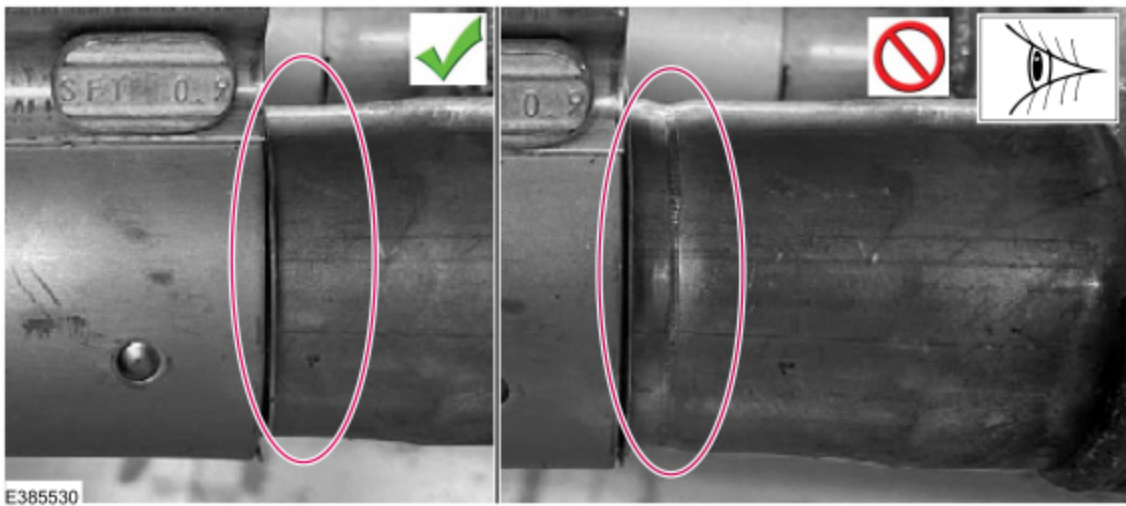
Figure 2 - Non-GT500 exhaust with ridge.

by the exhaust clamps (Refer to Figures 2-3). Adjustments can be made by loosening the exhaust clamps and repositioning the muffler and tailpipe assembly. (Figures 1-3)

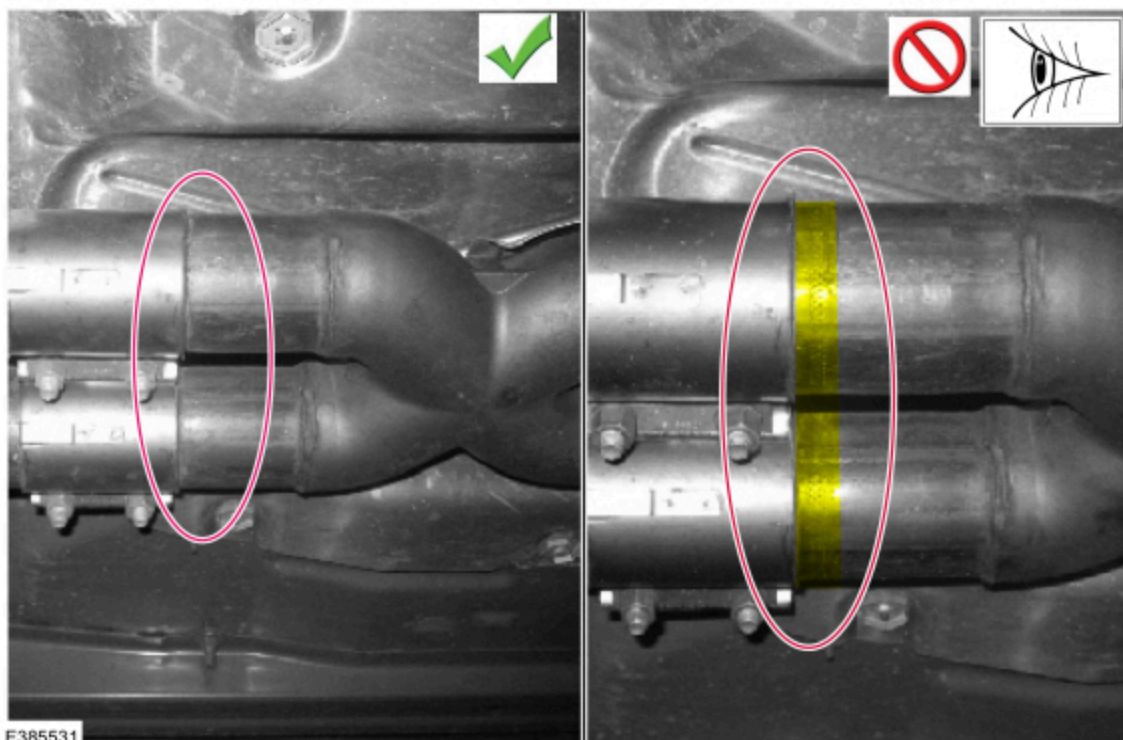
Figure 3 - GT500 exhaust with knurled area.
