#### SIB 64 04 25

# HARNESS DAMAGE POSSIBLE WHILE CHANGING CABIN NANOFILTER

E-Series	Model Description
G60	5 Series Sedan
G70	7 Series Sedan
G90	M5 Sedan
G99	M5 Touring

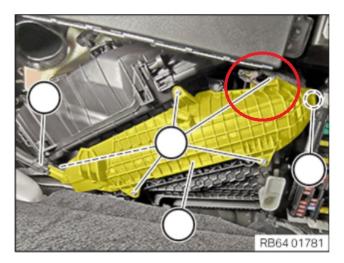
When following Repair Instructions REP **64 31 010** to change the cabin air nanofilter, check the vehicle wiring harness routing (circled) before fastening the plastic cover over the filter.

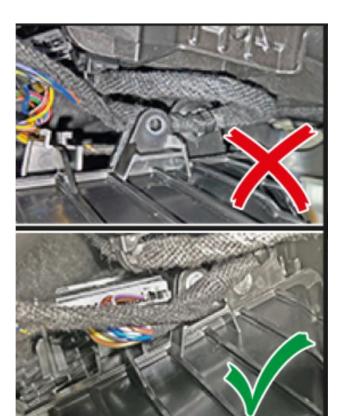
With the harness pulled out of the way, you can see the screw mounting hole for the cabin air filter cover

Double check the routing of the harness prior to installing the screws for the cabin air filter cover.

If the wiring harness has already been damaged during the installation of the cabin air filter cover, the damaged section of the wiring harness must be repaired.
