SIM 51 01 25

FOGGING ON THE INSIDE OF THE WINDSHIELD IN THE AREA OF THE ADCAM

E-Series	Model Description
U25	MINI Countryman

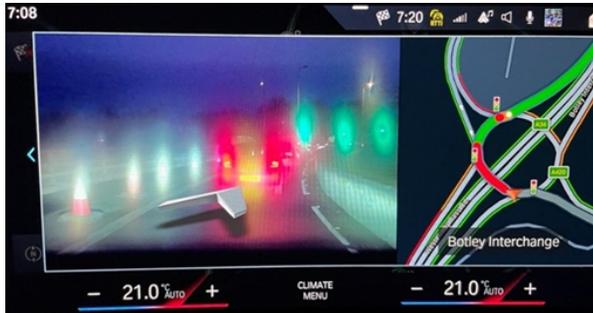
The Augmented Reality Camera (ARCAM) shows up blurry when activated.

Contamination on the inside of the windshield in front of the Autonomous Driving Camera (ADCAM; arrow).

Using a clean and dry microfiber cloth, clean the affected area of the inner windshield and ADCAM lenses using BMW Group glass cleaner.

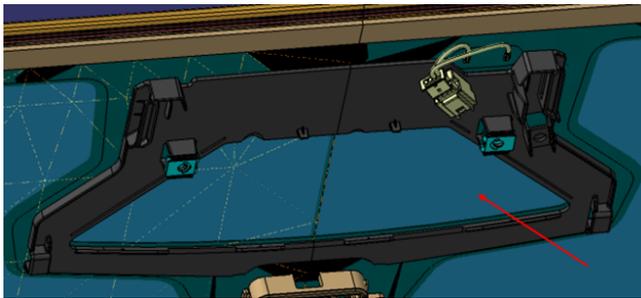
Contamination on the inside of the windshield in front of the Autonomous Driving Camera (ADCAM; arrow).

1. Remove the ADCAM camera per the repair instructions listed in ISTA/AIR 66 51 541 or 66 51 590.
2. Spray the glass cleaner onto a clean/dry microfiber cloth.

3. Clean the inner section of windshield where the ADCAM sits and clean the ADCAM lenses.
4. Reinstall the ADCAM and reassess the vehicle.
