# Service Bulletin

Bulletin No.: 25-NA-021

**Subject: Radio Software Update W23E-178.1.2-M174-SQBR6-93.3**

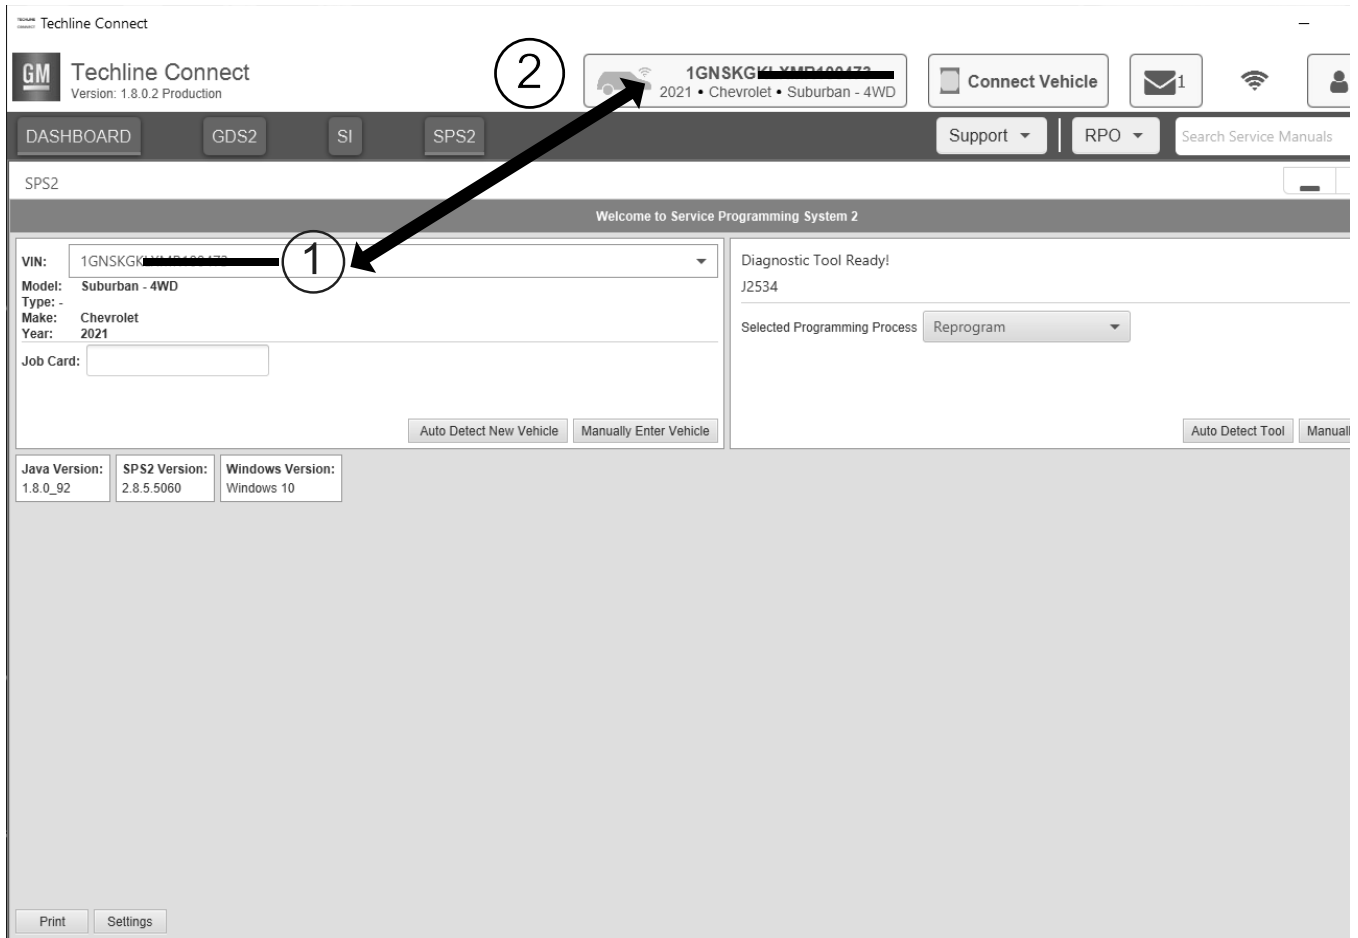
5743643

**Caution:** Be sure the VIN selected in the drop-down menu (1) is the same as the vehicle connected (2) before beginning programming.

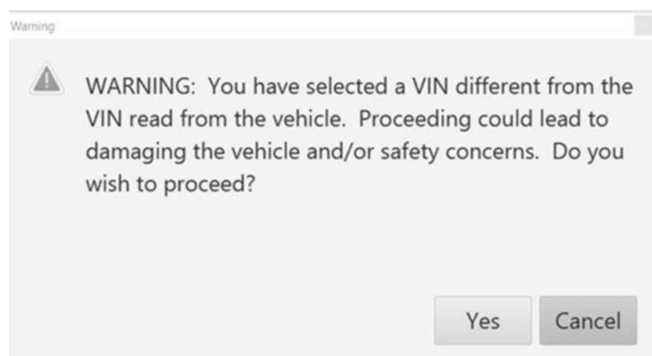
5877000

**Important:** If the vehicle VIN DOES NOT match, the message below will be shown

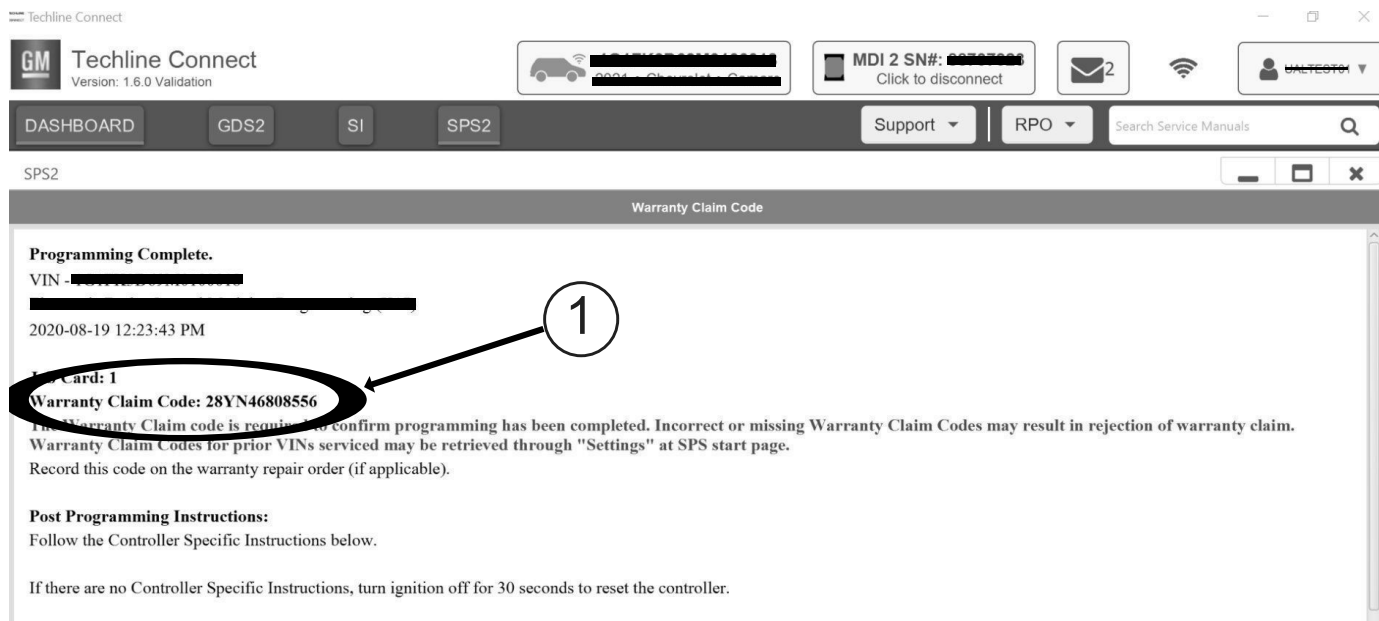
5644478

**Note:** The screenshot above is an example of module programming and may not be indicative of the specific module that is being programmed. Module selection and VIN information have been blacked out.

**Important:** To avoid warranty transaction rejections, you **MUST** record the warranty claim code provided on the Warranty Claim Code (WCC) screen shown above on the job card. Refer to callout 1 above for the location of the WCC on the screen.
