**SIB 72 04 17**

**F90 FALSE ALERT RF SEAT OCCUPIED W BELT UNBUCKLED-
EXTENDED LTD WARRANTY**

This Service Information Bulletin (Revision 15) replaces SI B72 04 17 dated **December 2022**.

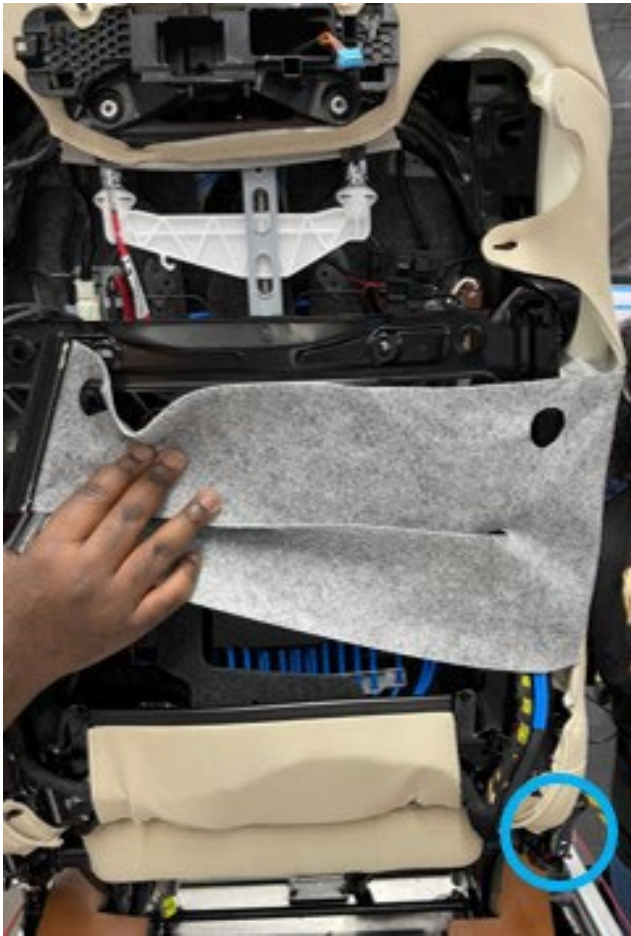
3. Prior to replacing components, inspect the connection of the CIS mat's ground wire to the structure at the lower right side of the backrest (circled).

The eyelet on the ground wire should make solid connection to the structure with no free play.

If free play is identified, repair as needed.

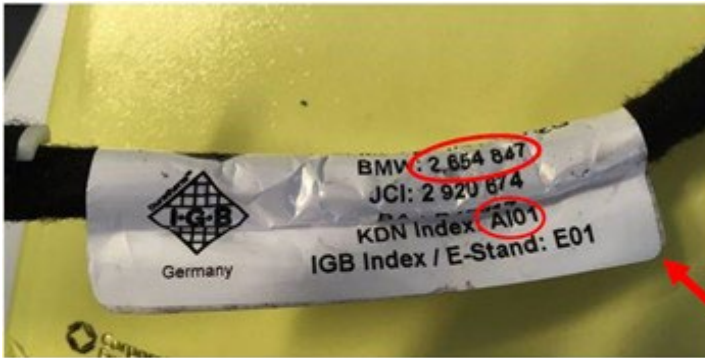
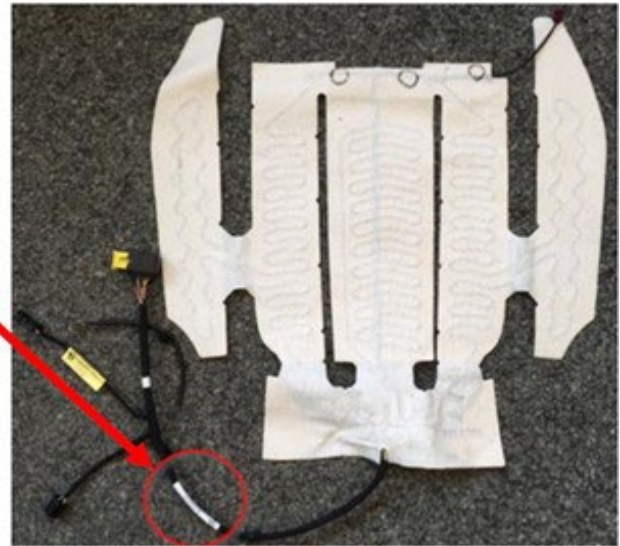
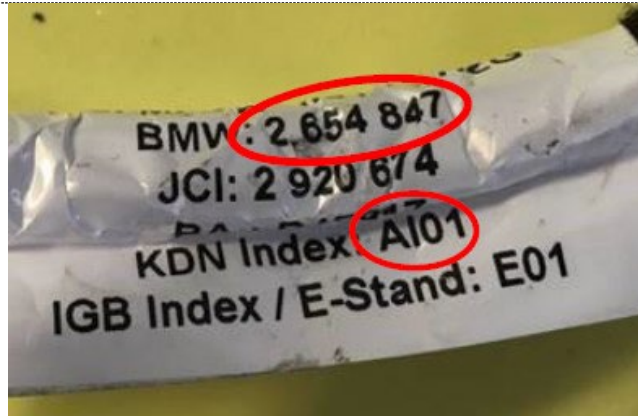
To access the label's information, loosen seat mounting, open the central connector, fold seat to the back, completely.

In this example, the BMW **Part Number 2 654 847** is shown (circled).

The corresponding KDN (Revision) Index number "A101" is shown (circled).
