SIB 72 03 25

G01/G02 FALSE ALERT RF SEAT OCCUPIED W BELT UNBUCKLED-  
EXTENDED LTD WARRANTY

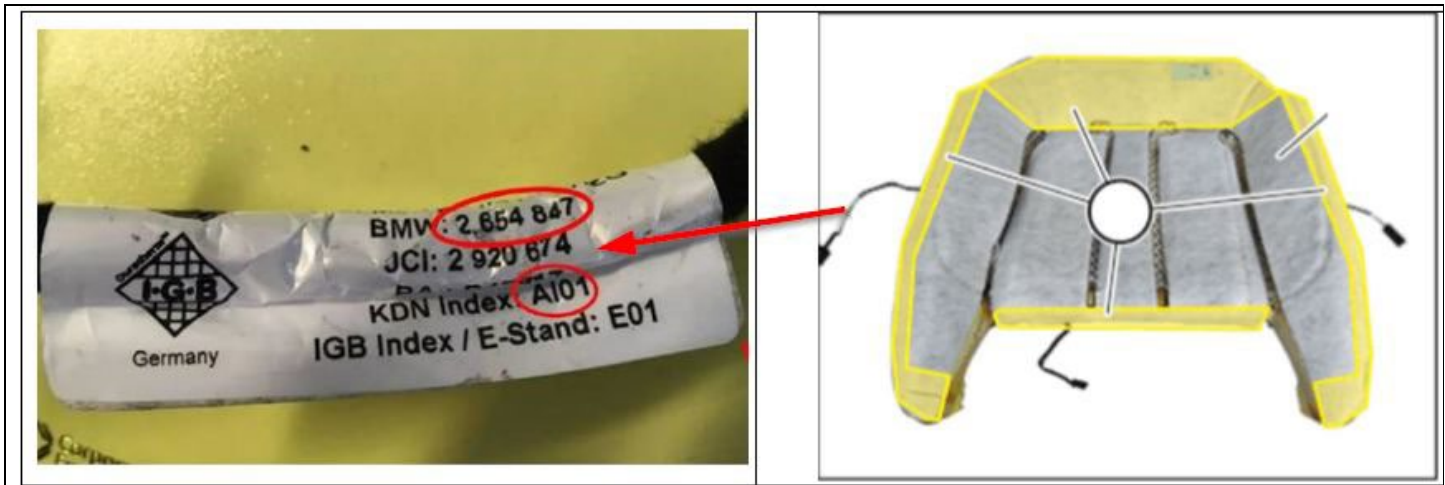
In this example, the **BMW Part Number 2 654 847** is shown (circled).

**The corresponding KDN (Revision) Index number "AI01" is shown (circled).**
