SIB 72 02 25

2025-04-09

G0X/G20 FALSE ALERT RF SEAT OCCUPIED W BELT UNBUCKLED- EXTENDED LTD WARRANTY

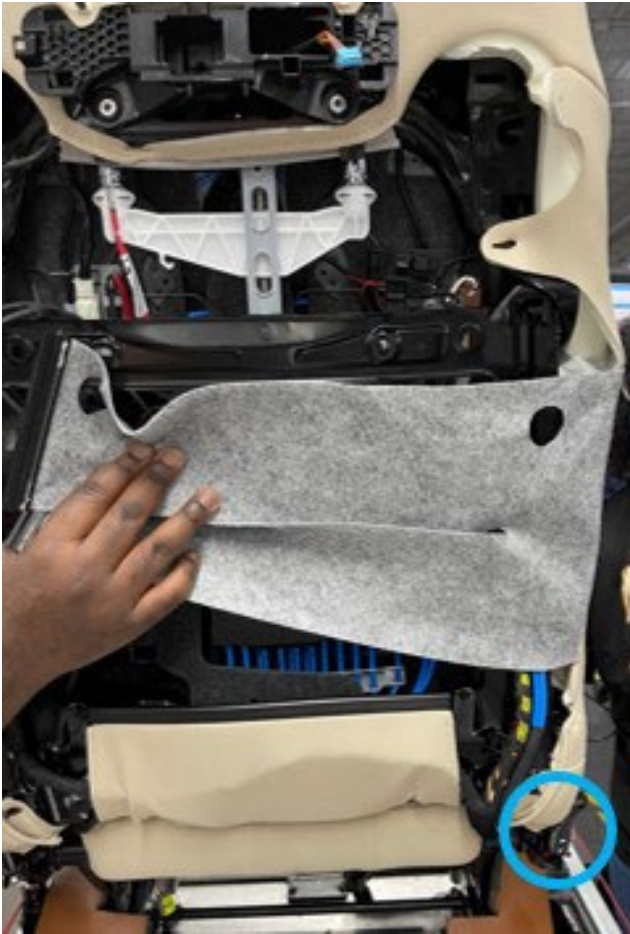
3. Prior to replacing components, inspect the connection of the CIS mat ground wire to the structure at the lower right side of the backrest (circled).

The eyelet on the ground wire should make solid connection to the structure with no free play.

If free play is identified, repair as needed.
