SIB 72 01 25

2025-04-09

## G1x/G3x FALSE ALERT RF SEAT OCCUPIED W BELT UNBUCKLED- EXTENDED LTD WARRANTY

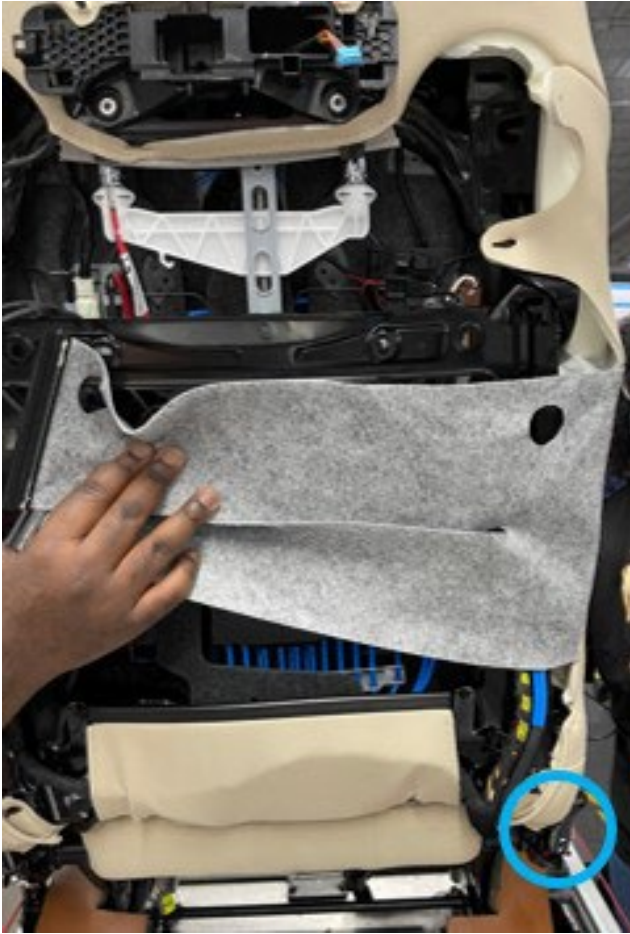
3. Prior to replacing components, inspect the connection of the CIS mat ground wire to the structure at the lower right side of the backrest (circled).

The eyelet on the ground wire should make solid connection to the structure with no free play.

If free play is identified, repair as needed.

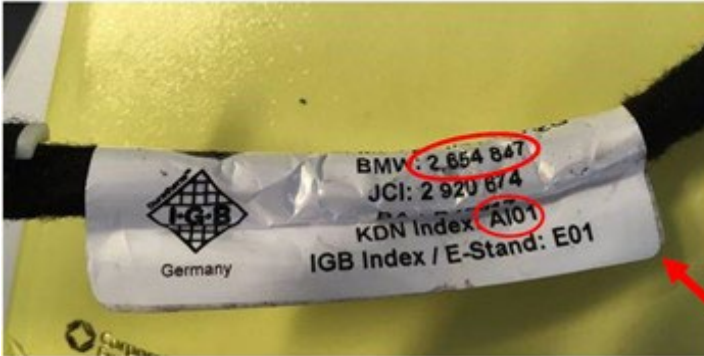
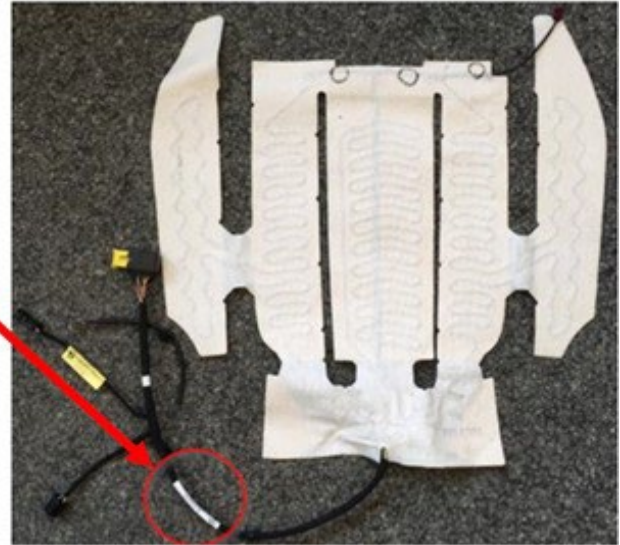
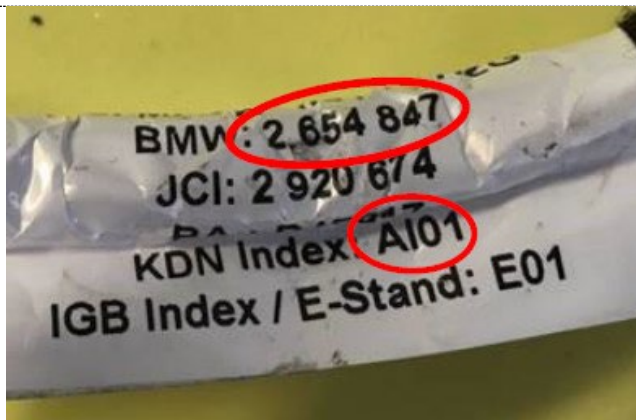
In this example, the BMW **Part Number 2 654 847** is shown (circled).

The corresponding KDN (Revision) Index number "AI01" is shown (circled).
