SIB 01 07 25

G05/20 PHEV FRONT GRILLE LOWER ACTIVE AIR FLAP EXT LIMITED WARRANTY (ELW) 15/150

Component-Specific Limited Warranty Extension

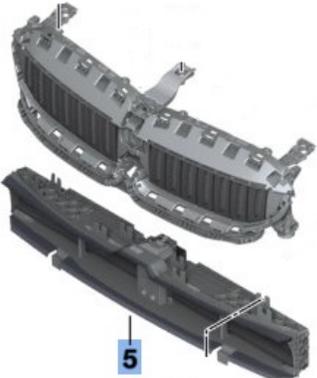
Over time, there could be an operational issue with your vehicle's lower active air flap assembly. Should this situation occur, the corresponding check control messages (CCM) will display, and/or the Malfunction Indicator Lamp (MIL) will illuminate when the vehicle's monitoring system stores the corresponding fault codes that are generated.

Perform a visual inspection of the lower active air flap first, and if still required, perform a Vehicle Test and the additional corresponding diagnosis.

As specified or as instructed, replace the lower air flap assembly to address a component defect, and/or as determined by the vehicle's current i-level and the lower active air flap test plan, update the vehicle's software as required to optimize its operation.
