SIB 01 03 25

G0X G20 FRONT GRILLE LOWER ACTIVE AIR FLAP EXT LTD WTY (ELW)
15 YRS/150,000 MLES

Component-Specific Limited Warranty Extension

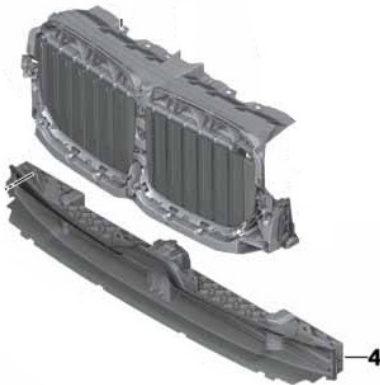
For the eligible vehicles, BMW of North America, LLC (BMW NA) is extending the limited warranty for defects in materials and/or workmanship on these vehicle's **Radiator Grille's Lower Active Air Flap Assembly (Item # 4, X7 shown)** to:

Over time, there could be an operational issue with your vehicle's lower active air flap assembly. Should this situation occur, the corresponding check control messages (CCM) will display, and/or the Malfunction Indicator Lamp (MIL) will illuminate when the vehicle's monitoring system stores the corresponding fault codes that are generated.

As specified or as instructed, replace the lower air flap assembly to address a component defect, and/or as determined by the vehicle’s current i-level and the lower active air flap test plan, update the vehicle’s software as required to optimize its operation.
