GROUP	MODEL
ELE	2025MY EV9 (MV1a)
NUMBER	DATE
383	April 2025

TECHNICAL SERVICE BULLETIN

SUBJECT: **SUNROOF/REAR ROLLER BLIND INITIALIZATION (SA615)**

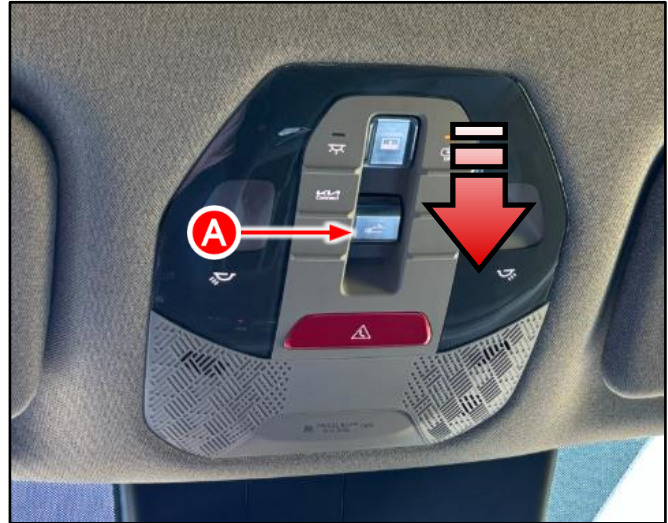
Sunroof Initialization Procedure:

This bulletin provides information to upgrade the Roof Control Module 'RCM' system software on certain 2025MY EV9 (MV1a) vehicles produced from May 16, 2024 through March 17, 2025, which may exhibit an inoperative sunroof or rear roller blind due to a loss of motor position data during states of 'sleep' or 'low' power. To rectify this concern, follow the procedure outlined in this publication to apply the improved logic to the 'RCM' module and perform the sunroof and rear roller blind reinitialization. Refer to [SST081](#) for software upgrade instructions using Kia Diagnostic System (KDS) tablet and VCI-II and confirm the Upgrade Event Number/Name, ROM ID Information, and Manual Mode passwords (if applicable) on the applicable vehicle.

1. Turn the ignition 'ON'.
2. Close the sunroof completely (if opened).
3. Lightly press (half click) the sunroof switch (A) forward until the sunroof motor moves once, then release the sunroof switch.
4. Press (full click) and hold the sunroof switch (A) forward until the sunroof glass opens and closes.
5. Release the sunroof switch (A).
6. Confirm normal operation of the sunroof.
7. Proceed to the 'Rear Roller Blind Initialization Procedure' below.

DO NOT release the sunroof switch (A) until the operation has completed. If the switch is released prematurely, the initialization procedure will need to be restarted.
