R232 - Seat Backrest Of Front Seat Collides With Draft Stop

| Topic number | LI91.10-P-079211 |
| Validity | Valid for model series 232. |

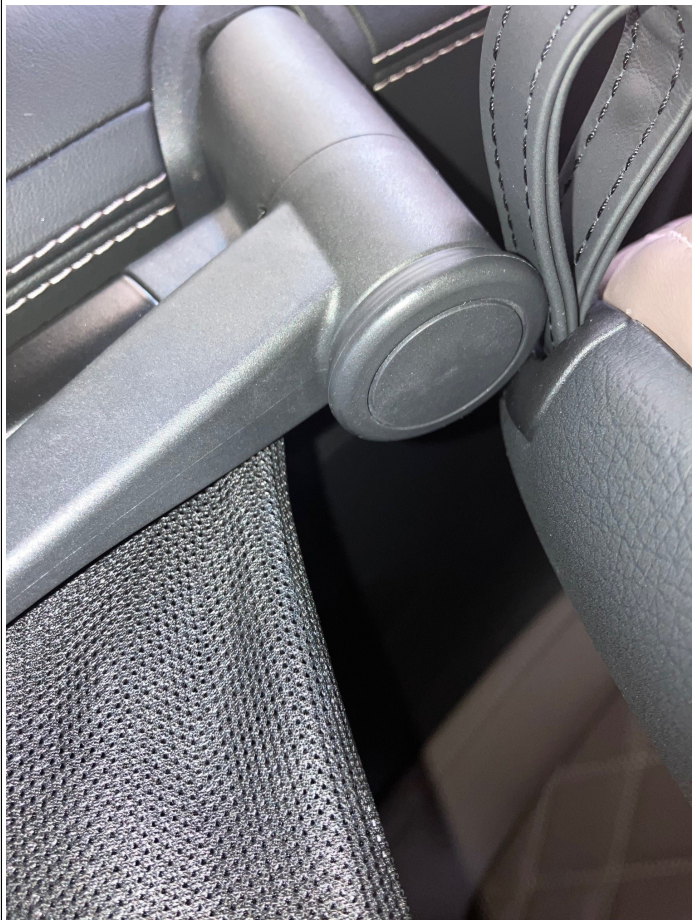
| Attachments | |
|---|---|
| Berührung Windschott mit Sitz.jpg | |

Seat backrest of front seat collides with the installed draft stop in the rearmost position.

The seat can be adjusted too far to the rear beyond the correct limit (combination of seat adjustment and seat back-rest angle).

Remedy SW A2329038302 for the SEAT control unit to limit the adjustment range of the mechanical seat components.
