## STAR ONLINE PUBLICATION

**Case Number:** S2523000029

**Symptom/Vehicle Issue:** Front Footwell Wet. Water On Floor At A Pillar. Front Carpet Wet.

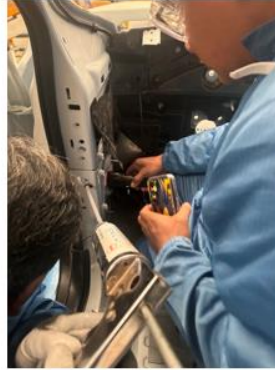
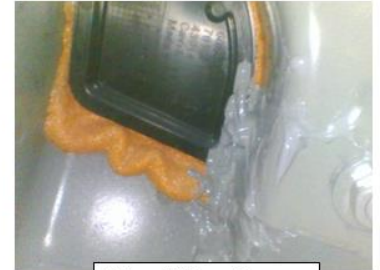
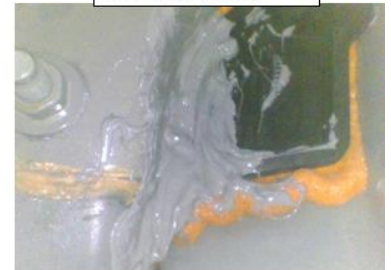
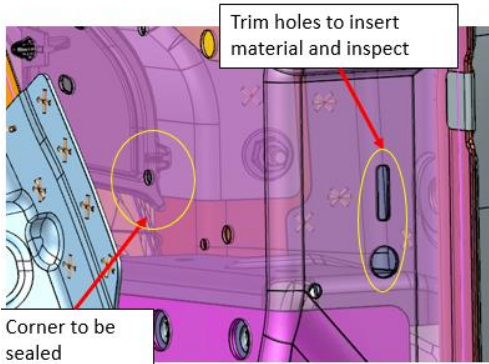
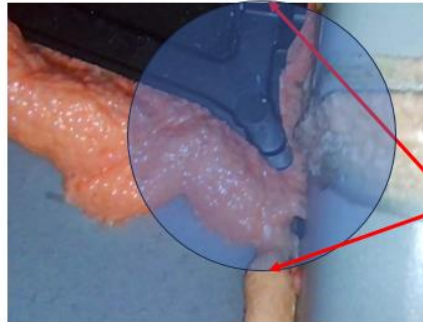
RH and LH repairs

**Customer Complaint/Technician Observation:** After a car wash or rain event, front floor area is wet. Technician may find water coming from A-Pillar area.

- Remove trim panel to gain access to hinge pillar metal
- Apply pumpable sealer to lower outboard corner of baffle
  - See next slide for list of approved materials.
- Brush sealer into corner
- Use a borescope inserted in cavity, to provide visual during repair work and to confirm completion of repair. (using flashlight is also possible)
- Allow to cure at least one hour before water test
- Validate repair by spraying water on exterior of vehicle at outboard corner of windshield. Confirm no water entering metal cavity. If water is still seen, apply additional sealer where leak is occurring.

Cover entire corner, insuring overlap of:  
Black nylon  
Orange baffle material  
White sealer  
Sheet metal
