STAR ONLINE PUBLICATION

Case Number: S2523000030

Symptom/Vehicle Issue: Fender To Fascia Flush And Or Gap Adjustment.

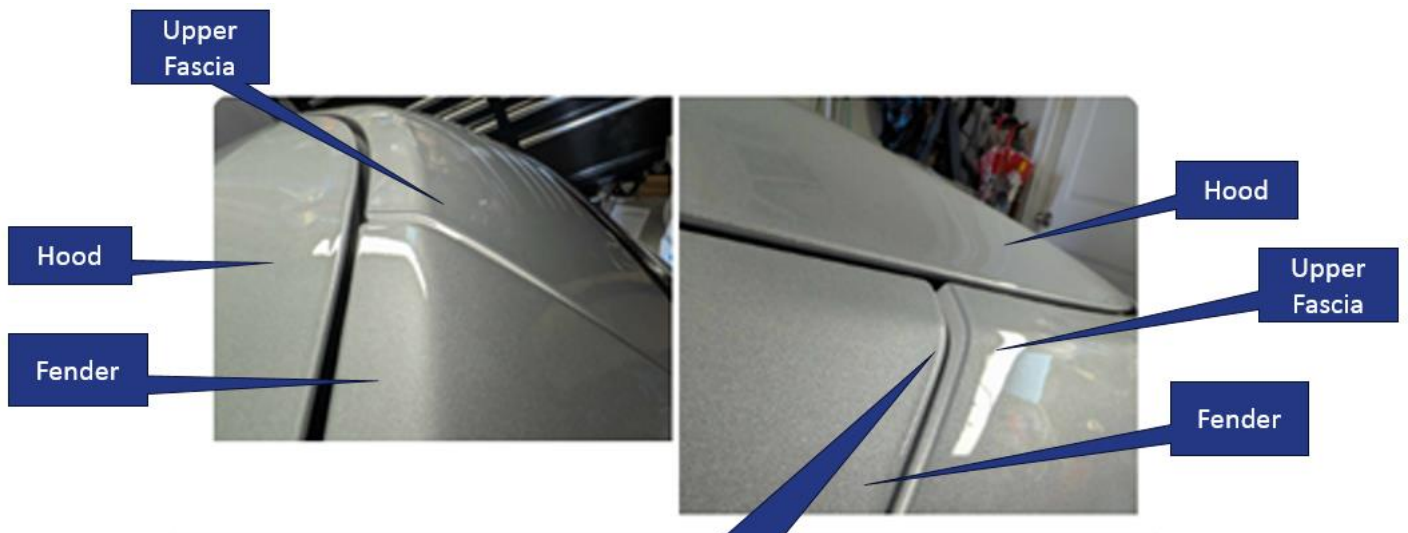
Fender to Fascia Gap/Flush Issues

Customer Complaint/Technician Observation: Customer may notice the fender, hood and upper fascia may have improper gaps or flush issues.

Discussion: If the vehicle has a flush or gap issue, review the below information to improve fender to fascia fitment.
