REFERENCE:	TSB: 08-121-25 GROUP: 08 - Electrical	Date:	April 16, 2025	REVISION:	—
VEHICLES AFFECTED:	2025 (DT) 1500 Pickup This bulletin applies to vehicles built on or after December 01, 2023 (MDH 1201XX) and on or before November 24, 2024 (MDH 1124XX) equipped with one of the following radios: <ul style="list-style-type: none"> • Uconnect 5 w 8.4" Display (USA) (Sales Codes UBE). • Uconnect 5 w 8.4" Display (ROW-DAB) (Sales Codes UPE). • Uconnect 5 w 8.4" Display (CAN) (Sales Code UEE). 			MARKET APPLICABILITY:	
				<input checked="" type="checkbox"/> NA	<input checked="" type="checkbox"/> MEA
				<input type="checkbox"/> SA	<input type="checkbox"/> IAP
				<input type="checkbox"/> EE	<input type="checkbox"/> CH
CUSTOMER SYMPTOM:	The customer may describe one or more of the following: <ul style="list-style-type: none"> • Clock resets to default when vehicle is turned off. 				
CAUSE:	Radio software.

This bulletin involves updating the software via USB to R370.02.32.

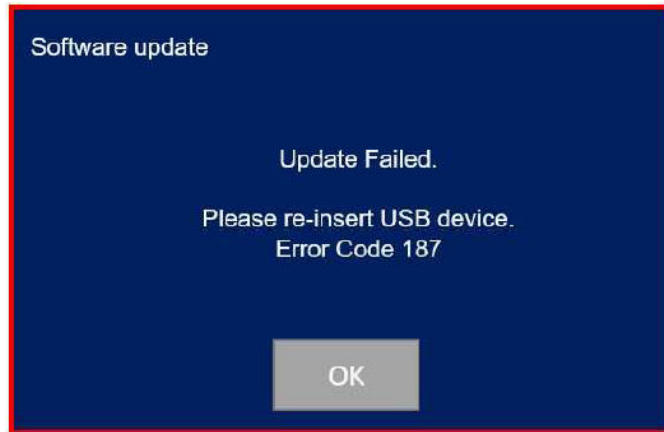
Fig. 6

9. If you see during reflash on the screen any error message like “Error code 187, 255 or 260” there is a reading problem with USB stick. Just reinsert USB. If it repeats use another USB stick [Fig. 6](#).

Error Message Display
