**Technical Service Bulletin (TSB)**  
**Improperly Installed Wastegate Rod Retention Clips**

<b>REFERENCE:</b>	<b>TSB:</b> 09-008-25 <b>GROUP:</b> 09 - Engine	<b>Date:</b>	April 16, 2025	<b>REVISION:</b>	—
<b>VEHICLES AFFECTED:</b>	<b>2025 (DT) RAM 1500 Pickup</b> This bulletin applies to vehicles built on or after June 01, 2024 (MDH 0601XX) and on or before March 03, 2025 (MDH 0325XX) equipped with the 3.0L I6 Hurricane HO Twin Turbo ESS (Sales Code EFC).	<b>MARKET APPLICABILITY:</b>		<input checked="" type="checkbox"/> NA	<input type="checkbox"/> MEA
				<input type="checkbox"/> EE	<input type="checkbox"/> IAP
				<input type="checkbox"/> SA	<input type="checkbox"/> CH
<b>CUSTOMER SYMPTOM:</b>	<p><b>Customers must experience a Malfunction Indicator Lamp (MIL) illumination and the vehicle must exhibit/set one or more of the following Diagnostic Trouble Codes (DTCs):</b></p> <ul style="list-style-type: none"> <li>• P0248-00 - Turbocharger-Supercharger Wastegate Actuator B Range-performance.</li> <li>• P2B94-00 - Wastegate Position Sensor B Exceeded Learning Limit.</li> </ul> <p><b>Customers may also experience the following:</b></p> <ul style="list-style-type: none"> <li>• Lack o

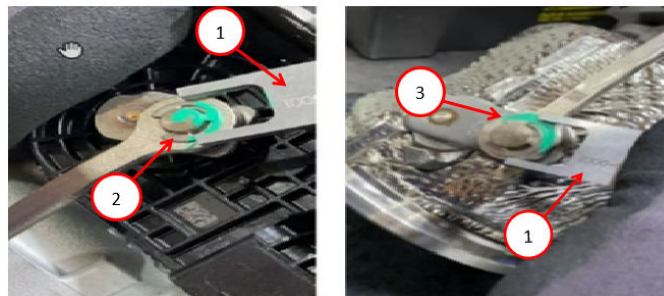
**Fig. 1**  
Wastegate Rod Retaining Clips

<b>CAUSE:</b>	Incorrectly installed wastegate rod retention clips

- 1 - Measuring Tool
- 2 - Actuator Side Wastegate Rod Retaining Clip
- 3 - Housing Side Wastegate Rod Retaining Clip

1. Remove the clean air tube. Refer to the detailed service procedures available in DealerCONNECT/Service Library under: Service Info> 09 - Engine, 3.0L GMET6 / Air Intake System / Tube, Intake Air / Removal.
2. Using a caliper, measure the dimensions of the two wastegate rod retaining clips on the actuator side [Fig. 1](#).

3. Is the measurement of either wastegate rod retaining clip on the actuator side greater than 13.70 mm (0.5 in.)?
  - YES>>> Proceed to [Step 4](#).
  - NO>>> Proceed to [Step 5](#).
4. Replace any wastegate rod retaining clip on the actuator side that measures larger than 13.70 mm (0.5 in.).

5. Using a caliper, measure the dimensions of the two wastegate rod retaining clips on the housing side [Fig. 1](#).
6. Is the measurement of either of the wastegate rod retaining clips on the housing side greater than 17.78 mm (0.7 in.)?
  - YES>>> Proceed to [Step 7](#).
  - NO>>> This bulletin has been completed, use Inspect LOP (09-44-03-92) to close this active RSU and proceed to [Step 8](#).
7. Replace any wastegate rod retaining clip on the housing side that measures larger than 17.78 mm (0.7 in.).
8. Install the clean air tube. Refer to the detailed service procedures available in DealerCONNECT/Service Library under: Service Info> 09 - Engine, 3.0L GMET6 / Air Intake System / Tube, Intake Air / Installation.
9. Clear DTCs.
