**Technical Service Bulletin (TSB)**  
**Oil Leak In Transfer Case Rear Output Shaft Seal**

<b>REFERENCE:</b>	<b>TSB:</b> 21-031-25 <b>GROUP:</b> 03 - Differential and Driveline	<b>Date:</b>	April 15, 2025	<b>REVISION:</b>	—
<b>VEHICLES AFFECTED:</b>	<p>2024 (DJ) RAM 2500 Pickup 2024 (D2) RAM 3500 Pickup</p> <p>This bulletin applies to vehicles built on and after May 01, 2024 (MDH 0501XX) and on and before November 18, 2024 (MDH 1118XX) equipped with either the:</p> <ul style="list-style-type: none"> <li>6.4L V8 Heavy Duty Hemi MDS Engine (Sales Code ESB).</li> <li>6.7L I6 Cummins Turbo Diesel Engine (Sales Code ETL).</li> </ul>	<b>MARKET APPLICABILITY:</b>			
<b>CUSTOMER SYMPTOM:</b>	<p><b>Customers may experience the following:</b></p> <ul style="list-style-type: none"> <li>Oil leak from transfer case rear output shaft seal.</li> </ul>				
<b>CAUSE:</b>	Dirt contamination

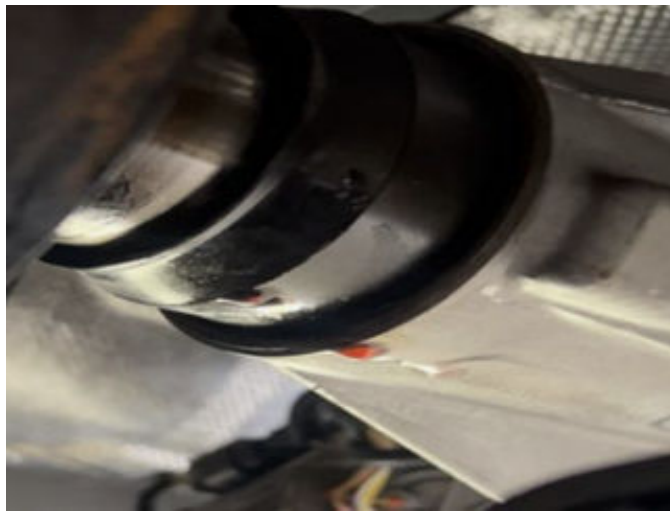
1. Is the vehicle on the RSU VIN list?
  - YES>>> Proceed to [Step 2](#).
  - NO>>> This bulletin does not apply.
2. Raise and support the vehicle. Refer to the detailed service procedures available in DealerCONNECT/ Service Library under: Service Info>04 - Vehicle Quick Reference / Hoisting / Standard Procedure.
3. Inspect the output shaft seal on the rear of the transfer case.
4. Is there oil leaking from the transfer case rear output shaft seal [Fig. 1](#)?

**Fig. 1**  
Oil Leak

- YES>>> Proceed to [Step 5](#).
  - NO>>> This bulletin does not apply. Use Inspect LOP (21-03-20-92) to close the active RSU.
5. Replace the rear output shaft seal. Refer to the detailed service procedures available in DealerCONNECT/ Service Library under: Service Info> 21 - Transmission and Transfer Case / Transfer Case/ Seal, Extension Housing, Rear / Removal and Installation.
