TECHNICAL SERVICE BULLETIN

Headliner Detaching From Soft Top Material

25-2153

Ford 2021-2025 Bronco	Factory soft top roof
---------------------------------	-----------------------

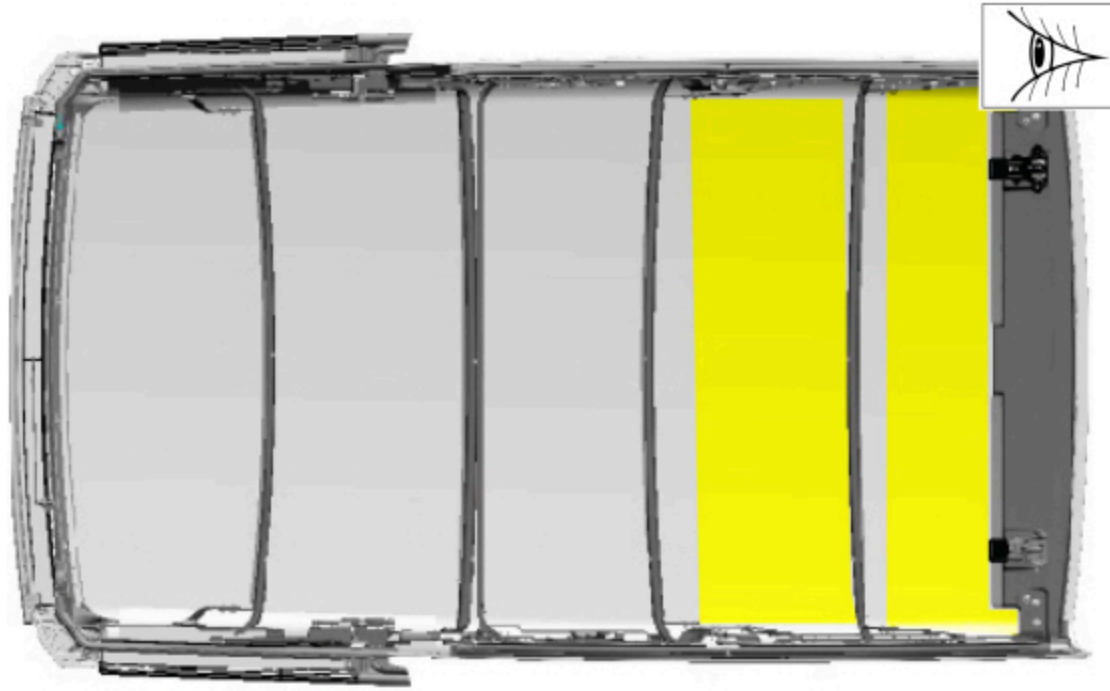
2. The soft top material has 2 separate sections of headliners, refer to Figure 1 for locations. Are either of the 2 headliners completely detached from the soft top material and/or damaged, such as stretched, cut and/or warped? (Figures 1-3)

Figure 1 - View from underside of the soft top assembly. Both headliner locations shown.

- (1). Yes - replace the soft top material. Refer to WSM, Section 501-18A. Repair is complete.
- (2). No - proceed to Step 3.

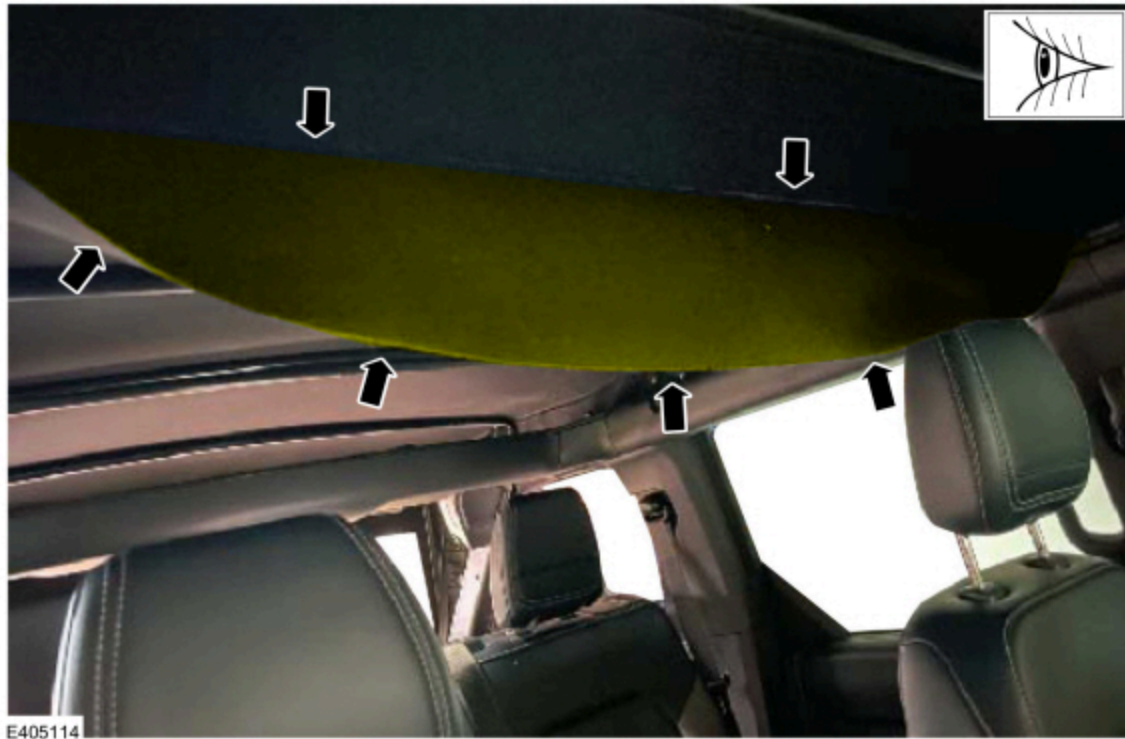
Figure 2 - Example of an undamaged, partially detached headliner that can be repaired

Figure 3 - Example of an undamaged, partially detached headliner that can be repaired

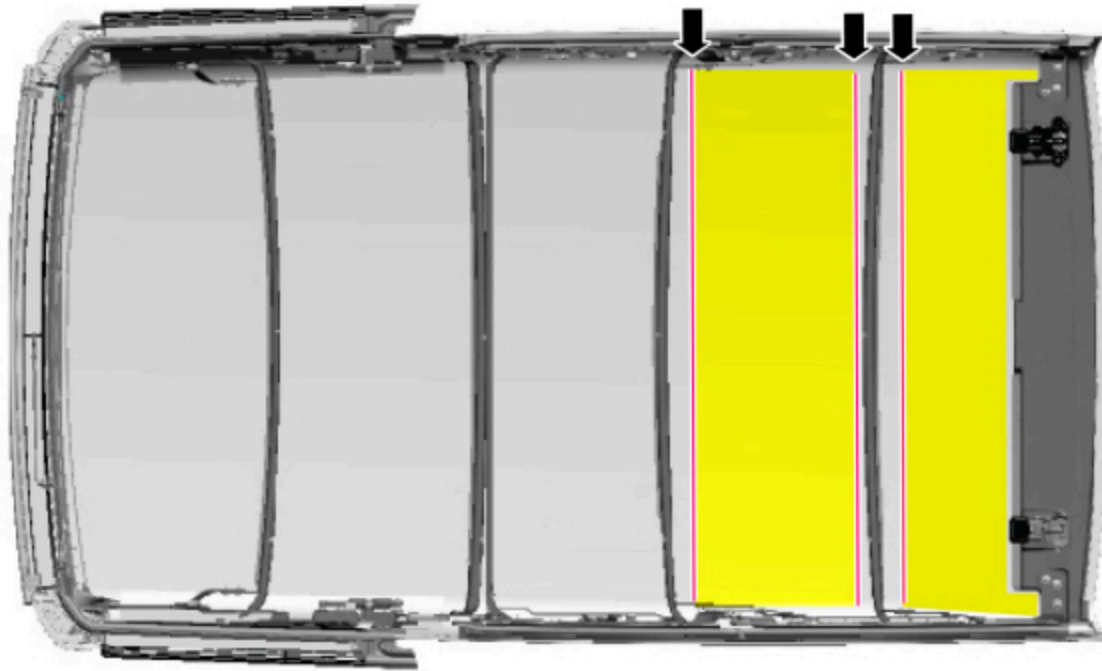
Figure 6 - Showing all 3 headliner seams that must be taped

- (5). Remove all protective material (tape/paper/cardboard). Proceed to Step 8.
8. Install 3M™ Film Tape 9343 over the cross-car headliner seams.
 - (1). Tape all 3 cross-car headliner seams regardless of if they were becoming partially detached or not. Refer to Figure 6 for cross-car headliner seam locations.

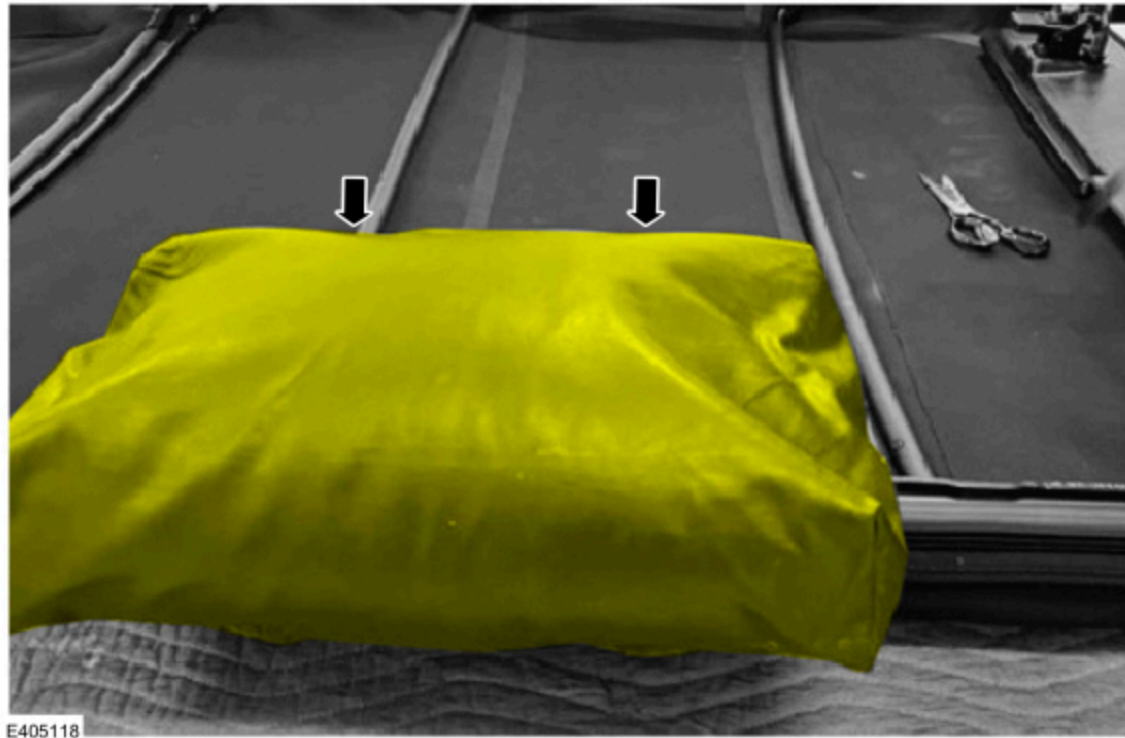
Figure 7 - Sandbag shown on top of frame hinge location. Left side shown, right side similar.

(2). Place a 50 lb. (22.6 kg) sandbag (or similar item) on each the side of the frame to weigh down the raised hinged sections of the frame. This flattens the soft top assembly for easier application. If needed, place a clean cloth underneath the sandbags to prevent the soft top assembly from getting dirty. Refer to Figure 7.

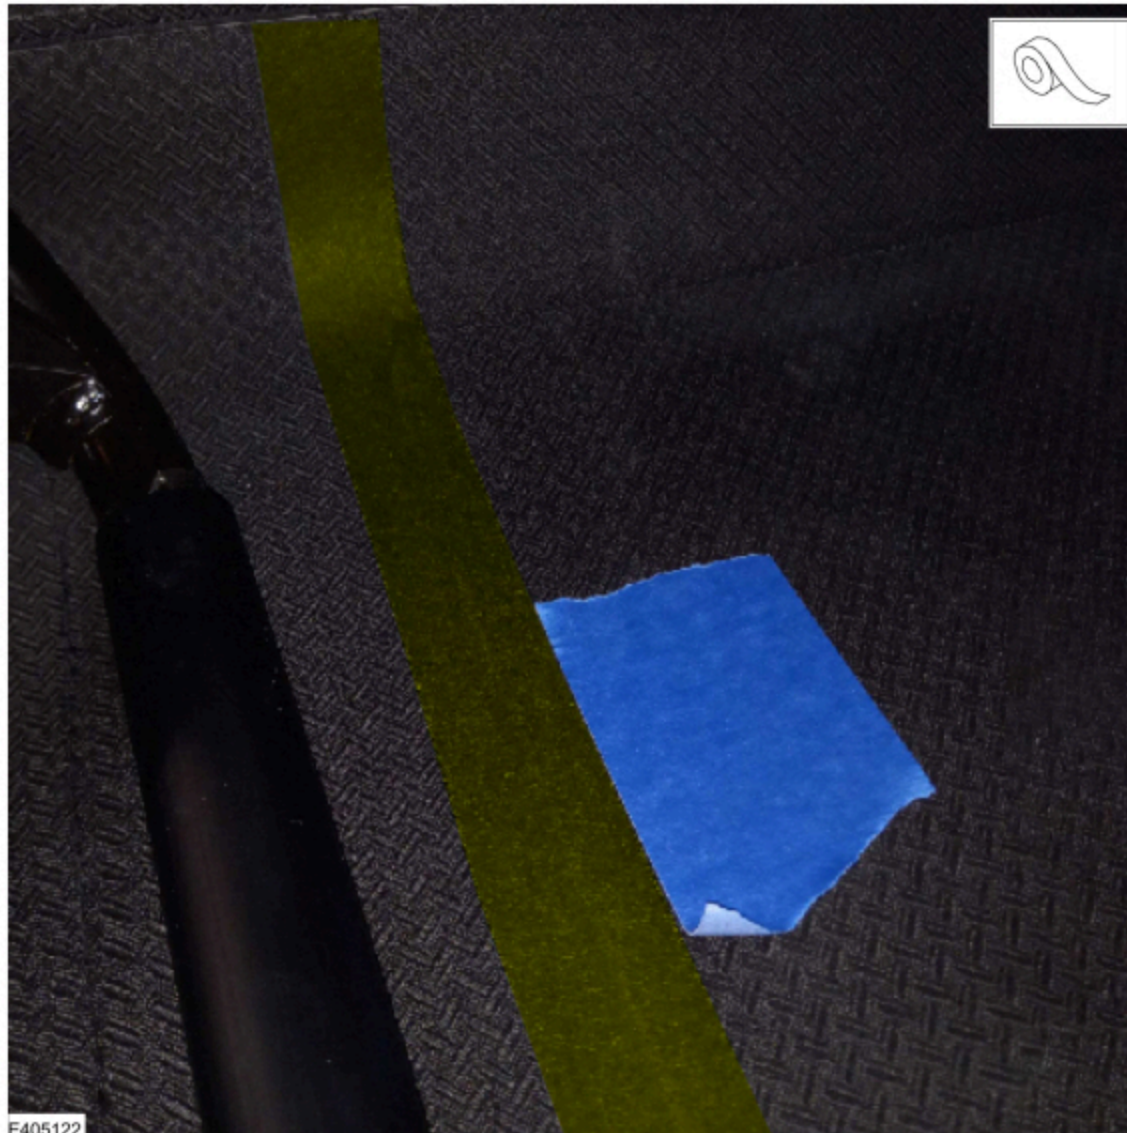
Figure 11 - Showing proper tape installation on the edge of the soft top material.

(7). When the section of film tape reaches the end of the headliner seam, continue to tape in a straight line all the way to the edge of the soft top seam. Allow the tape to stay loose during application. Cut the end of the film tape so that it ends just before the soft top material edge but do not tape past the edge, which runs perpendicular to the tape routing. Be sure that 100% of the film tape is secured and flat to the surface. Do not leave any sections of tape loose/unattached, as this causes tape to peel over time. Perform this step on the opposite edge of the section of film tape, then proceed to the next step. (Figure 11)
