# GranTurismo, GranCabrio: Air Suspension System Diagnosis

**ATTENTION! This bulletin supersedes [MAS004471 RU 25-09](#) released on December 17, 2024. This bulletin has been updated with new diagnostic info. Please discard/remove all copies of the previous**

DATE: April 4, 2025

- M189 GranTurismo and GranCabrio(All MY)

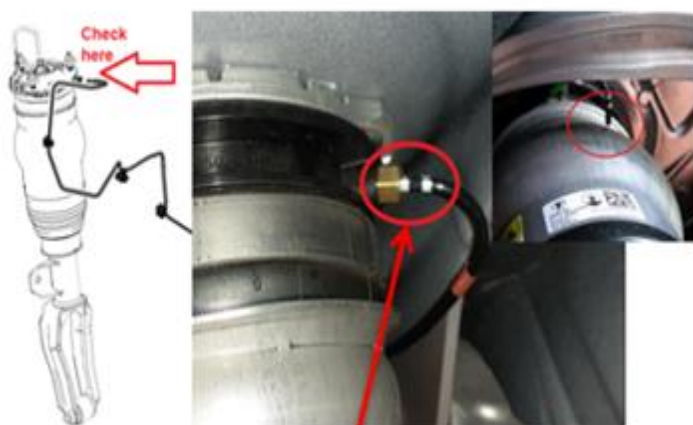
Sample of incorrect Air Suspension pipe installation on the front Air spring

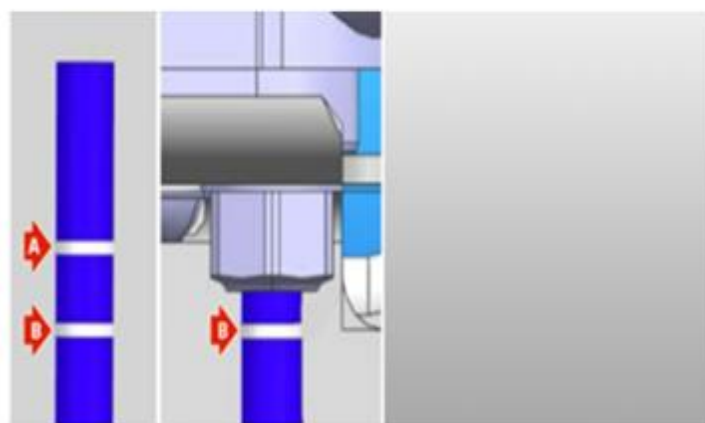
Correct layout to be ensured on the vehicle (points A and B)

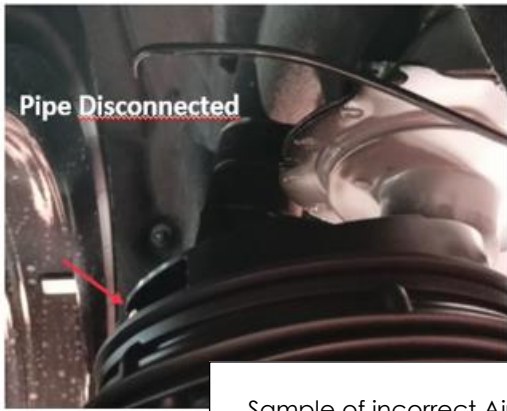
Sample of incorrect Air Suspension pipe installation on the Rear Air Spring

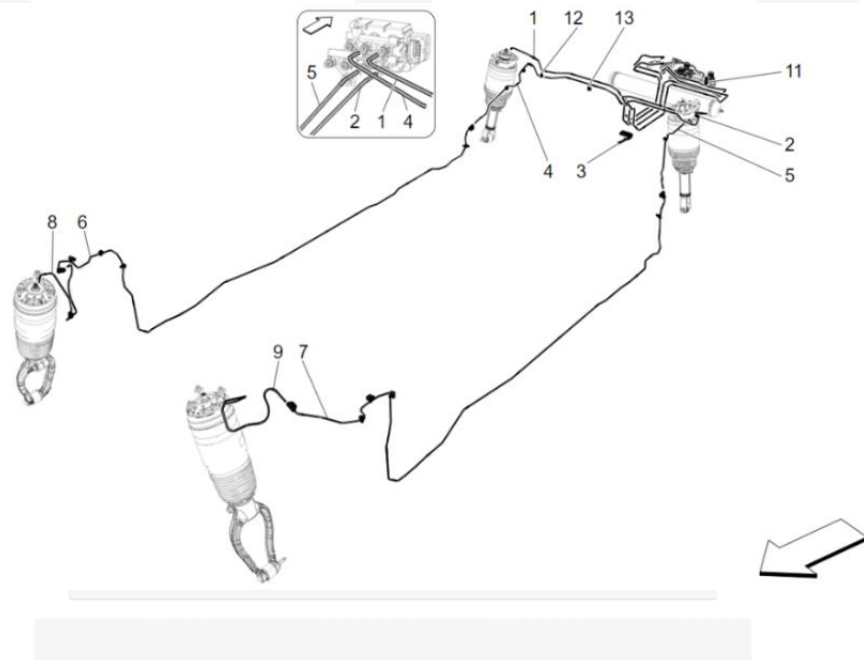
Old configuration

3b – Pipes connection area (check the connections for at least 5-10 minutes with one of the products indicated at the end of this document)

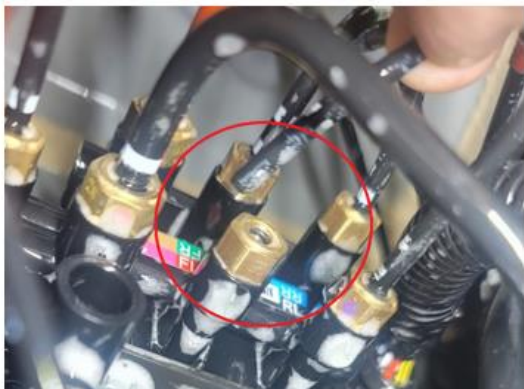
**4 – Air Valves Block pipes – disconnected or wrongly fitted (check the connections for at least 5-10 minutes with one of the products indicated at the end of this document)**

Check the air valves block pipes to ensure that there isn't any disconnected and/or wrongly installed line

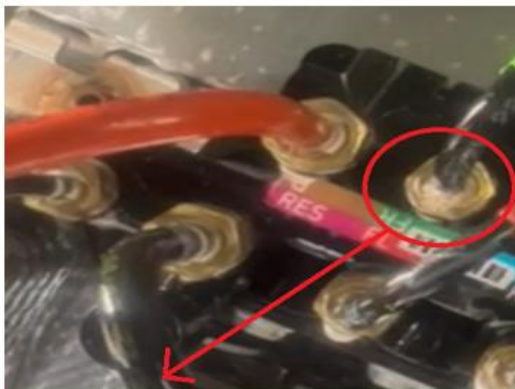
Use soapy water to detect potential air leak through the system

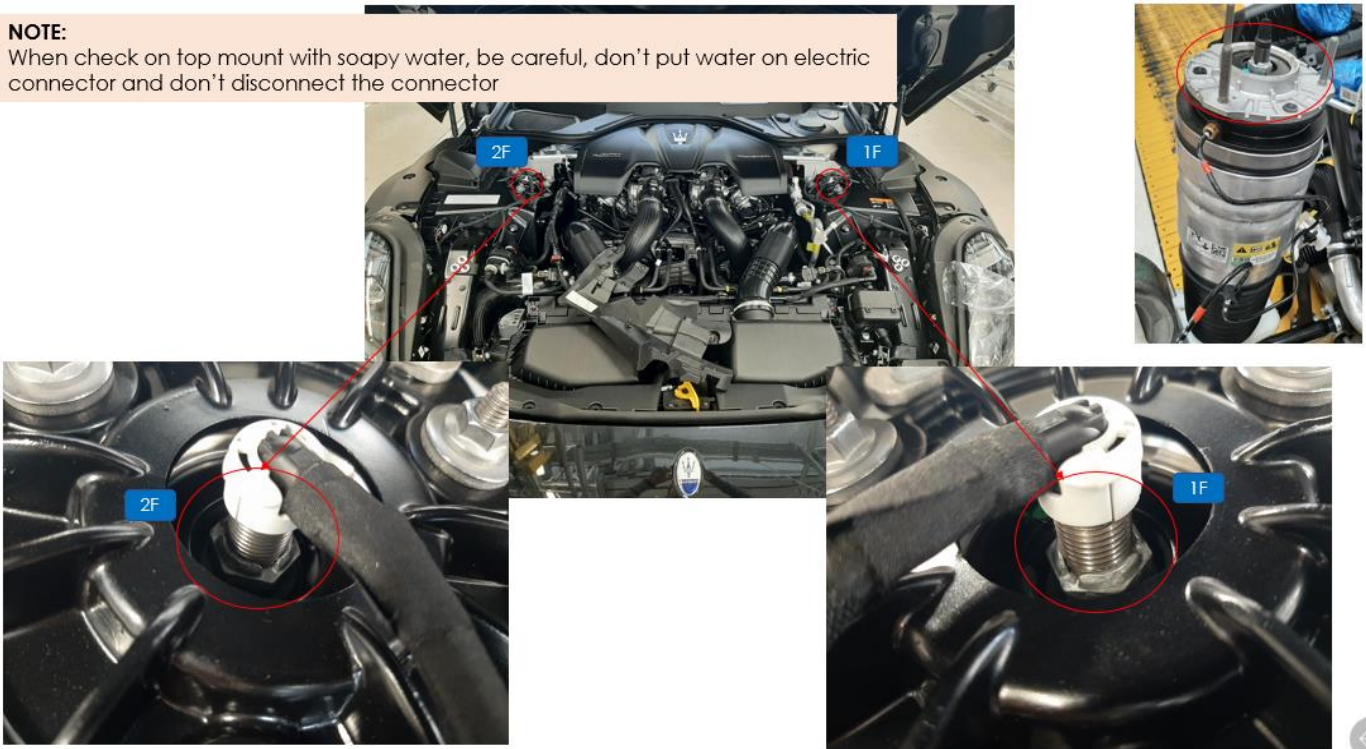
# M189 – Front Top Mount

**NOTE:**  
When check on top mount with soapy water, be careful, don't put water on electric connector and don't disconnect the connector
